Date: July, 2005
Report Ref: R9925.115.5.07.001_DR

2 Llys Nazareth
Llwewlyn Street
Pentre
CF41 7BS

TYPE II ASBESTOS SURVEY

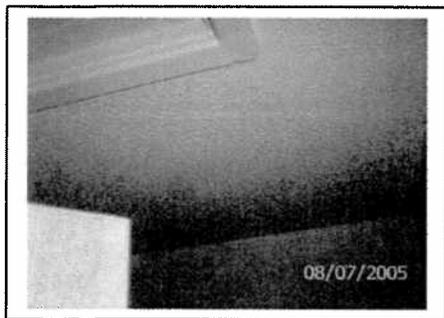
Sample No. 50807CB025
Location G001
Description Textured coating to ceiling

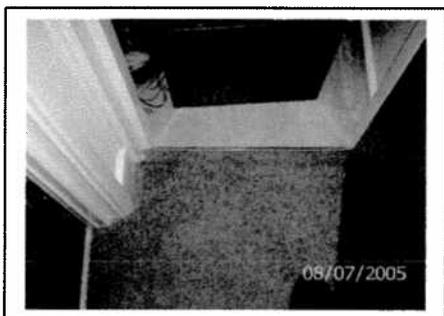
Sample No. 50807CB026
Location G006
Description Beige floor tiles and bitumen adhesive
