Asbestos Management Survey

20 Llys Nazareth
Llewellyn Street
Pentre
Mid Glamorgan
CF41 7BS
UPRN: 005474

Name and address of site:	20 Llys Nazareth, Llewellyn Street, Pentre, Mid Glamorgan		
Name and address of client:	Wales & West Housing, Head Office, Archway House, 77 Parc Ty Glas, Llanishen, Cardiff		
Client contact:	Perry Dobbins		
Type of survey:	Management Survey (with MA and PA)		
Date of survey:	8 Nov 2018		
Report revision number:	1		
TEAMS internal job number:	J016164		
Lead surveyor(s):	Dave Milton	Signature:

Report issue date:	15 Nov 2018

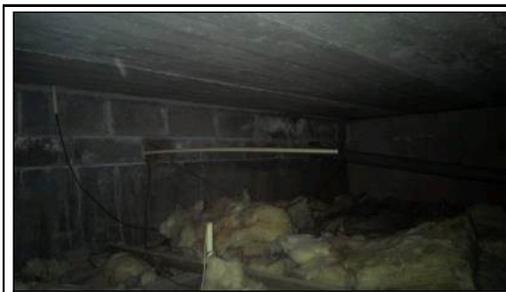
Survey Date:	Lead Surveyor	Survey Type	Floor	Analysis
8 Nov 2018	Dave Milton	Management Survey	Roof	N/A
Building	Room	Item	Quantity	
Flat 20, Block 1-20	Loft space 1 R01	No suspect materials identified	N/A	
Sample No (S,SP,P,As)	Product Type	Surface Treatment	Condition	Accessibility
Visual (P)	N/A	N/A	N/A	N/A

Normal Occupancy	Score	Likelihood of disturbance	Score	Exposure Potential	Score	Maintenance Activity	Score
Main type of activity	N/A	Location	N/A	Number of occupants	N/A	Type of Maintenance	N/A
		Accessibility	N/A	Frequency of use	N/A	Frequency of maintenance	N/A
		Amount	N/A	Average Time	N/A		
Average Score	N/A	Average Score	N/A	Average Score	N/A	Average Score	N/A
Average of Priority	N/A						
Material Assessment Score	N/A						
Recommendation	No further action required						
Surveyor comments	N/A

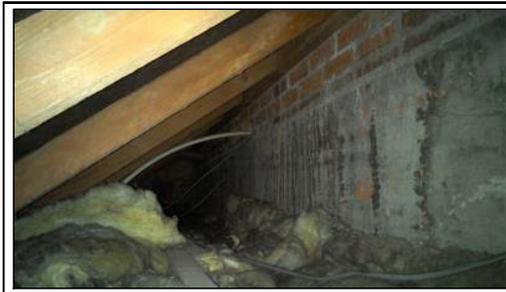
Survey Date:	Lead Surveyor	Survey Type	Floor	Analysis
8 Nov 2018	Dave Milton	Management Survey	Roof	N/A
Building	Room	Item	Quantity	
Flat 20, Block 1-20	Loft space 2 R02	No suspect materials identified	N/A	
Sample No (S,SP,P,As)	Product Type	Surface Treatment	Condition	Accessibility
Visual (P)	N/A	N/A	N/A	N/A

Normal Occupancy	Score	Likelihood of disturbance	Score	Exposure Potential	Score	Maintenance Activity	Score
Main type of activity	N/A	Location	N/A	Number of occupants	N/A	Type of Maintenance	N/A
		Accessibility	N/A	Frequency of use	N/A	Frequency of maintenance	N/A
		Amount	N/A	Average Time	N/A		
Average Score	N/A	Average Score	N/A	Average Score	N/A	Average Score	N/A
Average of Priority	N/A						
Material Assessment Score	N/A						
Recommendation	No further action required						
Surveyor comments	N/A

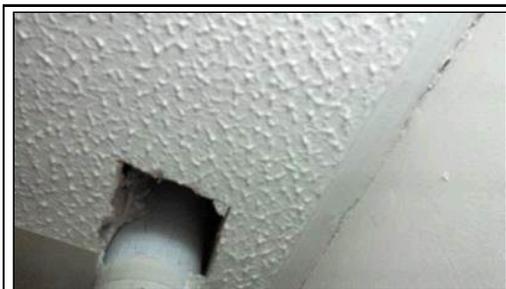
Survey Date:	Lead Surveyor	Survey Type	Floor	Analysis
8 Nov 2018	Dave Milton	Management Survey	Z-Sub	
Building	Room	Item	Quantity	No Asbestos Detected (0)
Flat 20, Block 1-20	Boiler cupboard Z101	Textured coating to plasterboard ceiling	0.5	
Sample No (S,SP,P,As)	Product Type	Surface Treatment	Condition	Accessibility
AI004799 (S)	Textured Coating (1)	Completely Sealed (0)	Medium Damage (2)	Occasionally likely to be disturbed (1)

Normal Occupancy	Score	Likelihood of disturbance	Score	Exposure Potential	Score	Maintenance Activity	Score
Main type of activity	N/A	Location	N/A	Number of occupants	N/A	Type of Maintenance	N/A
		Accessibility	N/A	Frequency of use	N/A	Frequency of maintenance	N/A
		Amount	N/A	Average Time	N/A		
Average Score	N/A	Average Score	N/A	Average Score	N/A	Average Score	N/A
Average of Priority	N/A						
Material Assessment Score	N/A						
Recommendation	No further action required						
Surveyor comments	N/A

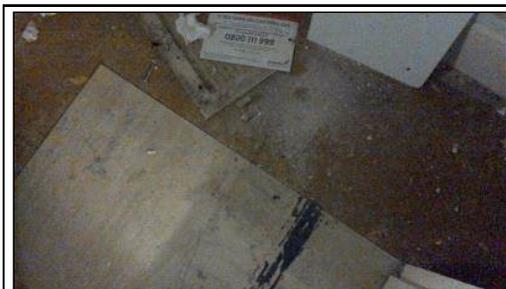
Survey Date:	Lead Surveyor	Survey Type	Floor	Analysis
8 Nov 2018	Dave Milton	Management Survey	Z-Sub	
Building	Room	Item	Quantity	
Flat 20, Block 1-20	Boiler cupboard Z101	Beige vinyl tiles to chipboard floor.	0.2m ²	No Asbestos Detected (0)
Sample No (S,SP,P,As)	Product Type	Surface Treatment	Condition	Accessibility
AI004800 (S)	Reinforced Composite (1)	Completely Sealed (0)	Good Condition (0)	Routinely disturbed (3)

Normal Occupancy	Score	Likelihood of disturbance	Score	Exposure Potential	Score	Maintenance Activity	Score
Main type of activity	N/A	Location	N/A	Number of occupants	N/A	Type of Maintenance	N/A
		Accessibility	N/A	Frequency of use	N/A	Frequency of maintenance	N/A
		Amount	N/A	Average Time	N/A		
Average Score	N/A	Average Score	N/A	Average Score	N/A	Average Score	N/A
Average of Priority	N/A						
Material Assessment Score	N/A						
Recommendation	No further action required						
Surveyor comments	N/A

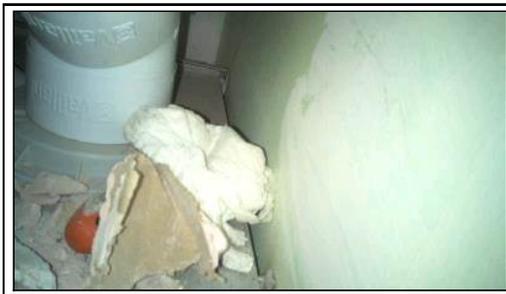
Survey Date:	Lead Surveyor	Survey Type	Floor	Analysis
8 Nov 2018	Dave Milton	Management Survey	Z-Sub	
Building	Room	Item	Quantity	
Flat 20, Block 1-20	Boiler cupboard Z101	Textured coating debris on top of boiler unit.	0.25m ²	No Asbestos Detected (0)
Sample No (S,SP,P,As)	Product Type	Surface Treatment	Condition	Accessibility
As AI004799 (SP)	Textured Coating (1)	Completely Sealed (0)	High Damage (3)	Easily disturbed (2)

Normal Occupancy	Score	Likelihood of disturbance	Score	Exposure Potential	Score	Maintenance Activity	Score
Main type of activity	N/A	Location	N/A	Number of occupants	N/A	Type of Maintenance	N/A
		Accessibility	N/A	Frequency of use	N/A	Frequency of maintenance	N/A
		Amount	N/A	Average Time	N/A		
Average Score	N/A	Average Score	N/A	Average Score	N/A	Average Score	N/A
Average of Priority	N/A						
Material Assessment Score	N/A						
Recommendation	No further action required						
Surveyor comments	Textured coating and plasterboard debris.

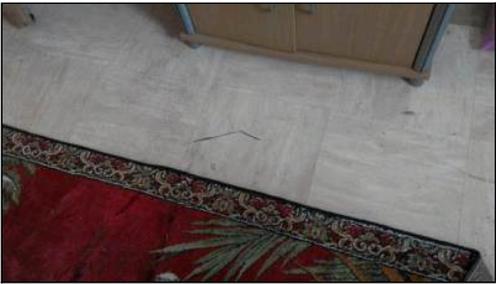
Survey Date:	Lead Surveyor	Survey Type	Floor	Analysis
	8 Nov 2018	Dave Milton	Management Survey	Z-Sub	No Asbestos Detected (0)
	Building	Room	Item	Quantity	
	Flat 20, Block 1-20	Lounge Z102	Beige vinyl tiles to chipboard floor.	9m ²	
	Sample No (S,SP,P,As)	Product Type	Surface Treatment	Condition	Accessibility
As AI004800 (SP)	Reinforced Composite (1)	Completely Sealed (0)	Good Condition (0)	Routinely disturbed (3)

Normal Occupancy	Score	Likelihood of disturbance	Score	Exposure Potential	Score	Maintenance Activity	Score
Main type of activity	N/A	Location	N/A	Number of occupants	N/A	Type of Maintenance	N/A
		Accessibility	N/A	Frequency of use	N/A	Frequency of maintenance	N/A
		Amount	N/A	Average Time	N/A		
Average Score	N/A	Average Score	N/A	Average Score	N/A	Average Score	N/A
Average of Priority	N/A						
Material Assessment Score	N/A						
Recommendation	No further action required						
Surveyor comments	N/A

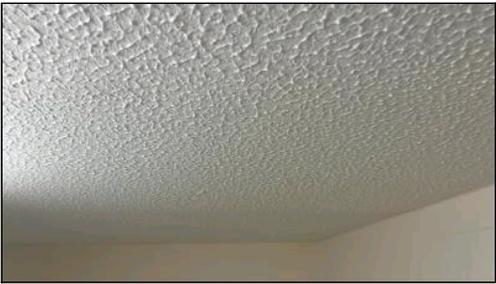
Survey Date:	Lead Surveyor	Survey Type	Floor	Analysis
	8 Nov 2018	Dave Milton	Management Survey	Z-Sub	No Asbestos Detected (0)
	Building	Room	Item	Quantity	
	Flat 20, Block 1-20	Kitchen Z103	Textured coating to plasterboard ceiling	6m ²	
	Sample No (S,SP,P,As)	Product Type	Surface Treatment	Condition	Accessibility
	As AI004799 (SP)	Textured Coating (1)	Completely Sealed (0)	Good Condition (0)	Occasionally likely to be disturbed (1)

Normal Occupancy	Score	Likelihood of disturbance	Score	Exposure Potential	Score	Maintenance Activity	Score
Main type of activity	N/A	Location	N/A	Number of occupants	N/A	Type of Maintenance	N/A
		Accessibility	N/A	Frequency of use	N/A	Frequency of maintenance	N/A
		Amount	N/A	Average Time	N/A		
Average Score	N/A	Average Score	N/A	Average Score	N/A	Average Score	N/A
Average of Priority	N/A						
Material Assessment Score	N/A						
Recommendation	No further action required						
Surveyor comments	N/A

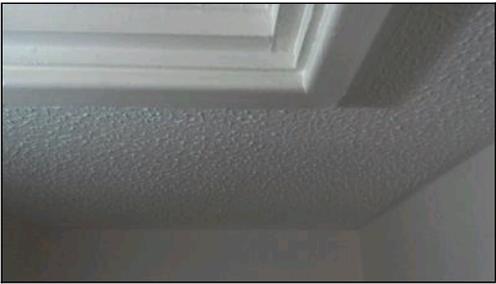
Survey Date:	Lead Surveyor	Survey Type	Floor	Analysis
	8 Nov 2018	Dave Milton	Management Survey	Z-Sub	
	Building	Room	Item	Quantity	
	Flat 20, Block 1-20	Hall Z104	Textured coating to plasterboard ceiling	2m ²	No Asbestos Detected (0)
	Sample No (S,SP,P,As)	Product Type	Surface Treatment	Condition	Accessibility
	As AI004799 (SP)	Textured Coating (1)	Completely Sealed (0)	Good Condition (0)	Occasionally likely to be disturbed (1)

Normal Occupancy	Score	Likelihood of disturbance	Score	Exposure Potential	Score	Maintenance Activity	Score
Main type of activity	N/A	Location	N/A	Number of occupants	N/A	Type of Maintenance	N/A
		Accessibility	N/A	Frequency of use	N/A	Frequency of maintenance	N/A
		Amount	N/A	Average Time	N/A		
Average Score	N/A	Average Score	N/A	Average Score	N/A	Average Score	N/A
Average of Priority	N/A						
Material Assessment Score	N/A						
Recommendation	No further action required						
Surveyor comments	N/A

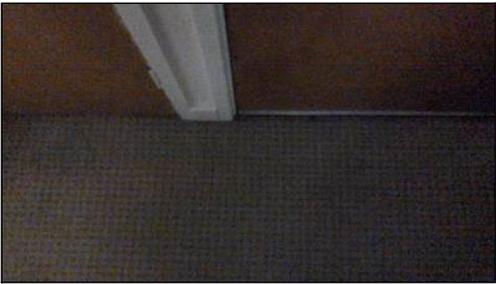
Survey Date:	Lead Surveyor	Survey Type	Floor	Analysis
	8 Nov 2018	Dave Milton	Management Survey	Z-Sub	Chrysotile (1)
	Building	Room	Item	Quantity	
	Flat 20, Block 1-20	Hall Z104	Strongly presumed vinyl tiles to chipboard floor beneath fitted beige carpet.	2m ²	
	Sample No (S,SP,P,As)	Product Type	Surface Treatment	Condition	Accessibility
Visual (SP)	Reinforced Composite (1)	Completely Sealed (0)	Good Condition (0)	Occasionally likely to be disturbed (1)

Normal Occupancy	Score	Likelihood of disturbance	Score	Exposure Potential	Score	Maintenance Activity	Score
Main type of activity	1	Location	2	Number of occupants	1	Type of Maintenance	1
		Accessibility	1	Frequency of use	3	Frequency of maintenance	1
		Amount	1	Average Time	0		
Average Score	1	Average Score	2	Average Score	2	Average Score	1
Average of Priority	6						
Material Assessment Score	2						
Recommendation	Inspection required						
Surveyor comments	No access at the time of the survey due to the potential to cause damage to fixtures and fittings.

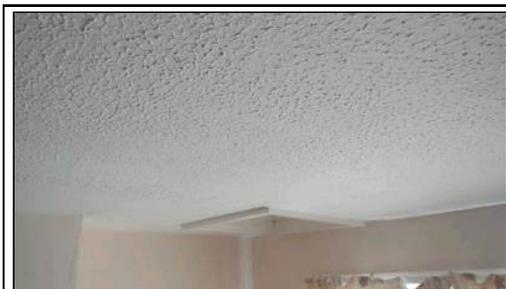
Survey Date:	Lead Surveyor	Survey Type	Floor	Analysis
8 Nov 2018	Dave Milton	Management Survey	Z-Sub	No Asbestos Detected (0)
Building	Room	Item	Quantity	
Flat 20, Block 1-20	Bedroom Z105	Textured coating to plasterboard ceiling	6m ²	
Sample No (S,SP,P,As)	Product Type	Surface Treatment	Condition	Accessibility
As AI004799 (SP)	Textured Coating (1)	Completely Sealed (0)	Good Condition (0)	Occasionally likely to be disturbed (1)

Normal Occupancy	Score	Likelihood of disturbance	Score	Exposure Potential	Score	Maintenance Activity	Score
Main type of activity	N/A	Location	N/A	Number of occupants	N/A	Type of Maintenance	N/A
		Accessibility	N/A	Frequency of use	N/A	Frequency of maintenance	N/A
		Amount	N/A	Average Time	N/A		
Average Score	N/A	Average Score	N/A	Average Score	N/A	Average Score	N/A
Average of Priority	N/A						
Material Assessment Score	N/A						
Recommendation	No further action required						
Surveyor comments	N/A

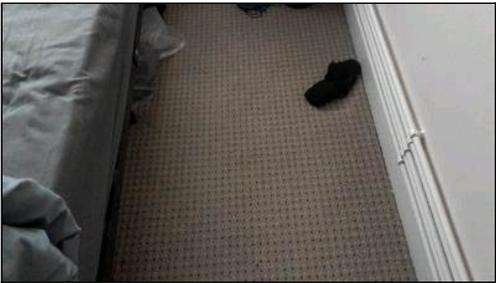
Survey Date:	Lead Surveyor	Survey Type	Floor	Analysis
	8 Nov 2018	Dave Milton	Management Survey	Z-Sub	Chrysotile (1)
	Building	Room	Item	Quantity	
	Flat 20, Block 1-20	Bedroom Z105	Strongly presumed vinyl tiles to chipboard floor beneath fitted beige carpet.	6m ²	
	Sample No (S,SP,P,As)	Product Type	Surface Treatment	Condition	Accessibility
Visual (SP)	Reinforced Composite (1)	Completely Sealed (0)	Good Condition (0)	Occasionally likely to be disturbed (1)

Normal Occupancy	Score	Likelihood of disturbance	Score	Exposure Potential	Score	Maintenance Activity	Score
Main type of activity	1	Location	2	Number of occupants	1	Type of Maintenance	1
		Accessibility	1	Frequency of use	3	Frequency of maintenance	1
		Amount	1	Average Time	3		
Average Score	1	Average Score	2	Average Score	3	Average Score	1
Average of Priority	7						
Material Assessment Score	2						
Recommendation	Inspection required						
Surveyor comments	No access at the time of the survey due to the potential to cause damage to fixtures and fittings.

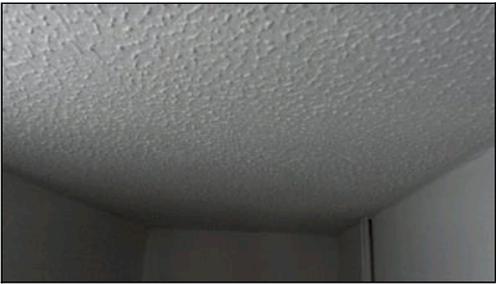
Survey Date:	Lead Surveyor	Survey Type	Floor	Analysis
	8 Nov 2018	Dave Milton	Management Survey	Z-Sub	No Asbestos Detected (0)
	Building	Room	Item	Quantity	
	Flat 20, Block 1-20	Store Z106	Textured coating to plasterboard ceiling	2m ²	
	Sample No (S,SP,P,As)	Product Type	Surface Treatment	Condition	Accessibility
	As AI004799 (SP)	Textured Coating (1)	Completely Sealed (0)	Good Condition (0)	Occasionally likely to be disturbed (1)

Normal Occupancy	Score	Likelihood of disturbance	Score	Exposure Potential	Score	Maintenance Activity	Score
Main type of activity	N/A	Location	N/A	Number of occupants	N/A	Type of Maintenance	N/A
		Accessibility	N/A	Frequency of use	N/A	Frequency of maintenance	N/A
		Amount	N/A	Average Time	N/A		
Average Score	N/A	Average Score	N/A	Average Score	N/A	Average Score	N/A
Average of Priority	N/A						
Material Assessment Score	N/A						
Recommendation	No further action required						
Surveyor comments	N/A

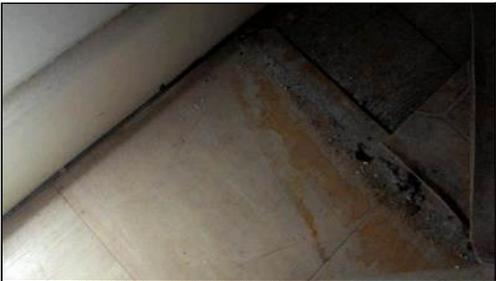
Survey Date:	Lead Surveyor	Survey Type	Floor	Analysis No Asbestos Detected (0)	
	8 Nov 2018	Dave Milton	Management Survey	Z-Sub		
	Building	Room	Item	Quantity		
	Flat 20, Block 1-20	Store Z106	Beige vinyl tiles to chipboard floor partially beneath non-suspect beige vinyl flooring.	2m ²		
	Sample No (S,SP,P,As)	Product Type	Surface Treatment	Condition		Accessibility
	As AI004800 (SP)	Reinforced Composite (1)	Completely Sealed (0)	Good Condition (0)		Easily disturbed (2)

Normal Occupancy	Score	Likelihood of disturbance	Score	Exposure Potential	Score	Maintenance Activity	Score
Main type of activity	N/A	Location	N/A	Number of occupants	N/A	Type of Maintenance	N/A
		Accessibility	N/A	Frequency of use	N/A	Frequency of maintenance	N/A
		Amount	N/A	Average Time	N/A		
Average Score	N/A	Average Score	N/A	Average Score	N/A	Average Score	N/A
Average of Priority	N/A						
Material Assessment Score	N/A						
Recommendation	No further action required						
Surveyor comments	N/A

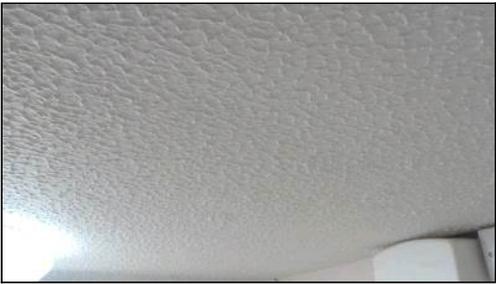
Survey Date:	Lead Surveyor	Survey Type	Floor	Analysis
	8 Nov 2018	Dave Milton	Management Survey	Z-Sub	No Asbestos Detected (0)
	Building	Room	Item	Quantity	
	Flat 20, Block 1-20	Shower room Z107	Textured coating to plasterboard ceiling	4m ²	
	Sample No (S,SP,P,As)	Product Type	Surface Treatment	Condition	Accessibility
As AI004799 (SP)	Textured Coating (1)	Completely Sealed (0)	Good Condition (0)	Occasionally likely to be disturbed (1)

Normal Occupancy	Score	Likelihood of disturbance	Score	Exposure Potential	Score	Maintenance Activity	Score
Main type of activity	N/A	Location	N/A	Number of occupants	N/A	Type of Maintenance	N/A
		Accessibility	N/A	Frequency of use	N/A	Frequency of maintenance	N/A
		Amount	N/A	Average Time	N/A		
Average Score	N/A	Average Score	N/A	Average Score	N/A	Average Score	N/A
Average of Priority	N/A						
Material Assessment Score	N/A						
Recommendation	No further action required						
Surveyor comments	N/A

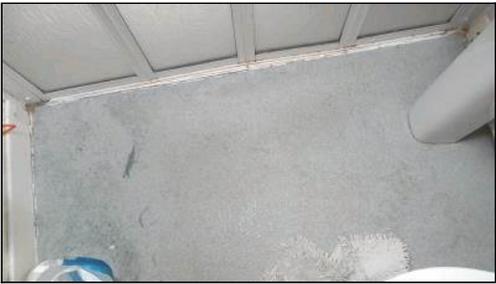
Flat 20, Block 1- 20	Z- Sub	Shower room Z107, Strongly presumed vinyl tiles to chipboard floor beneath fixed non-suspect blue vinyl flooring.	SP Visual	Reinforced Composite	Good Condition	Completely Sealed	Chrysotile	4m ²	Occasionally likely to be disturbed	2	6	8	Inspection required

Survey Date:	Lead Surveyor	Survey Type	Floor	Analysis
	8 Nov 2018	Dave Milton	Management Survey	Z-Sub	Chrysotile (1)
	Building	Room	Item	Quantity	
	Flat 20, Block 1-20	Shower room Z107	Strongly presumed vinyl tiles to chipboard floor beneath fixed non-suspect blue vinyl flooring.	4m ²	
	Sample No (S,SP,P,As)	Product Type	Surface Treatment	Condition	Accessibility
	Visual (SP)	Reinforced Composite (1)	Completely Sealed (0)	Good Condition (0)	Occasionally likely to be disturbed (1)

Normal Occupancy	Score	Likelihood of disturbance	Score	Exposure Potential	Score	Maintenance Activity	Score
Main type of activity	1	Location	2	Number of occupants	1	Type of Maintenance	1
		Accessibility	1	Frequency of use	3	Frequency of maintenance	1
		Amount	1	Average Time	0		
Average Score	1	Average Score	2	Average Score	2	Average Score	1
Average of Priority	6						
Material Assessment Score	2						
Recommendation	Inspection required						
Surveyor comments	No access at the time of the survey due to the potential to cause damage to fixtures and fittings.
