## Management with Targeted Refurbishment Survey To Wet Room

5 Llys Nazareth  
Llewellyn Street  
Pentre  
Rhondda  
CF41 7BS  
UPRN: 005459

**Building Designation:** Block 1-20. Flat 5.

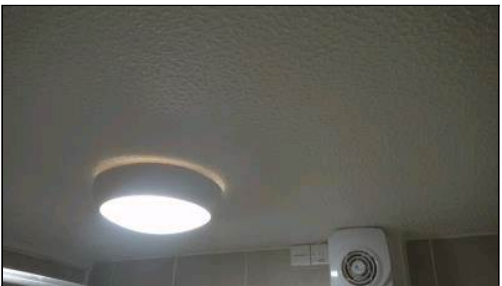
| | Survey Date: | Lead Surveyor | Survey Type | Floor | Analysis |
|---|---|---|---|---|---|
| | 27 Jul 2016 | Sebastian Lawniczak | Refurbishment and Demolition Survey | Ground | No Asbestos Detected (0) |
| | AE001622 (S) | Textured Coating (1) | Completely Sealed (0) | Good Condition (0) | Occasionally likely to be disturbed (1) |

| Normal Occupancy | Score | Likelihood of disturbance | Score | Exposure Potential | Score | Maintenance Activity | Score |
|---|---|---|---|---|---|---|---|
| Recommendation | No further action required | | | | | | |

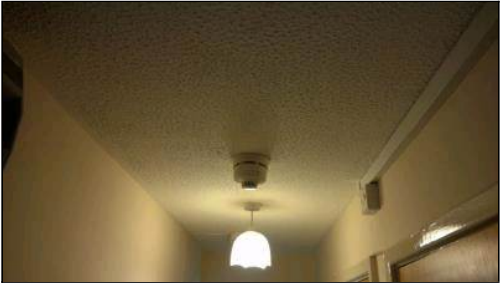
| | 27 Jul 2016 | Sebastian Lawniczak | Management Survey | Ground | No Asbestos Detected (0) |
| | As AE001622 (SP) | Textured Coating (1) | Completely Sealed (0) | Good Condition (0) | Occasionally likely to be disturbed (1) |

| Recommendation | No further action required | | | | | | |

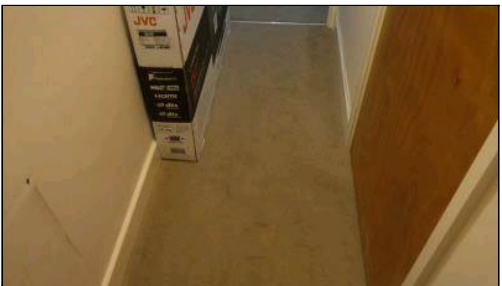
| | Survey Date: | Lead Surveyor | Survey Type | Floor | Analysis |
|---|---|---|---|---|---|
| | 27 Jul 2016 | Sebastian Lawniczak | Management Survey | Ground | No Asbestos Detected (0) |
| | AE001623 (S) | Reinforced Composite (1) | Completely Sealed (0) | Good Condition (0) | Usually inaccessible or unlikely to be disturbed (0) |

| Normal Occupancy | Score | Likelihood of disturbance | Score | Exposure Potential | Score | Maintenance Activity | Score |
|---|---|---|---|---|---|---|---|
| Recommendation | No further action required | | | | | | |

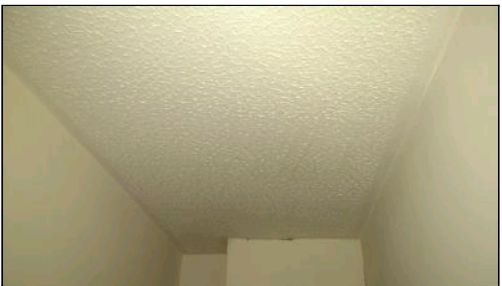
| | 27 Jul 2016 | Sebastian Lawniczak | Management Survey | Ground | No Asbestos Detected (0) |
| | As AE001622 (SP) | Textured Coating (1) | Completely Sealed (0) | Good Condition (0) | Occasionally likely to be disturbed (1) |

| Recommendation | No further action required | | | | | | |

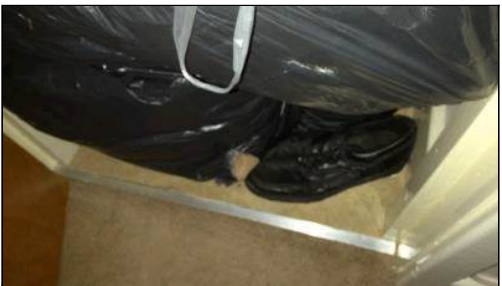
| | Survey Date: | Lead Surveyor | Survey Type | Floor | Analysis |
|---|---|---|---|---|---|
| | 27 Jul 2016 | Sebastian Lawniczak | Management Survey | Ground | No Asbestos Detected (0) |
| | As AE001623 (SP) | Reinforced Composite (1) | Completely Sealed (0) | Good Condition (0) | Usually inaccessible or unlikely to be disturbed (0) |

| Normal Occupancy | Score | Likelihood of disturbance | Score | Exposure Potential | Score | Maintenance Activity | Score |
|---|---|---|---|---|---|---|---|
| Recommendation | No further action required | | | | | | |

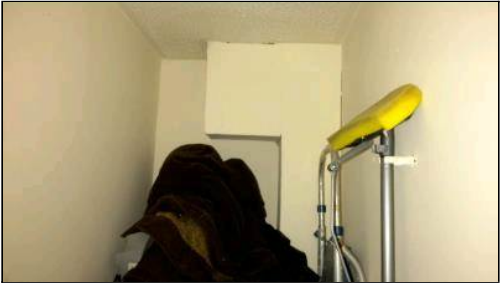
| | 27 Jul 2016 | Sebastian Lawniczak | Management Survey | Ground | No Asbestos Detected (0) |
| | AE001624 (S) | Insulation board (2) | Unsealed (2) | Low Damage (1) | Easily disturbed (2) |

| Recommendation | No further action required | | | | | | |

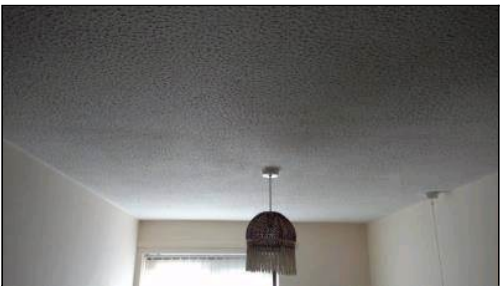
| | 27 Jul 2016 | Sebastian Lawniczak | Management Survey | Ground | No Asbestos Detected (0) |
| | As AE001622 (SP) | Textured Coating (1) | Completely Sealed (0) | Good Condition (0) | Occasionally likely to be disturbed (1) |

| Recommendation | No further action required | | | | | | |

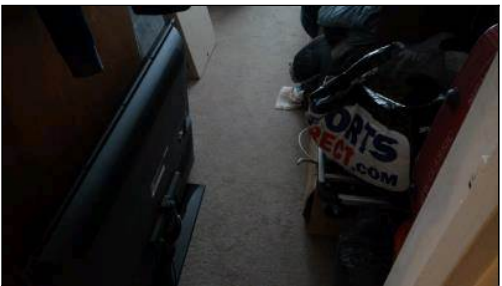
| | 27 Jul 2016 | Sebastian Lawniczak | Management Survey | Ground | No Asbestos Detected (0) |
| | As AE001623 (SP) | Reinforced Composite (1) | Completely Sealed (0) | Good Condition (0) | Usually inaccessible or unlikely to be disturbed (0) |

| Recommendation | No further action required | | | | | | |

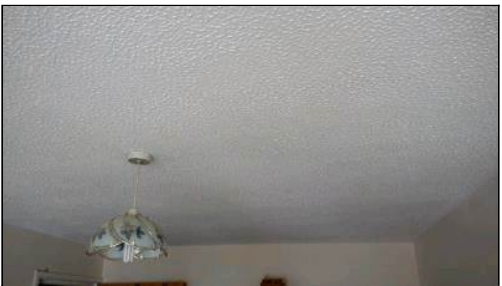
| | Survey Date: | Lead Surveyor | Survey Type | Floor | Analysis |
|---|---|---|---|---|---|
| | 27 Jul 2016 | Sebastian Lawniczak | Management Survey | Ground | No Asbestos Detected (0) |
| | As AE001622 (SP) | Textured Coating (1) | Completely Sealed (0) | Good Condition (0) | Occasionally likely to be disturbed (1) |

| Normal Occupancy | Score | Likelihood of disturbance | Score | Exposure Potential | Score | Maintenance Activity | Score |
|---|---|---|---|---|---|---|---|
| Recommendation | No further action required | | | | | | |

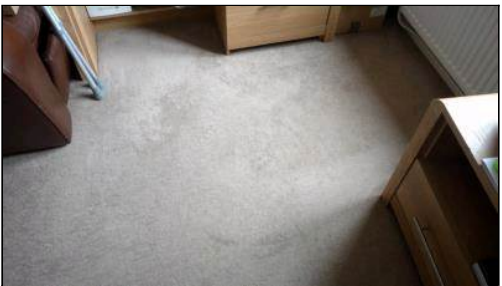
| | Survey Date: | Lead Surveyor | Survey Type | Floor | Analysis |
|---|---|---|---|---|---|
| | 27 Jul 2016 | Sebastian Lawniczak | Management Survey | Ground | No Asbestos Detected (0) |
| | As AE001623 (SP) | Reinforced Composite (1) | Completely Sealed (0) | Good Condition (0) | Usually inaccessible or unlikely to be disturbed (0) |

| Normal Occupancy | Score | Likelihood of disturbance | Score | Exposure Potential | Score | Maintenance Activity | Score |
|---|---|---|---|---|---|---|---|
| Recommendation | No further action required | | | | | | |

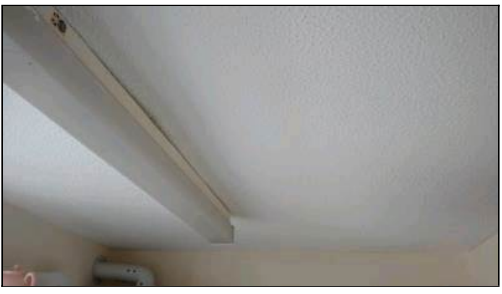
| | 27 Jul 2016 | Sebastian Lawniczak | Management Survey | Ground | No Asbestos Detected (0) |
| | As AE001622 (SP) | Textured Coating (1) | Completely Sealed (0) | Good Condition (0) | Occasionally likely to be disturbed (1) |

| Recommendation | No further action required | | | | | | |
