## Management with Targeted Refurbishment Survey to Shower Room

8 Llys Nazareth  
Llewellyn Street  
Pentre  
Rhondda  
CF41 7BS  
UPRN: 005462

| Type of survey: | Management Survey with part Refurbishment/Demolition (MA and PA) | | |
| Date of survey: | 27 Jul 2016 | | |

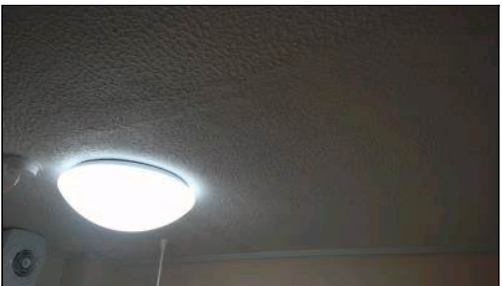
| | Survey Date: | Lead Surveyor | Survey Type | Floor | Analysis |
|---|---|---|---|---|---|
| | 27 Jul 2016 | Sebastian Lawniczak | Refurbishment and Demolition Survey | 1st | No Asbestos Detected (0) |
| | AE001625 (S) | Textured Coating (1) | Completely Sealed (0) | Good Condition (0) | Occasionally likely to be disturbed (1) |

| Normal Occupancy | Score | Likelihood of disturbance | Score | Exposure Potential | Score | Maintenance Activity | Score |
|---|---|---|---|---|---|---|---|
| Recommendation | No further action required | | | | | | |

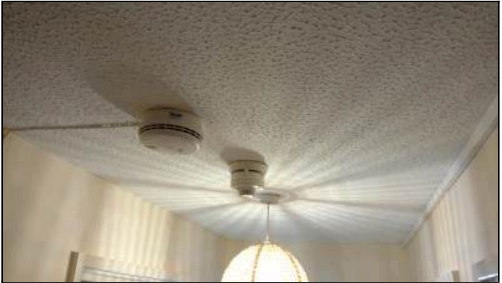
| | 27 Jul 2016 | Sebastian Lawniczak | Management Survey | 1st | No Asbestos Detected (0) |
| | As AE001625 (SP) | Textured Coating (1) | Completely Sealed (0) | Good Condition (0) | Occasionally likely to be disturbed (1) |

| Recommendation | No further action required | | | | | | |

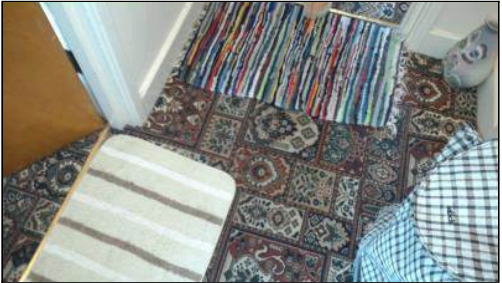
| | Survey Date: | Lead Surveyor | Survey Type | Floor | Analysis |
|---|---|---|---|---|---|
| | 27 Jul 2016 | Sebastian Lawniczak | Management Survey | 1st | No Asbestos Detected (0) |
| | AE001626 (S) | Reinforced Composite (1) | Completely Sealed (0) | Good Condition (0) | Occasionally likely to be disturbed (1) |

| Normal Occupancy | Score | Likelihood of disturbance | Score | Exposure Potential | Score | Maintenance Activity | Score |
|---|---|---|---|---|---|---|---|
| Recommendation | No further action required | | | | | | |

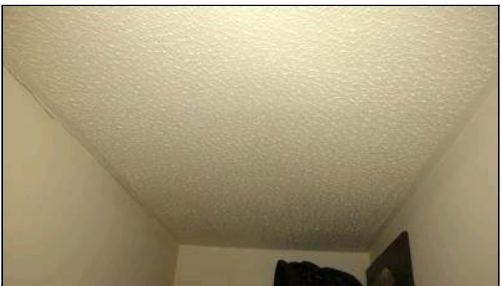
| | 27 Jul 2016 | Sebastian Lawniczak | Management Survey | 1st | No Asbestos Detected (0) |
| | As AE001625 (SP) | Textured Coating (1) | Completely Sealed (0) | Good Condition (0) | Occasionally likely to be disturbed (1) |

| Recommendation | No further action required | | | | | | |

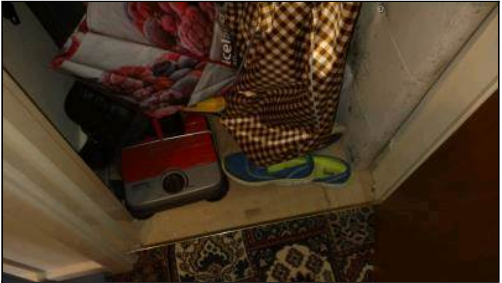
| | Survey Date: | Lead Surveyor | Survey Type | Floor | Analysis |
|---|---|---|---|---|---|
| | 27 Jul 2016 | Sebastian Lawniczak | Management Survey | 1st | No Asbestos Detected (0) |
| | As AE001626 (SP) | Reinforced Composite (1) | Completely Sealed (0) | Good Condition (0) | Routinely disturbed (3) |

| Normal Occupancy | Score | Likelihood of disturbance | Score | Exposure Potential | Score | Maintenance Activity | Score |
|---|---|---|---|---|---|---|---|
| Recommendation | No further action required | | | | | | |

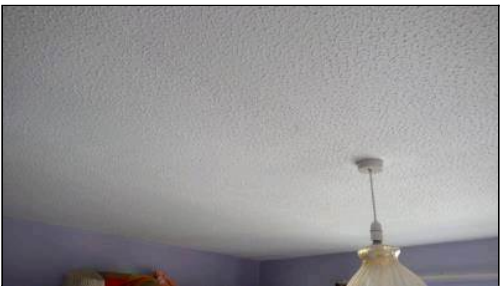
| | 27 Jul 2016 | Sebastian Lawniczak | Management Survey | 1st | No Asbestos Detected (0) |
| | As AE001625 (SP) | Textured Coating (1) | Completely Sealed (0) | Good Condition (0) | Occasionally likely to be disturbed (1) |

| Recommendation | No further action required | | | | | | |

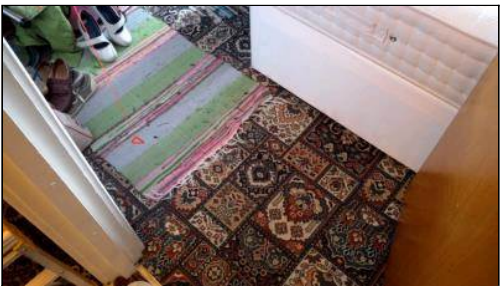
| | Survey Date: | Lead Surveyor | Survey Type | Floor | Analysis |
|---|---|---|---|---|---|
| | 27 Jul 2016 | Sebastian Lawniczak | Management Survey | 1st | No Asbestos Detected (0) |
| | As AE001626 (SP) | Reinforced Composite (1) | Completely Sealed (0) | Good Condition (0) | Usually inaccessible or unlikely to be disturbed (0) |

| Normal Occupancy | Score | Likelihood of disturbance | Score | Exposure Potential | Score | Maintenance Activity | Score |
|---|---|---|---|---|---|---|---|
| Recommendation | No further action required | | | | | | |

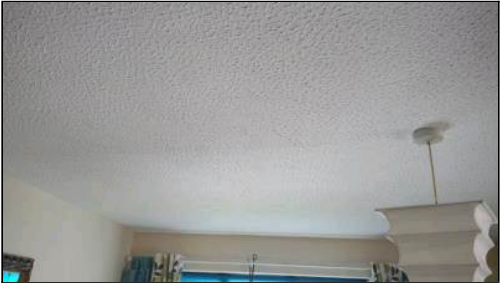
| | Survey Date: | Lead Surveyor | Survey Type | Floor | Analysis |
|---|---|---|---|---|---|
| | 27 Jul 2016 | Sebastian Lawniczak | Management Survey | 1st | No Asbestos Detected (0) |
| | As AE001625 (SP) | Textured Coating (1) | Completely Sealed (0) | Good Condition (0) | Occasionally likely to be disturbed (1) |

| Normal Occupancy | Score | Likelihood of disturbance | Score | Exposure Potential | Score | Maintenance Activity | Score |
|---|---|---|---|---|---|---|---|
| Recommendation | No further action required | | | | | | |

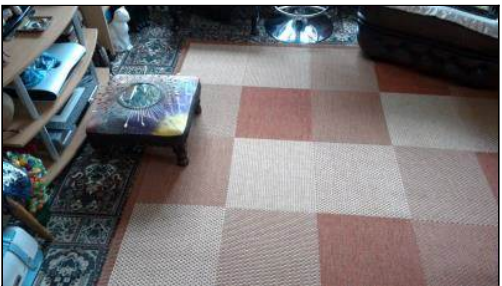
| | 27 Jul 2016 | Sebastian Lawniczak | Management Survey | 1st | No Asbestos Detected (0) |
| | As AE001626 (SP) | Reinforced Composite (1) | Completely Sealed (0) | Good Condition (0) | Usually inaccessible or unlikely to be disturbed (0) |

| Recommendation | No further action required | | | | | | |

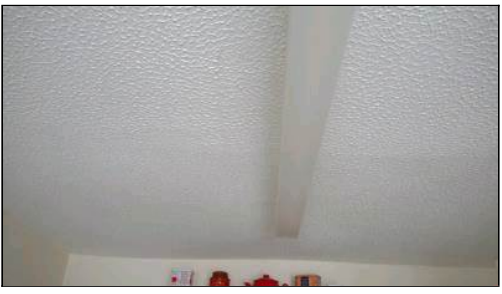
| | Survey Date: | Lead Surveyor | Survey Type | Floor | Analysis |
|---|---|---|---|---|---|
| | 27 Jul 2016 | Sebastian Lawniczak | Management Survey | 1st | No Asbestos Detected (0) |
| | As AE001625 (SP) | Textured Coating (1) | Completely Sealed (0) | Good Condition (0) | Occasionally likely to be disturbed (1) |

| Normal Occupancy | Score | Likelihood of disturbance | Score | Exposure Potential | Score | Maintenance Activity | Score |
|---|---|---|---|---|---|---|---|
| Recommendation | No further action required | | | | | | |

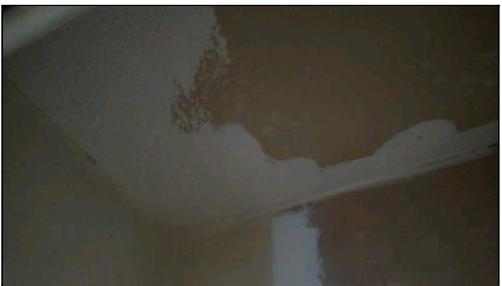
| | 27 Jul 2016 | Sebastian Lawniczak | Management Survey | 1st | No Asbestos Detected (0) |
| | As AE001625 (SP) | Textured Coating (1) | Completely Sealed (0) | Low Damage (1) | Occasionally likely to be disturbed (1) |

| Recommendation | No further action required | | | | | | |

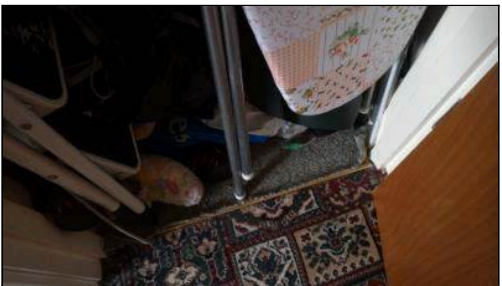
| | Survey Date: | Lead Surveyor | Survey Type | Floor | Analysis |
|---|---|---|---|---|---|
| | 27 Jul 2016 | Sebastian Lawniczak | Management Survey | 1st | No Asbestos Detected (0) |
| | As AE001626 (SP) | Reinforced Composite (1) | Completely Sealed (0) | Good Condition (0) | Usually inaccessible or unlikely to be disturbed (0) |

| Normal Occupancy | Score | Likelihood of disturbance | Score | Exposure Potential | Score | Maintenance Activity | Score |
|---|---|---|---|---|---|---|---|
| Recommendation | No further action required | | | | | | |
