## Management with Targeted Refurbishment Survey to Bathroom

11 Llys Nazareth  
Llewellyn Street  
Pentre  
Rhondda  
CF41 7BS  
UPRN: 005465

| Type of survey: | Management Survey with part Refurbishment/Demolition (MA and PA) | | |
| Date of survey: | 27 Jul 2016 | | |

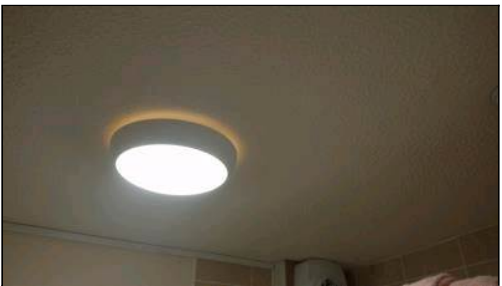
| | Survey Date: | Lead Surveyor | Survey Type | Floor | Analysis |
|---|---|---|---|---|---|
| | 27 Jul 2016 | Sebastian Lawniczak | Refurbishment and Demolition Survey | 1st | No Asbestos Detected (0) |
| | AE001627 (S) | Textured Coating (1) | Completely Sealed (0) | Good Condition (0) | Occasionally likely to be disturbed (1) |

| Normal Occupancy | Score | Likelihood of disturbance | Score | Exposure Potential | Score | Maintenance Activity | Score |
|---|---|---|---|---|---|---|---|
| Recommendation | No further action required | | | | | | |

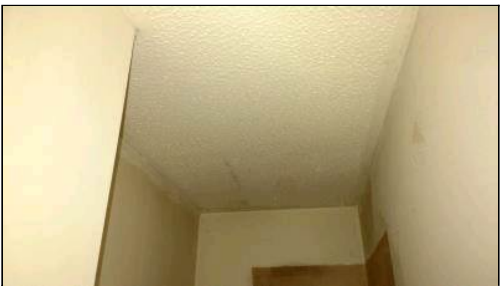
| | 27 Jul 2016 | Sebastian Lawniczak | Management Survey | 1st | No Asbestos Detected (0) |
| | As AE001627 (SP) | Textured Coating (1) | Completely Sealed (0) | Good Condition (0) | Occasionally likely to be disturbed (1) |

| Recommendation | No further action required | | | | | | |

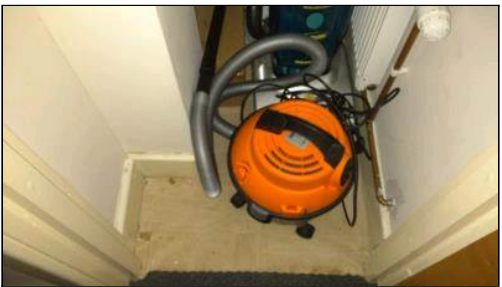
| | 27 Jul 2016 | Sebastian Lawniczak | Management Survey | 1st | No Asbestos Detected (0) |
| | AE001628 (S) | Reinforced Composite (1) | Completely Sealed (0) | Low Damage (1) | Routinely disturbed (3) |

| Recommendation | No further action required | | | | | | |

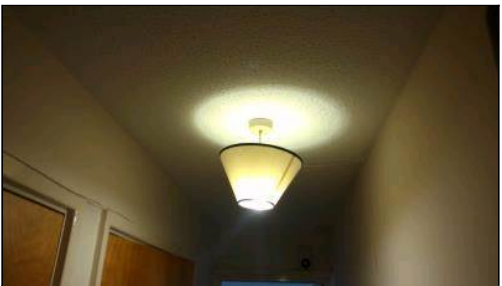
| | 27 Jul 2016 | Sebastian Lawniczak | Management Survey | 1st | No Asbestos Detected (0) |
| | As AE001627 (SP) | Textured Coating (1) | Completely Sealed (0) | Good Condition (0) | Occasionally likely to be disturbed (1) |

| Recommendation | No further action required | | | | | | |

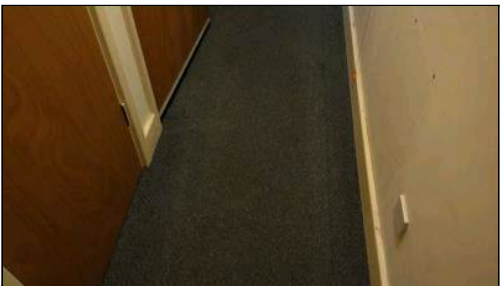
| | Survey Date: | Lead Surveyor | Survey Type | Floor | Analysis |
|---|---|---|---|---|---|
| | 27 Jul 2016 | Sebastian Lawniczak | Management Survey | 1st | No Asbestos Detected (0) |
| | As AE001628 (SP) | Reinforced Composite (1) | Completely Sealed (0) | Good Condition (0) | Usually inaccessible or unlikely to be disturbed (0) |

| Normal Occupancy | Score | Likelihood of disturbance | Score | Exposure Potential | Score | Maintenance Activity | Score |
|---|---|---|---|---|---|---|---|
| Recommendation | No further action required | | | | | | |

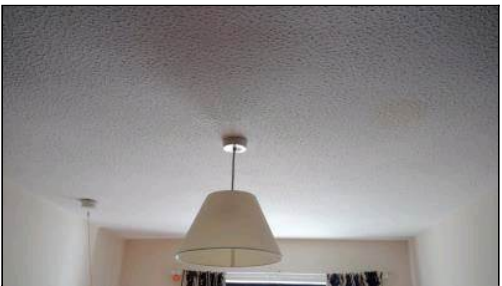
| | 27 Jul 2016 | Sebastian Lawniczak | Management Survey | 1st | No Asbestos Detected (0) |
| | As AE001627 (SP) | Textured Coating (1) | Completely Sealed (0) | Good Condition (0) | Occasionally likely to be disturbed (1) |

| Recommendation | No further action required | | | | | | |

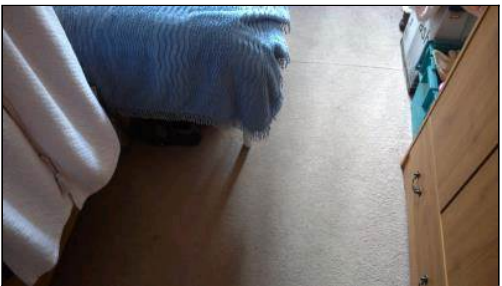
| | Survey Date: | Lead Surveyor | Survey Type | Floor | Analysis |
|---|---|---|---|---|---|
| | 27 Jul 2016 | Sebastian Lawniczak | Management Survey | 1st | No Asbestos Detected (0) |
| | As AE001628 (SP) | Reinforced Composite (1) | Completely Sealed (0) | Good Condition (0) | Usually inaccessible or unlikely to be disturbed (0) |

| Normal Occupancy | Score | Likelihood of disturbance | Score | Exposure Potential | Score | Maintenance Activity | Score |
|---|---|---|---|---|---|---|---|
| Recommendation | No further action required | | | | | | |

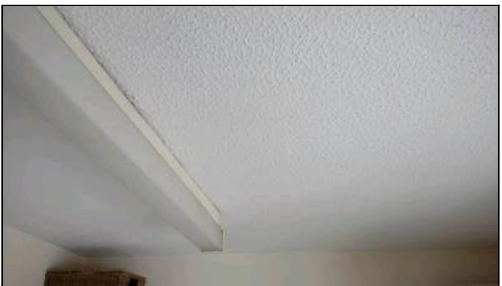
| | Survey Date: | Lead Surveyor | Survey Type | Floor | Analysis |
|---|---|---|---|---|---|
| | 27 Jul 2016 | Sebastian Lawniczak | Management Survey | 1st | No Asbestos Detected (0) |
| | As AE001627 (SP) | Textured Coating (1) | Completely Sealed (0) | Good Condition (0) | Occasionally likely to be disturbed (1) |

| Normal Occupancy | Score | Likelihood of disturbance | Score | Exposure Potential | Score | Maintenance Activity | Score |
|---|---|---|---|---|---|---|---|
| Recommendation | No further action required | | | | | | |

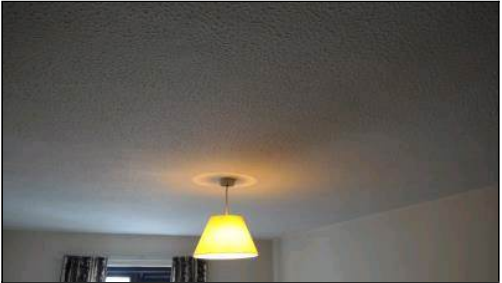
| | 27 Jul 2016 | Sebastian Lawniczak | Management Survey | 1st | No Asbestos Detected (0) |
| | As AE001627 (SP) | Textured Coating (1) | Completely Sealed (0) | Good Condition (0) | Occasionally likely to be disturbed (1) |

| Recommendation | No further action required | | | | | | |

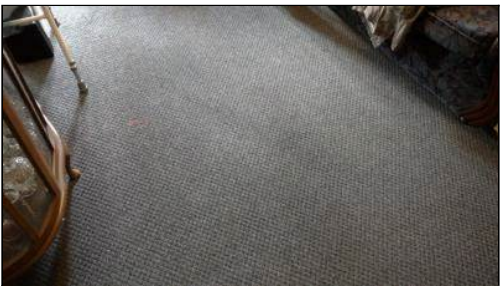
| | 27 Jul 2016 | Sebastian Lawniczak | Management Survey | 1st | No Asbestos Detected (0) |
| | As AE001628 (SP) | Reinforced Composite (1) | Completely Sealed (0) | Good Condition (0) | Usually inaccessible or unlikely to be disturbed (0) |

| Recommendation | No further action required | | | | | | |
