## Management with Targeted Refurbishment Survey to Bathroom

6 Llys Yr Onnen  
Miskin Road  
Mountain Ash  
CF45 3TS  
UPRN: 7983

**Kovia**

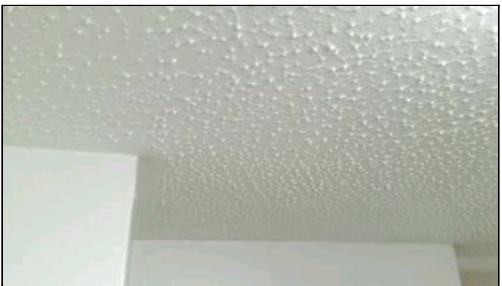
| | Survey Date: | Lead Surveyor | Survey Type | Floor | Analysis |
| | 20 Feb 2017 | Dave Milton | Refurbishment and Demolition Survey | Ground | Chrysotile (1) |
| | AD002225 (S) | Textured Coating (1) | Completely Sealed (0) | Good Condition (0) | Occasionally likely to be disturbed (1) |

| Normal Occupancy | Score | Likelihood of disturbance | Score | Exposure Potential | Score | Maintenance Activity | Score |
|---|---|---|---|---|---|---|---|
| Recommendation | Manage in-situ or remove if affected by works | | | | | | |

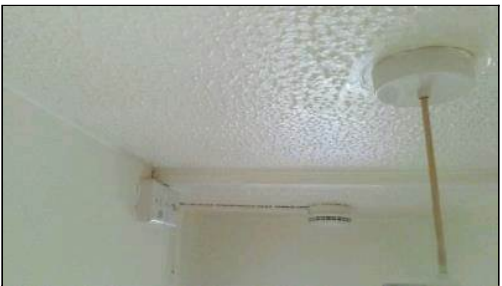
| | Survey Date: | Lead Surveyor | Survey Type | Floor | Analysis |
| | 20 Feb 2017 | Dave Milton | Management Survey | Ground | Chrysotile (1) |
| | As AD002225 (SP) | Textured Coating (1) | Completely Sealed (0) | Good Condition (0) | Occasionally likely to be disturbed (1) |

| Recommendation | Manage and re-inspect | | | | | | |

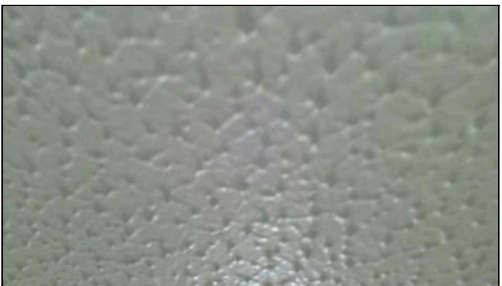
| | Survey Date: | Lead Surveyor | Survey Type | Floor | Analysis |
| | 20 Feb 2017 | Dave Milton | Management Survey | Ground | Chrysotile (1) |
| | As AD002225 (SP) | Textured Coating (1) | Completely Sealed (0) | Good Condition (0) | Occasionally likely to be disturbed (1) |

| Normal Occupancy | Score | Likelihood of disturbance | Score | Exposure Potential | Score | Maintenance Activity | Score |
|---|---|---|---|---|---|---|---|
| Recommendation | Manage and re-inspect | | | | | | |

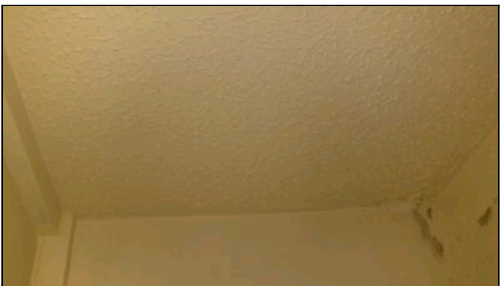
| | Survey Date: | Lead Surveyor | Survey Type | Floor | Analysis |
| | 20 Feb 2017 | Dave Milton | Management Survey | Ground | Chrysotile (1) |
| | As AD002225 (SP) | Textured Coating (1) | Completely Sealed (0) | Good Condition (0) | Occasionally likely to be disturbed (1) |

| Recommendation | Manage and re-inspect | | | | | | |

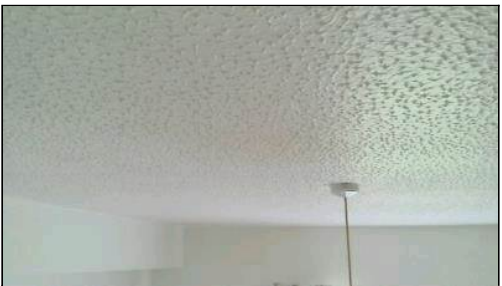
| | Survey Date: | Lead Surveyor | Survey Type | Floor | Analysis |
| | 20 Feb 2017 | Dave Milton | Management Survey | Ground | Chrysotile (1) |
| | As AD002225 (SP) | Textured Coating (1) | Completely Sealed (0) | Good Condition (0) | Occasionally likely to be disturbed (1) |

| Normal Occupancy | Score | Likelihood of disturbance | Score | Exposure Potential | Score | Maintenance Activity | Score |
|---|---|---|---|---|---|---|---|
| Recommendation | Manage and re-inspect | | | | | | |

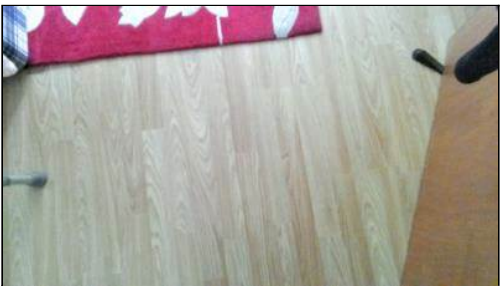
| | Survey Date: | Lead Surveyor | Survey Type | Floor | Analysis |
| | 20 Feb 2017 | Dave Milton | Management Survey | Ground | Chrysotile (1) |
| | Visual (SP) | Reinforced Composite (1) | Completely Sealed (0) | Good Condition (0) | Occasionally likely to be disturbed (1) |

| Normal Occupancy | Score | Likelihood of disturbance | Score | Exposure Potential | Score | Maintenance Activity | Score |
|---|---|---|---|---|---|---|---|
| Surveyor comments | No access at time of the survey due to the potential to damage fixtures and fittings. | | | | | | |

| Normal Occupancy | Score | Likelihood of disturbance | Score | Exposure Potential | Score | Maintenance Activity | Score |
|---|---|---|---|---|---|---|---|
| Recommendation | Inspection required | | | | | | |

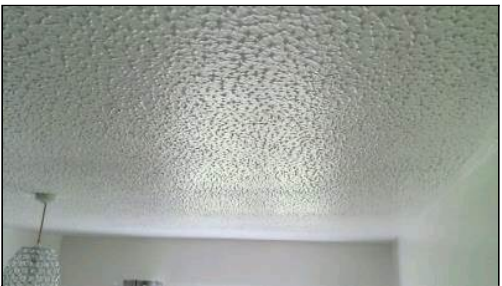
| | Survey Date: | Lead Surveyor | Survey Type | Floor | Analysis |
| | 20 Feb 2017 | Dave Milton | Management Survey | Ground | Chrysotile (1) |
| | As AD002225 (SP) | Textured Coating (1) | Completely Sealed (0) | Good Condition (0) | Occasionally likely to be disturbed (1) |

| Normal Occupancy | Score | Likelihood of disturbance | Score | Exposure Potential | Score | Maintenance Activity | Score |
|---|---|---|---|---|---|---|---|
| Recommendation | Manage and re-inspect | | | | | | |

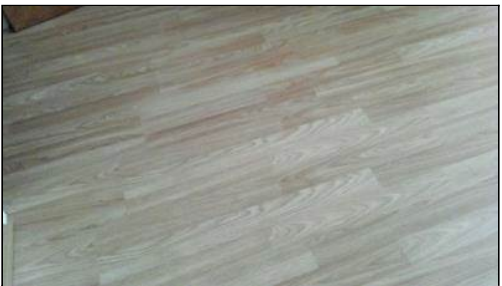
| | Survey Date: | Lead Surveyor | Survey Type | Floor | Analysis |
| | 20 Feb 2017 | Dave Milton | Management Survey | Ground | Chrysotile (1) |
| | Visual (SP) | Reinforced Composite (1) | Completely Sealed (0) | Good Condition (0) | Occasionally likely to be disturbed (1) |

| Normal Occupancy | Score | Likelihood of disturbance | Score | Exposure Potential | Score | Maintenance Activity | Score |
|---|---|---|---|---|---|---|---|
| Surveyor comments | No access at the time of the survey due to the potential to damage fixtures and fittings. | | | | | | |

| Normal Occupancy | Score | Likelihood of disturbance | Score | Exposure Potential | Score | Maintenance Activity | Score |
|---|---|---|---|---|---|---|---|
| Recommendation | Inspection required | | | | | | |

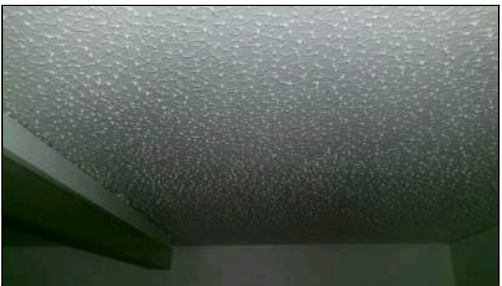
| | Survey Date: | Lead Surveyor | Survey Type | Floor | Analysis |
| | 20 Feb 2017 | Dave Milton | Management Survey | Ground | Chrysotile (1) |
| | As AD002225 (SP) | Textured Coating (1) | Completely Sealed (0) | Good Condition (0) | Occasionally likely to be disturbed (1) |

| Recommendation | Manage and re-inspect | | | | | | |
