**CLIENT:**  
**WALES AND WEST HOUSING ASSOCIATION**  
**3 ALEXANDRA GATE**  
**FFORDD PENGAM**  
**TREMORFA**  
**CARDIFF**  
**CF24 2UD**

**PROJECT NO:** 41596/JL/MS

**DATE:** JUNE 2011

**ASBESTOS MANAGEMENT SURVEY WITH REFURBISHMENT AND DEMOLITION  
TO SPECIFIED AREAS  
WITHIN  
26 LLYS YR ONNEN, MISKIN ROAD, MOUNTAIN ASH, CF45 3TS**

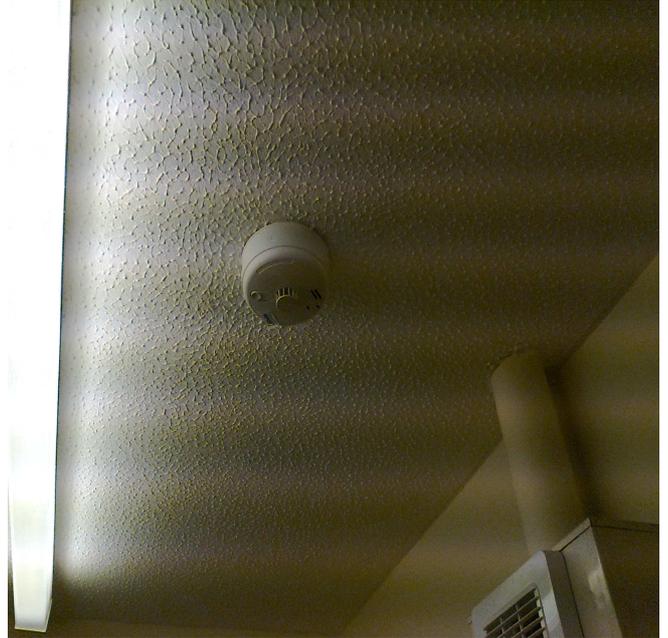
**EXTENT:** 4 m<sup>2</sup>**SAMPLE REF:** BS101670/S1**RESULT:** Chrysotile**CROSS REFERENCE  
ASBESTOS REGISTER:** Page 1

Inform maintenance personnel prior relevant works

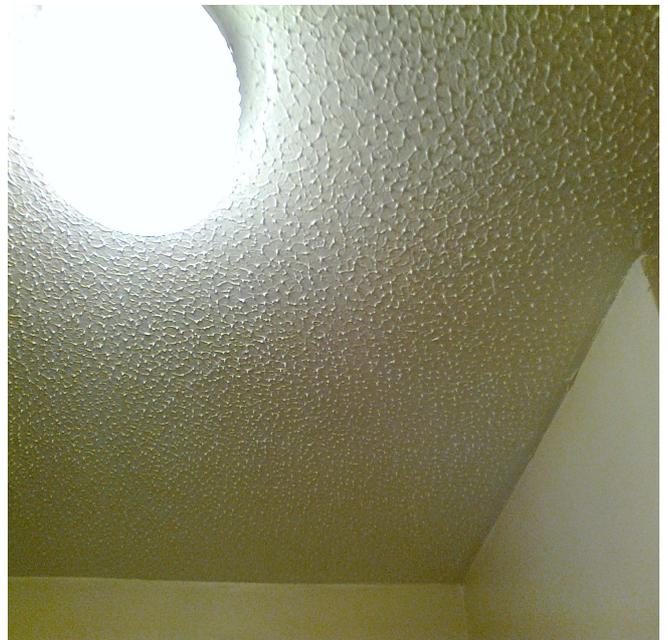
Second floor – Bathroom 005

**EXTENT:** 5 m<sup>2</sup>**SAMPLE REF:** BS101674/S3**RESULT:** Chrysotile**CROSS REFERENCE  
ASBESTOS REGISTER:** Page 2

Remove under controlled conditions
