**CLIENT:**  
**WALES AND WEST HOUSING ASSOCIATION**  
**3 ALEXANDRA GATE**  
**FFORDD PENGAM**  
**TREMORFA**  
**CARDIFF**  
**CF24 2UD**

**PROJECT NO:** 41596/JL/MS

**DATE:** JUNE 2011

**ASBESTOS MANAGEMENT SURVEY WITH REFURBISHMENT AND DEMOLITION  
TO SPECIFIED AREAS  
WITHIN  
27 LLYS YR ONNEN, MISKIN ROAD, MOUTAIN ASH, CF45 3TS**

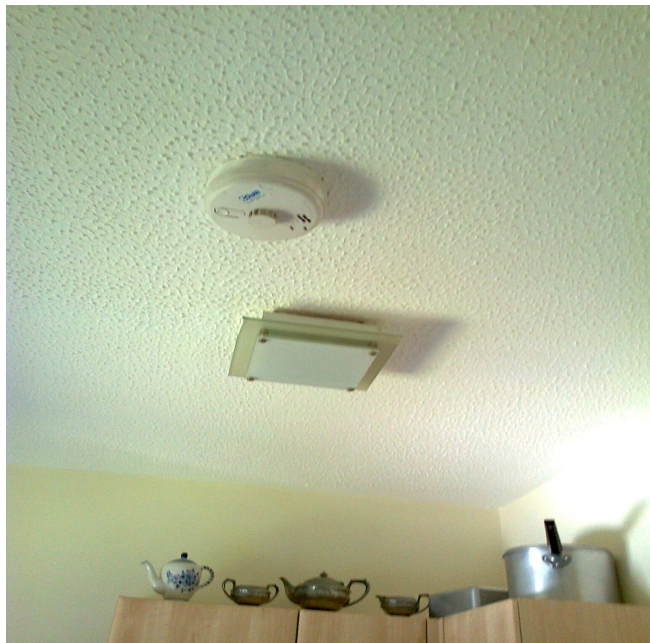
| Location<br>✓ A | No. of Occupants<br>✓ B | Description<br>(product type)<br>*C | Approx Extent of Material<br>✓ D | Condition<br>(Surface Treatment)<br>*E | Condition<br>(Damage/Deterioration)<br>*F | Vulnerability to Damage<br>✓ G | Sample No/<br>Analytical Result<br>(Asbestos Type)<br>*H | Total Score<br>MA +PA =<br>*<br>✓ | Priority Rating | Recommendations |
|---|---|---|---|---|---|---|---|---|---|---|
| Kitchen 001(1) | 1 – 3 (1) | Textured coating to ceiling (1) | 4 m <sup>2</sup> (1) | Sealed (1) | No visible damage or deterioration (0) | Rare (0) | BS101665/S1<br>Chrysotile (1)<br>(Photo page 1) | 3 + 3 = 6 | Very low | Inform maintenance personnel prior relevant works |

**LOCATION/FLOOR:****Second Floor – Kitchen 001****DESCRIPTION:****Textured coating to ceiling****RECOMMENDATIONS:****Inform maintenance personnel prior relevant works****EXTENT:** 4 m2**SAMPLE REF:** BS101665/S1**RESULT:** Chrysotile**CROSS REFERENCE  
ASBESTOS REGISTER:** Page 1

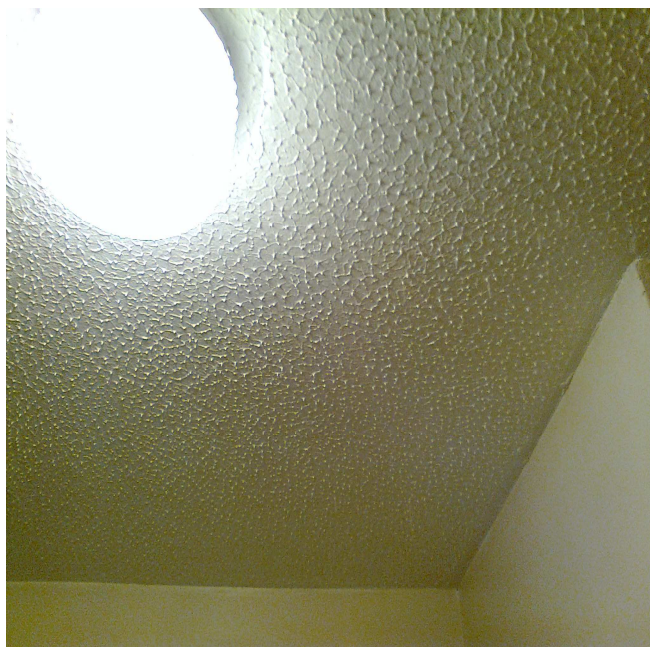
| Location<br>✓ A | No. of Occupants<br>✓ B | Description<br>(product type)<br>*C | Approx Extent of Material<br>✓ D | Condition<br>(Surface Treatment)<br>*E | Condition<br>(Damage/Deterioration)<br>*F | Vulnerability to Damage<br>✓ G | Sample No/<br>Analytical Result<br>(Asbestos Type)<br>*H | Total Score<br>MA +PA =<br>* ✓ | Priority Rating | Recommendations |
|---|---|---|---|---|---|---|---|---|---|---|
| Bathroom 005<br><br>Bathroom 005 | | Textured coating to ceiling<br><br>All other areas visually no asbestos detected: solid plaster wall, plasterboard ceiling, carpet to concrete floor, ceramic wall tiles and UPVC pipework | 4 m <sup>2</sup> | Sealed | No visible damage or deterioration | Rare | BS101667/S3<br>Chrysotile<br>(Photo page 1) | | | Remove under controlled conditions |

**LOCATION/FLOOR:****Second Floor – Bathroom 005****DESCRIPTION:****Textured coating to ceiling****RECOMMENDATIONS:****Remove under controlled conditions****EXTENT:** 4 m2**SAMPLE REF:** BS101667/S3**RESULT:** Chrysotile**CROSS REFERENCE  
ASBESTOS REGISTER:** Page 3
