**WALES & WEST HOUSING
ASSOCIATION
3 ALEXANDRA GATE
FFORDD PENGAM
TREMORFA
CARDIFF
CF24 2UD**

PROJECT NO: J139149

DATE: NOVEMBER 2013

**ASBESTOS MANAGEMENT SURVEY TO COMMUNAL AND EXTERNAL AREAS
OF
LLYS YR ONNEN, MOUNTAIN ASH, RHONDDA CYNON TAFF, CF45 3TS**

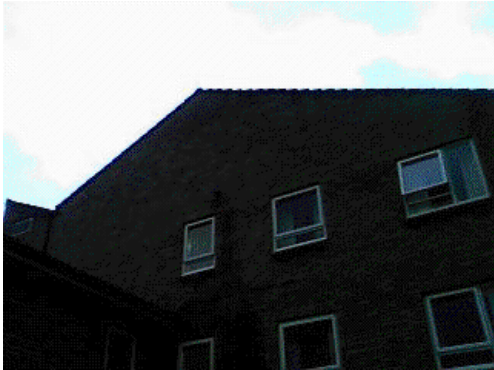
FLOOR/LOCATION:	External

DESCRIPTION:	Strongly presumed high level undercloaking - unable to sample due to height restrictions	
RECOMMENDATIONS:	Conduct further investigation prior to relevant maintenance / refurbishment works	
EXTENT:	10 - 50 m² or 10 - 50m pipe run	
SAMPLE REF:	Presumed	
RESULT:	Presumed Crocidolite (or unknown)

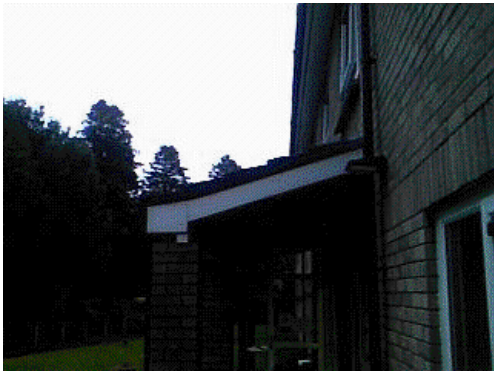
FLOOR/LOCATION:	External

DESCRIPTION:	Undercloaking (ground floor entrance canopies)	
RECOMMENDATIONS:	Manage, label, monitor and inform maintenance personnel prior to relevant works	
EXTENT:	<10m² or <10m pipe run	
SAMPLE REF:	CZ002372	
RESULT:	Chrysotile

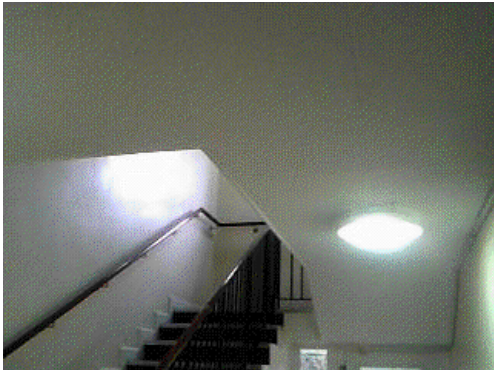
FLOOR/LOCATION:	Ground Floor Stairs 1 (002)

DESCRIPTION:	Textured coating to ceiling	
RECOMMENDATIONS:	Manage, label, monitor and inform maintenance personnel prior to relevant works	
EXTENT:	<10m² or <10m pipe run	
SAMPLE REF:	CZ002351	
RESULT:	Chrysotile

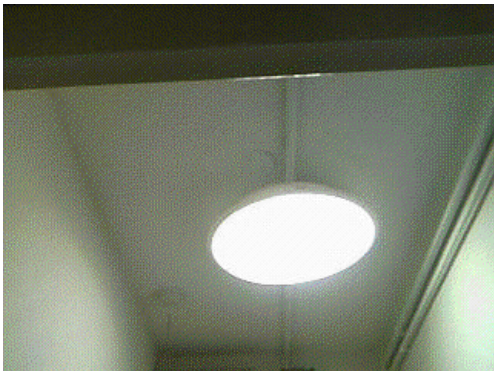
FLOOR/LOCATION:	Ground Floor Toilet (004)

DESCRIPTION:	Textured coating to ceiling	
RECOMMENDATIONS:	Manage, label, monitor and inform maintenance personnel prior to relevant works	
EXTENT:	<10m² or <10m pipe run	
SAMPLE REF:	SPST CZ002351	
RESULT:	Chrysotile

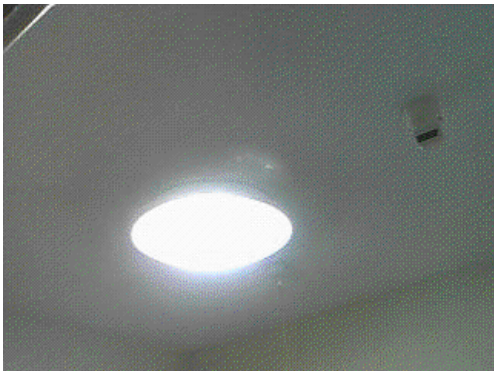
FLOOR/LOCATION:	Ground Floor Disabled Toilet (005)

Ground Floor / Disabled Toilet (005) (1)	1 - 3 (1)	Textured coating to ceiling (1)	5m ² (1)	Sealed (0)	Good Condition (0)	Low (1)	Strongly presumed similar to CZ002351 / Chrysotile (1)	2 + 4 = 6	Very Low	Manage, label, monitor and inform maintenance personnel prior to relevant works
Ground Floor / Disabled Toilet (005)	-	All other areas visually no asbestos identified	-	-	-	-		-	-	No further action required
Ground Floor / Disabled Toilet (005)		Plasterboard ceiling, solid walls, concrete floor, non suspect grey vinyl floor covering, ceramic toilet cistern, plastic soil pipe, exposed copper and plastic pipework, timber door and frame, timber boxing with plastic soil pipe within.								
Ground Floor / Office (006) (1)	1 - 3 (1)	Textured coating to ceiling (1)	5m ² (1)	Sealed (0)	Good Condition (0)	Low (1)	Strongly presumed similar to CZ002351 / Chrysotile (1)	2 + 4 = 6	Very Low	Manage, label, monitor and inform maintenance personnel prior to relevant works

DESCRIPTION:	Textured coating to ceiling	
RECOMMENDATIONS:	Manage, label, monitor and inform maintenance personnel prior to relevant works	
EXTENT:	<10m² or <10m pipe run	
SAMPLE REF:	SPST CZ002351	
RESULT:	Chrysotile

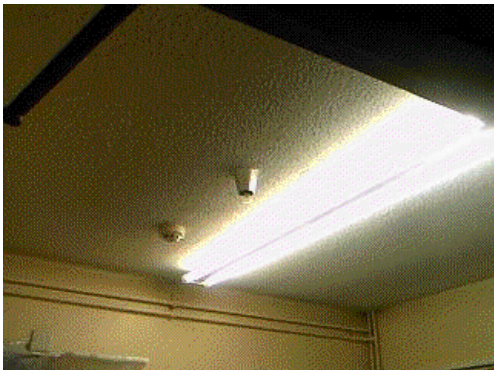
FLOOR/LOCATION:	Ground Floor Office (006)

DESCRIPTION:	Textured coating to ceiling	
RECOMMENDATIONS:	Manage, label, monitor and inform maintenance personnel prior to relevant works	
EXTENT:	<10m² or <10m pipe run	
SAMPLE REF:	SPST CZ002351	
RESULT:	Chrysotile

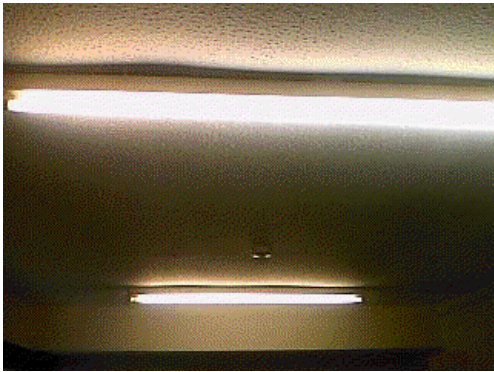
FLOOR/LOCATION:	Ground Floor Kitchen (008)

Ground Floor / Kitchen (008) (1)	4 - 10 (2)	Textured coating to ceiling (1)	15m² (2)	Sealed (0)	Good Condition (0)	Low (1)	CZ002353 / Chrysotile (1)	2 + 6 = 8	Very Low	Manage, label, monitor and inform maintenance personnel prior to relevant works
Ground Floor / Kitchen (008)	-	All other areas visually no asbestos identified	-	-	-	-		-	-	No further action required
Ground Floor / Kitchen (008)		Plasterboard ceiling, solid walls, concrete floor, fixed non suspect grey vinyl floor covering, non suspect sinkpads, PVC window frames, exposed copper pipework, metal radiator, ceramic wall tiles, non suspect electric fuse board, timber doors and frames.								
Ground Floor / Communal Room (009) (1)	4 - 10 (2)	Textured coating to ceiling (1)	20m² (2)	Sealed (0)	Good Condition (0)	Low (1)	CZ002354 / Chrysotile (1)	2 + 6 = 8	Very Low	Manage, label, monitor and inform maintenance personnel prior to relevant works

DESCRIPTION:	Textured coating to ceiling	
RECOMMENDATIONS:	Manage, label, monitor and inform maintenance personnel prior to relevant works	
EXTENT:	10 - 50 m² or 10 - 50m pipe run	
SAMPLE REF:	CZ002353	
RESULT:	Chrysotile

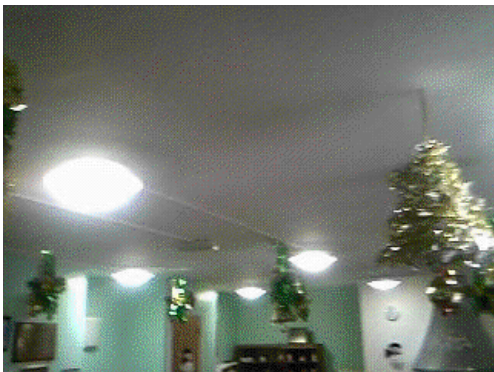
FLOOR/LOCATION:	Ground Floor Communal Room (009)

DESCRIPTION:	Textured coating to ceiling	
RECOMMENDATIONS:	Manage, label, monitor and inform maintenance personnel prior to relevant works	
EXTENT:	10 - 50 m² or 10 - 50m pipe run	
SAMPLE REF:	CZ002354	
RESULT:	Chrysotile

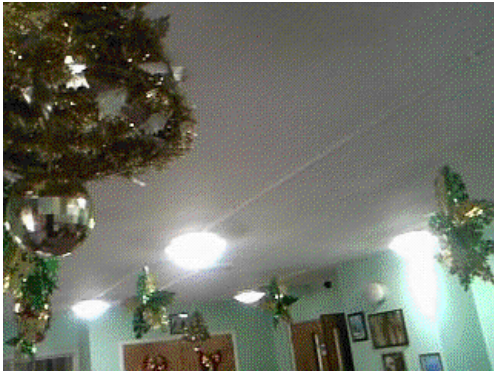
FLOOR/LOCATION:	Ground Floor Communal Room (009)

DESCRIPTION:	Textured coating to ceiling	
RECOMMENDATIONS:	Manage, label, monitor and inform maintenance personnel prior to relevant works	
EXTENT:	10 - 50 m² or 10 - 50m pipe run	
SAMPLE REF:	CZ002356	
RESULT:	Chrysotile

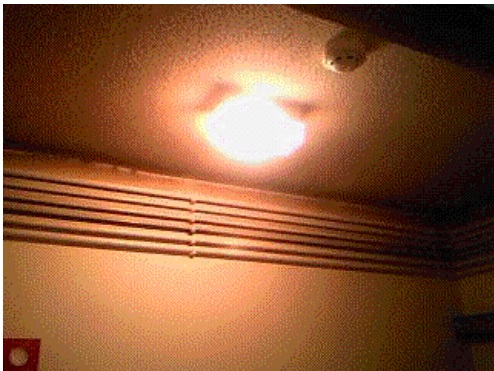
FLOOR/LOCATION:	Ground Floor Store (010)

DESCRIPTION:	Textured coating to ceiling	
RECOMMENDATIONS:	Manage, label, monitor and inform maintenance personnel prior to relevant works	
EXTENT:	<10m² or <10m pipe run	
SAMPLE REF:	SPST CZ002354	
RESULT:	Chrysotile

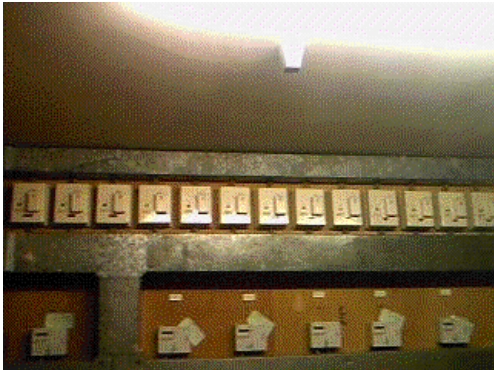
FLOOR/LOCATION:	Ground Floor Switch Room (013)

DESCRIPTION:	Presumed asbestos flashguards within live electric fuse boxes.	
RECOMMENDATIONS:	Conduct further investigation prior to relevant maintenance / refurbishment works	
EXTENT:	Minor amounts, String, Gaskets	
SAMPLE REF:	Presumed	
RESULT:	Presumed Crocidolite (or unknown)

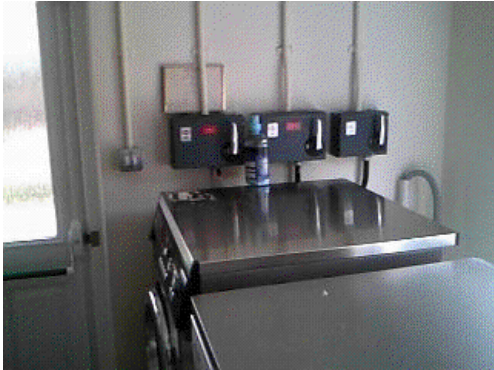
FLOOR/LOCATION:	Ground Floor Laundry Room (014)

DESCRIPTION:	Presumed asbestos flashguards within live electric fuse boxes.	
RECOMMENDATIONS:	Conduct further investigation prior to relevant maintenance / refurbishment works	
EXTENT:	Minor amounts, String, Gaskets	
SAMPLE REF:	Presumed	
RESULT:	Presumed Crocidolite (or unknown)

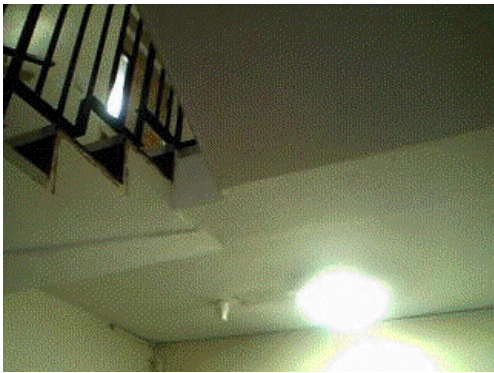
FLOOR/LOCATION:	Ground Floor Stairs 3 (019)

DESCRIPTION:	Textured coating to ceiling	
RECOMMENDATIONS:	Manage, label, monitor and inform maintenance personnel prior to relevant works	
EXTENT:	<10m² or <10m pipe run	
SAMPLE REF:	CZ002357	
RESULT:	Chrysotile

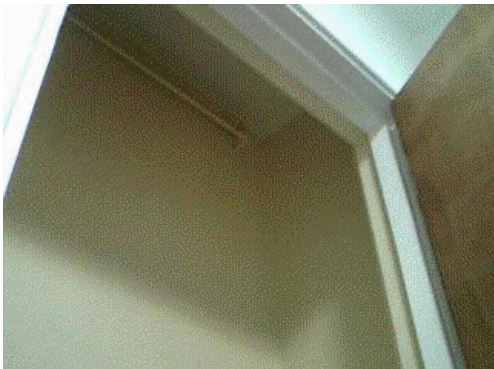
FLOOR/LOCATION:	Ground Floor Cupboard (033)

DESCRIPTION:	Textured coating to ceiling	
RECOMMENDATIONS:	Manage, label, monitor and inform maintenance personnel prior to relevant works	
EXTENT:	<10m² or <10m pipe run	
SAMPLE REF:	SPST CZ002351	
RESULT:	Chrysotile

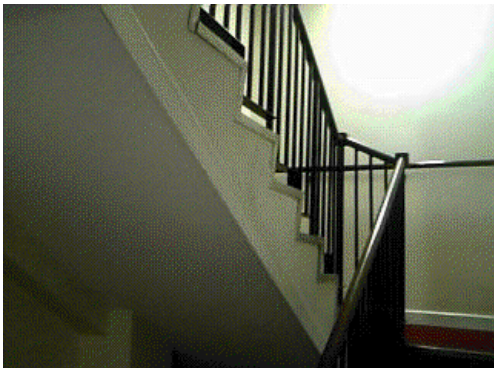
FLOOR/LOCATION:	Ground Floor Stairs 2 (034)

DESCRIPTION:	Textured coating to ceiling	
RECOMMENDATIONS:	Manage, label, monitor and inform maintenance personnel prior to relevant works	
EXTENT:	<10m² or <10m pipe run	
SAMPLE REF:	CZ002362	
RESULT:	Chrysotile

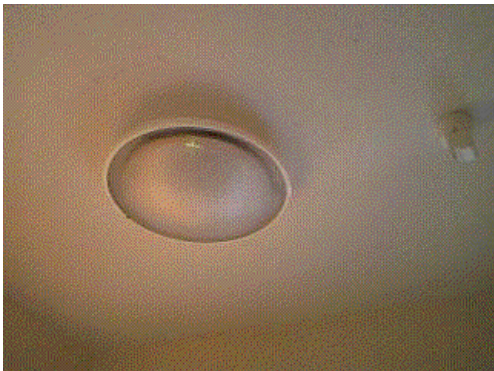
FLOOR/LOCATION:	1st Floor Guestroom Lobby (110)

DESCRIPTION:	Textured coating to ceiling	
RECOMMENDATIONS:	Manage, label, monitor and inform maintenance personnel prior to relevant works	
EXTENT:	<10m² or <10m pipe run	
SAMPLE REF:	CZ002359	
RESULT:	Chrysotile

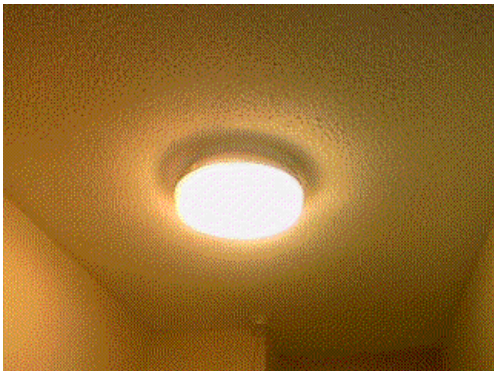
FLOOR/LOCATION:	1st Floor Guestroom Bathroom (129)

DESCRIPTION:	Textured coating to ceiling	
RECOMMENDATIONS:	Manage, label, monitor and inform maintenance personnel prior to relevant works	
EXTENT:	<10m² or <10m pipe run	
SAMPLE REF:	SPST CZ002359	
RESULT:	Chrysotile

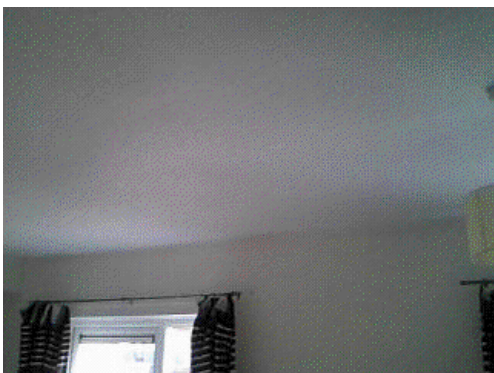
FLOOR/LOCATION:	1st Floor Guestroom Bedroom (130)

DESCRIPTION:	Textured coating to ceiling	
RECOMMENDATIONS:	Manage, label, monitor and inform maintenance personnel prior to relevant works	
EXTENT:	10 - 50 m² or 10 - 50m pipe run	
SAMPLE REF:	SPST CZ002359	
RESULT:	Chrysotile

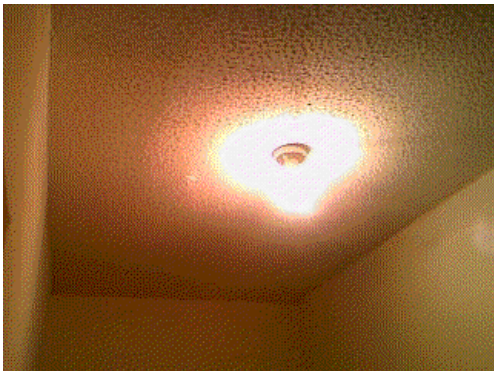
FLOOR/LOCATION:	1st Floor Cleaner's Cupboard (111)

DESCRIPTION:	Textured coating to ceiling	
RECOMMENDATIONS:	Manage, label, monitor and inform maintenance personnel prior to relevant works	
EXTENT:	<10m² or <10m pipe run	
SAMPLE REF:	CZ002360	
RESULT:	Chrysotile

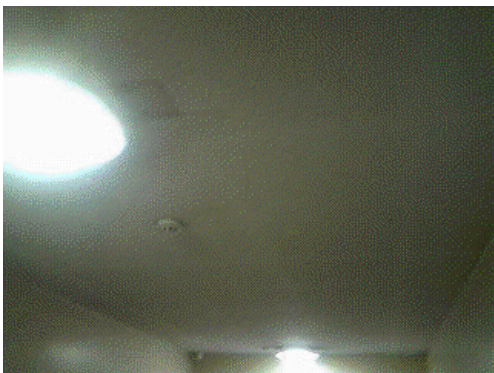
FLOOR/LOCATION:	1st Floor Stairs (102)

DESCRIPTION:	Textured coating to ceiling	
RECOMMENDATIONS:	Manage, label, monitor and inform maintenance personnel prior to relevant works	
EXTENT:	10 - 50 m² or 10 - 50m pipe run	
SAMPLE REF:	CZ002364	
RESULT:	Chrysotile

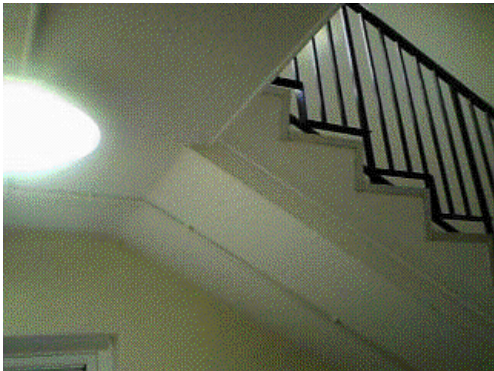
FLOOR/LOCATION:	1st Floor Stairs (109)

DESCRIPTION:	Textured coating to ceiling	
RECOMMENDATIONS:	Manage, label, monitor and inform maintenance personnel prior to relevant works	
EXTENT:	<10m² or <10m pipe run	
SAMPLE REF:	CZ002365	
RESULT:	Chrysotile

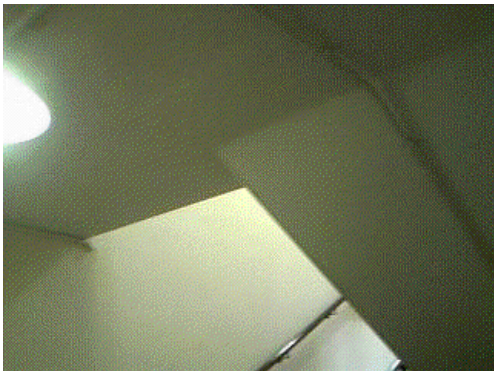
FLOOR/LOCATION:	1st Floor Stairs (113)

DESCRIPTION:	Textured coating to ceiling	
RECOMMENDATIONS:	Manage, label, monitor and inform maintenance personnel prior to relevant works	
EXTENT:	<10m² or <10m pipe run	
SAMPLE REF:	CZ002367	
RESULT:	Chrysotile

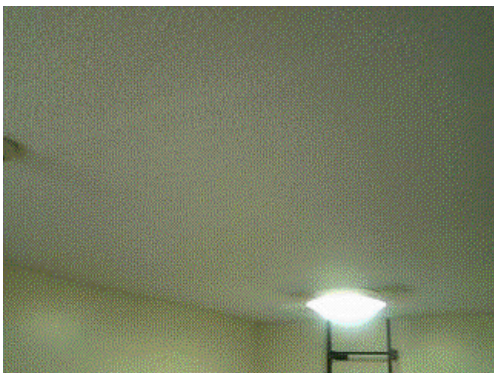
FLOOR/LOCATION:	2nd Floor Stairs 2 (201)

DESCRIPTION:	Textured coating to ceiling	
RECOMMENDATIONS:	Manage, label, monitor and inform maintenance personnel prior to relevant works	
EXTENT:	10 - 50 m² or 10 - 50m pipe run	
SAMPLE REF:	CZ002370	
RESULT:	Chrysotile

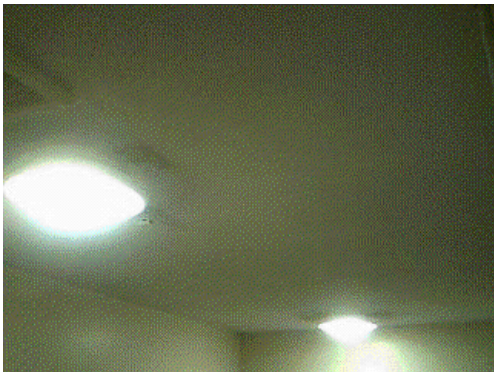
FLOOR/LOCATION:	2nd Floor Stairs 3 (205)

DESCRIPTION:	Textured coating to ceiling	
RECOMMENDATIONS:	Manage, label, monitor and inform maintenance personnel prior to relevant works	
EXTENT:	10 - 50 m² or 10 - 50m pipe run	
SAMPLE REF:	CZ002371	
RESULT:	Chrysotile

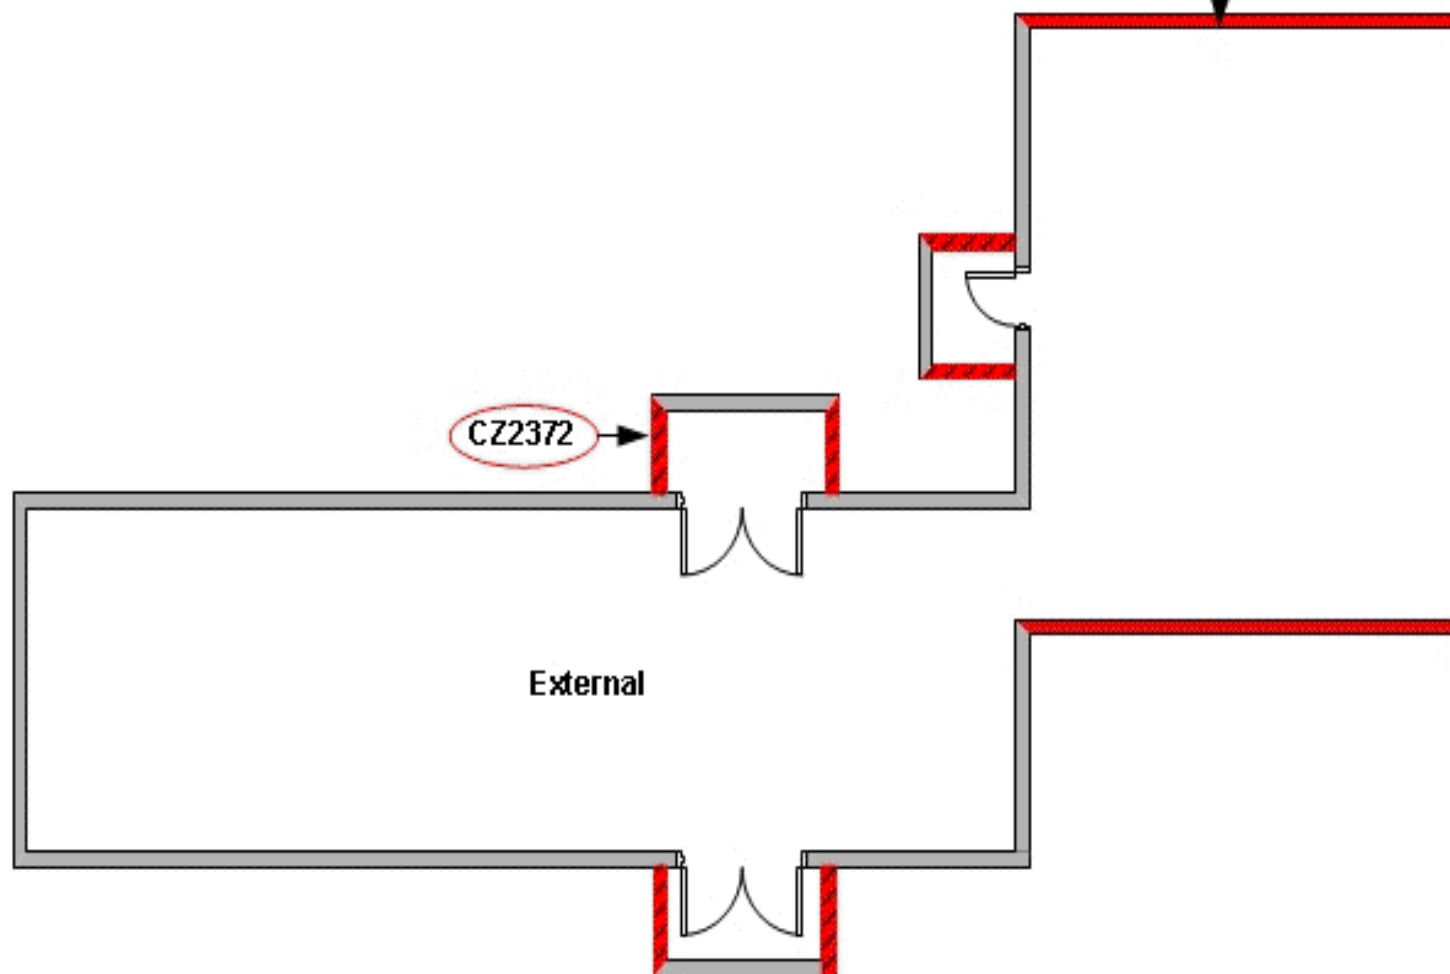
**Strongly Presumed
High Level
Undercloaking**
