**WALES & WEST HOUSING  
ASSOCIATION  
3 ALEXANDRA GATE  
FFORDD PENGAM  
TREMORFA  
CARDIFF  
CF24 2UD**

**PROJECT NO: J178945**

**DATE: MAY 2014**

**ASBESTOS MANAGEMENT SURVEY  
OF  
10 LLYS YR ONNEN, MISKIN ROAD, MOUNTAIN ASH, CF45 3TS**

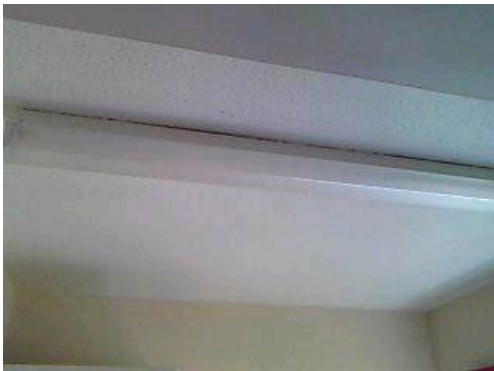
| <b>FLOOR/LOCATION:</b> | Ground Floor Kitchen (001) | |

| SITE ADDRESS: 10 LLYS YR ONNEN, MISKIN ROAD, MOUNTAIN ASH, CF45 3TS | | | | | | | | DATE: 27/05/2014 | | |
|---|---|---|---|---|---|---|---|---|---|---|
| Ground Floor /<br>Kitchen (001)<br>(1) | 1 - 3<br>(1) | Textured coating to ceiling (1) | 5m <sup>2</sup><br>(1) | Sealed<br>(0) | Good<br>Condition<br>(0) | Low (1) | CZ003360 / <b>Chrysotile</b> (1) | 2 + 4 = 6 | Very<br>Low | Manage, label, monitor and<br>inform maintenance personnel<br>prior to relevant works |

| <b>DESCRIPTION:</b> | Textured coating to ceiling | |
| <b>SAMPLE REF:</b> | CZ003360 | |
| <b>RESULT:</b> | Chrysotile | |

| <b>RECOMMENDATIONS:</b> | Manage, label, monitor and inform maintenance personnel prior to relevant works | |

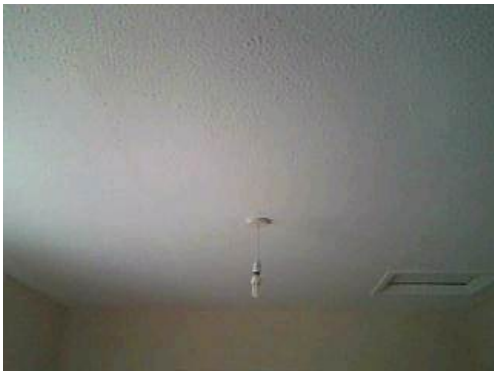
| <b>FLOOR/LOCATION:</b> | Ground Floor Lounge (002) | |

| SITE ADDRESS: 10 LLYS YR ONNEN, MISKIN ROAD, MOUNTAIN ASH, CF45 3TS | | | | | | | | DATE: 27/05/2014 | | |
|---|---|---|---|---|---|---|---|---|---|---|
| Ground Floor /<br>Lounge (002)<br>(1) | 1 - 3<br>(1) | Textured coating to ceiling (1) | 10m <sup>2</sup><br>(1) | Sealed<br>(0) | Good<br>Condition<br>(0) | Low (1) | Strongly presumed similar<br>to CZ003360 /<br><b>Chrysotile</b> (1) | 2 + 4 = 6 | Very<br>Low | Manage, label, monitor and<br>inform maintenance personnel<br>prior to relevant works |

| <b>DESCRIPTION:</b> | Textured coating to ceiling | |
| <b>SAMPLE REF:</b> | SPST CZ003360 | |
| <b>RESULT:</b> | Chrysotile | |

| <b>RECOMMENDATIONS:</b> | Manage, label, monitor and inform maintenance personnel prior to relevant works | |

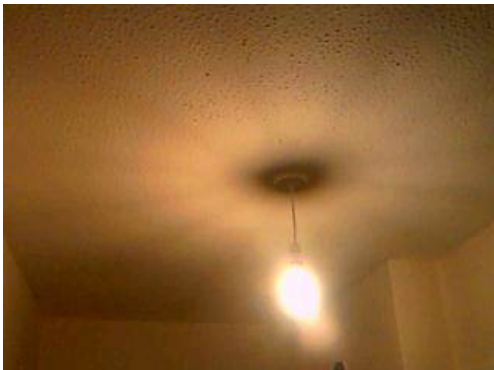
| <b>FLOOR/LOCATION:</b> | Ground Floor Hall (003) | |

| SITE ADDRESS: 10 LLYS YR ONNEN, MISKIN ROAD, MOUNTAIN ASH, CF45 3TS | | | | | | | | DATE: 27/05/2014 | | |
|---|---|---|---|---|---|---|---|---|---|---|
| Ground Floor /<br>Hall (003) (1) | 1 - 3<br>(1) | Textured coating to ceiling (1) | 6m <sup>2</sup><br>(1) | Sealed<br>(0) | Good<br>Condition<br>(0) | Low (1) | CZ003361 / <b>Chrysotile</b> (1) | 2 + 4 = 6 | Very<br>Low | Manage, label, monitor and<br>inform maintenance personnel<br>prior to relevant works |

| <b>DESCRIPTION:</b> | Textured coating to ceiling | |
| <b>RESULT:</b> | Chrysotile | |

| <b>RECOMMENDATIONS:</b> | Manage, label, monitor and inform maintenance personnel prior to relevant works | |

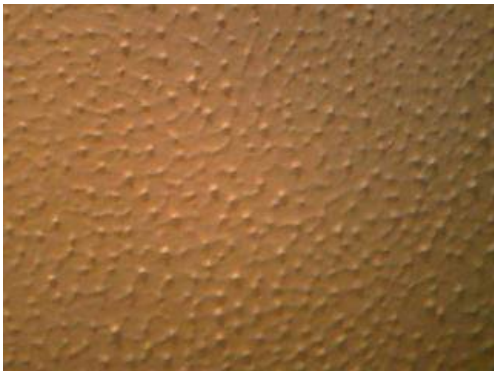
| <b>FLOOR/LOCATION:</b> | Ground Floor Cupboard (004) | |

| SITE ADDRESS: 10 LLYS YR ONNEN, MISKIN ROAD, MOUNTAIN ASH, CF45 3TS | | | | | | | | | DATE: 27/05/2014 | |
|---|---|---|---|---|---|---|---|---|---|---|
| Ground Floor /<br>Cupboard (004) (1) | 1 - 3<br>(1) | Textured coating to ceiling (1) | <3m²<br>(1) | Sealed<br>(0) | Good<br>Condition (0) | Low (1) | Strongly presumed similar to<br>CZ003361 / <b>Chrysotile</b> (1) | 2 + 4 = 6 | Very<br>Low | Manage, label, monitor and inform<br>maintenance personnel prior to<br>relevant works |

| <b>DESCRIPTION:</b> | Textured coating to ceiling | |
| <b>SAMPLE REF:</b> | SPST CZ003361 | |
| <b>RESULT:</b> | Chrysotile | |

| <b>RECOMMENDATIONS:</b> | Manage, label, monitor and inform maintenance personnel prior to relevant works | |

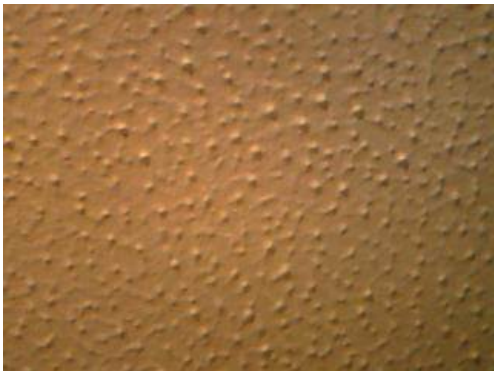
| <b>FLOOR/LOCATION:</b> | Ground Floor Cupboard (005) | |

| SITE ADDRESS: 10 LLYS YR ONNEN, MISKIN ROAD, MOUNTAIN ASH, CF45 3TS | | | | | | | | | DATE: 27/05/2014 | |
|---|---|---|---|---|---|---|---|---|---|---|
| Ground Floor /<br>Cupboard (005) (1) | 1 - 3<br>(1) | Textured coating to ceiling (1) | 1m²<br>(1) | Sealed<br>(0) | Good<br>Condition (0) | Low (1) | Strongly presumed similar to<br>CZ003361 / <b>Chrysotile</b> (1) | 2 + 4 = 6 | Very<br>Low | Manage, label, monitor and inform<br>maintenance personnel prior to<br>relevant works |

| <b>DESCRIPTION:</b> | Textured coating to ceiling | |
| <b>SAMPLE REF:</b> | SPST CZ003361 | |
| <b>RESULT:</b> | Chrysotile | |

| <b>RECOMMENDATIONS:</b> | Manage, label, monitor and inform maintenance personnel prior to relevant works | |

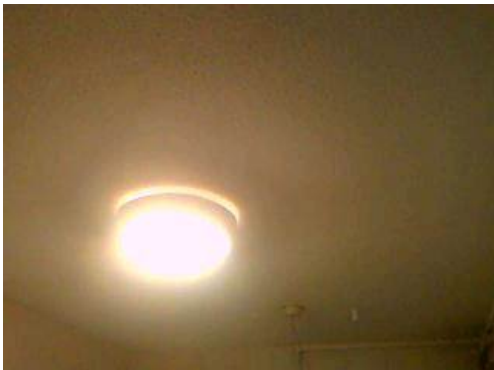
| <b>FLOOR/LOCATION:</b> | Ground Floor Bathroom (006) | |

| SITE ADDRESS: 10 LLYS YR ONNEN, MISKIN ROAD, MOUNTAIN ASH, CF45 3TS | | | | | | | | DATE: 27/05/2014 | | |
|---|---|---|---|---|---|---|---|---|---|---|
| Ground Floor / Bathroom (006) (1) | 1 - 3 (1) | Textured coating to ceiling (1) | 7m <sup>2</sup> (1) | Sealed (0) | Good Condition (0) | Low (1) | CZ003362 / Chrysotile (1) | 2 + 4 = 6 | Very Low | Manage, label, monitor and inform maintenance personnel prior to relevant works |

| <b>DESCRIPTION:</b> | Textured coating to ceiling | |
| <b>RESULT:</b> | Chrysotile | |

| <b>RECOMMENDATIONS:</b> | Manage, label, monitor and inform maintenance personnel prior to relevant works | |

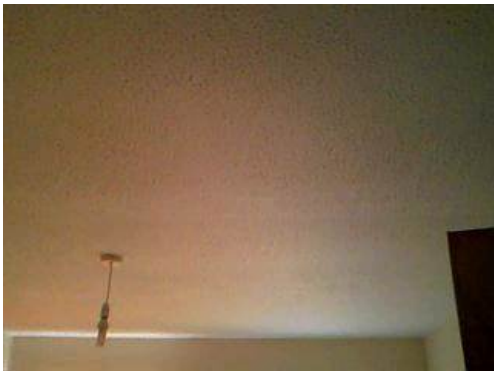
| <b>FLOOR/LOCATION:</b> | Ground Floor Bedroom (007) | |

| SITE ADDRESS: 10 LLYS YR ONNEN, MISKIN ROAD, MOUNTAIN ASH, CF45 3TS | | | | | | | | DATE: 27/05/2014 | | |
|---|---|---|---|---|---|---|---|---|---|---|
| Ground Floor / Bedroom (007) (1) | 1 - 3 (1) | Textured coating to ceiling (1) | 10m <sup>2</sup> (1) | Sealed (0) | Good Condition (0) | Low (1) | Strongly presumed similar to CZ003362 / Chrysotile (1) | 2 + 4 = 6 | Very Low | Manage, label, monitor and inform maintenance personnel prior to relevant works |

| <b>DESCRIPTION:</b> | Textured coating to ceiling | |
| <b>SAMPLE REF:</b> | SPST CZ003362 | |
| <b>RESULT:</b> | Chrysotile | |

| <b>RECOMMENDATIONS:</b> | Manage, label, monitor and inform maintenance personnel prior to relevant works | |

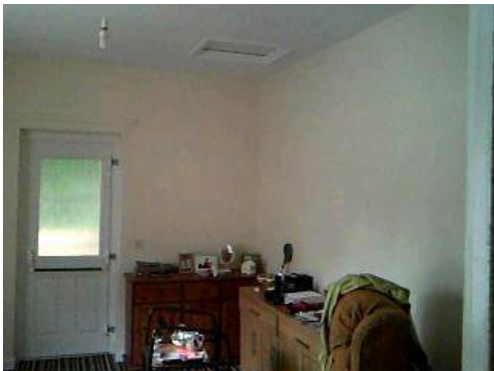
| <b>FLOOR/LOCATION:</b> | Roof Void Loft Space 1 | |

| <b>DESCRIPTION:</b> | Inaccessible | |

| <b>RECOMMENDATIONS:</b> | Conduct further investigation prior to relevant works | |
