**WALES & WEST HOUSING  
ASSOCIATION  
3 ALEXANDRA GATE  
FFORDD PENGAM  
TREMORFA  
CARDIFF  
CF24 2UD**

**PROJECT NO: J172418**

**DATE: APRIL 2014**

**ASBESTOS MANAGEMENT SURVEY  
OF  
23 LLYS YR ONNEN, MISKIN ROAD, MOUNTAIN ASH, CF45 3TS**

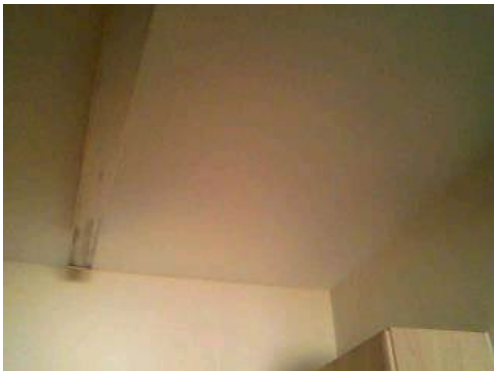
| <b>FLOOR/LOCATION:</b> | 1st Floor Kitchen (101) | |

| SITE ADDRESS: 23 LLYS YR ONNEN, MISKIN ROAD, MOUNTAIN ASH, CF45 3TS | | | | | | | | DATE: 16/04/2014 | | |
|---|---|---|---|---|---|---|---|---|---|---|
| 1st Floor /<br>Kitchen (101)<br>(1) | 1 - 3<br>(1) | Textured coating to ceiling (1) | 3m <sup>2</sup><br>(1) | Sealed<br>(0) | Good<br>Condition (0) | Rare (0) | EE002314 /<br>Chrysotile (1) | 2 + 3 = 5 | Very<br>Low | Manage, label, monitor and inform<br>maintenance personnel prior to<br>relevant works |

| <b>DESCRIPTION:</b> | Textured coating to ceiling | |
| <b>SAMPLE REF:</b> | EE002314 | |
| <b>RESULT:</b> | Chrysotile | |

| <b>RECOMMENDATIONS:</b> | Manage, label, monitor and inform maintenance personnel prior to relevant works | |

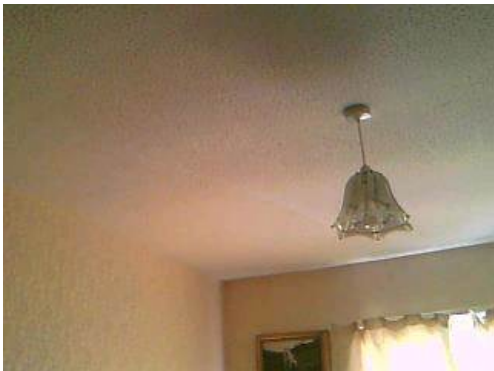
| <b>FLOOR/LOCATION:</b> | 1st Floor Lounge (102) | |

| SITE ADDRESS: 23 LLYS YR ONNEN, MISKIN ROAD, MOUNTAIN ASH, CF45 3TS | | | | | | | | DATE: 16/04/2014 | | |
|---|---|---|---|---|---|---|---|---|---|---|
| 1st Floor /<br>Lounge (102)<br>(1) | 1 - 3<br>(1) | Textured coating to ceiling (1) | 6m <sup>2</sup><br>(1) | Sealed<br>(0) | Good<br>Condition (0) | Rare (0) | EE002315 /<br>Chrysotile (1) | 2 + 3 = 5 | Very<br>Low | Manage, label, monitor and inform<br>maintenance personnel prior to<br>relevant works |

| <b>DESCRIPTION:</b> | Textured coating to ceiling | |
| <b>SAMPLE REF:</b> | EE002315 | |
| <b>RESULT:</b> | Chrysotile | |

| <b>RECOMMENDATIONS:</b> | Manage, label, monitor and inform maintenance personnel prior to relevant works | |

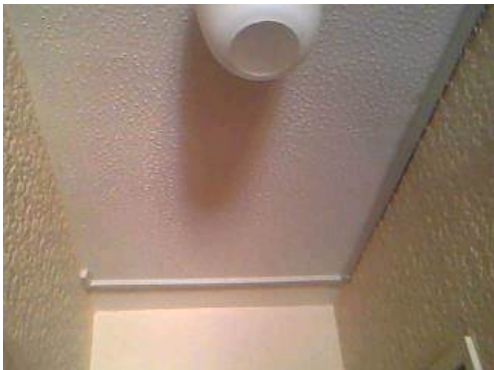
| <b>FLOOR/LOCATION:</b> | 1st Floor Hall (103) | |

| SITE ADDRESS: 23 LLYS YR ONNEN, MISKIN ROAD, MOUNTAIN ASH, CF45 3TS | | | | | | | | DATE: 16/04/2014 | | |
|---|---|---|---|---|---|---|---|---|---|---|
| 1st Floor / Hall<br>(103) (1) | 1 - 3<br>(1) | Textured coating to ceiling (1) | 3m <sup>2</sup><br>(1) | Sealed<br>(0) | Good<br>Condition (0) | Rare (0) | EE002316 /<br>Chrysotile (1) | 2 + 3 = 5 | Very<br>Low | Manage, label, monitor and inform<br>maintenance personnel prior to<br>relevant works |

| <b>DESCRIPTION:</b> | Textured coating to ceiling | |
| <b>RESULT:</b> | Chrysotile | |

| <b>RECOMMENDATIONS:</b> | Manage, label, monitor and inform maintenance personnel prior to relevant works | |

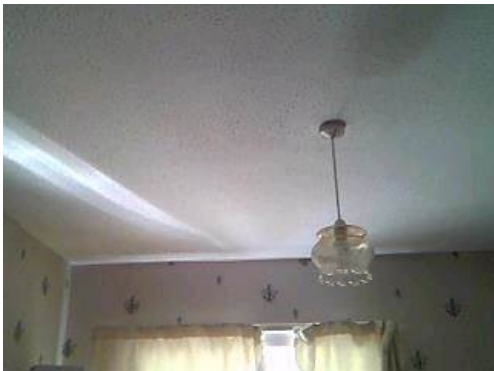
| <b>FLOOR/LOCATION:</b> | 1st Floor Bedroom (104) | |

| Location | Description | Priority/Risk | Recommendation |
|---|---|---|---|
| Bedroom (104) / 1st Floor | Textured coating to ceiling | Very Low | Manage, label, monitor and inform maintenance personnel prior to relevant works |

| <b>DESCRIPTION:</b> | Textured coating to ceiling | |
| <b>SAMPLE REF:</b> | EE002317 | |
| <b>RESULT:</b> | Chrysotile | |

| <b>RECOMMENDATIONS:</b> | Manage, label, monitor and inform maintenance personnel prior to relevant works | |

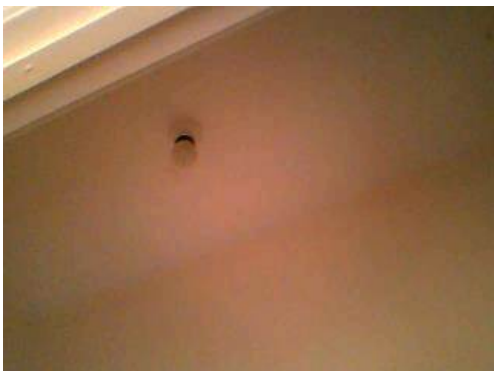
| <b>FLOOR/LOCATION:</b> | 1st Floor Electrical Cupboard (105) | |

| <b>DESCRIPTION:</b> | Textured coating to ceiling | |
| <b>SAMPLE REF:</b> | SPST EE002316 | |
| <b>RESULT:</b> | Chrysotile | |

| <b>RECOMMENDATIONS:</b> | Manage, label, monitor and inform maintenance personnel prior to relevant works | |

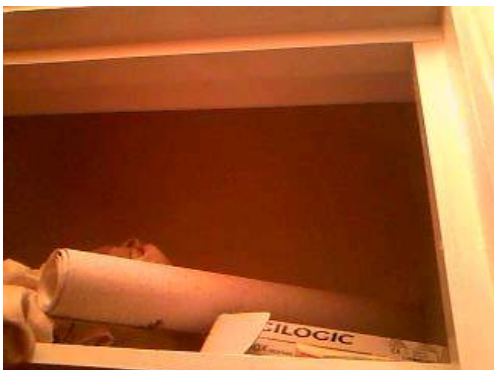
| <b>FLOOR/LOCATION:</b> | 1st Floor Cupboard (106) | |

| <b>DESCRIPTION:</b> | Textured coating to ceiling | |
| <b>RESULT:</b> | Chrysotile | |

| <b>RECOMMENDATIONS:</b> | Manage, label, monitor and inform maintenance personnel prior to relevant works | |

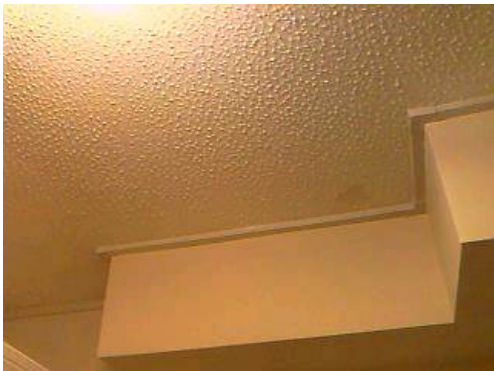
| <b>FLOOR/LOCATION:</b> | 1st Floor Wet Room (107) | |

| <b>DESCRIPTION:</b> | Textured coating to ceiling | |

| <b>RECOMMENDATIONS:</b> | Manage, label, monitor and inform maintenance personnel prior to relevant works | |
