**WALES & WEST HOUSING  
ASSOCIATION  
3 ALEXANDRA GATE  
FFORDD PENGAM  
TREMORFA  
CARDIFF  
CF24 2UD**

**PROJECT NO: J172421**

**DATE: APRIL 2014**

**ASBESTOS MANAGEMENT SURVEY  
OF  
24 LLYS YR ONNEN, MISKIN ROAD, MOUNTAIN ASH, CF45 3TS**

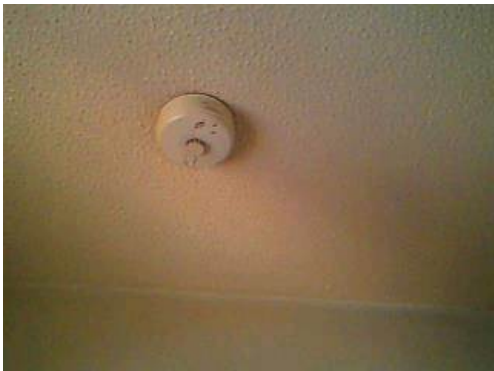
| <b>FLOOR/LOCATION:</b> | 2nd Floor Kitchen (201) | |

| SITE ADDRESS: 24 LLYS YR ONNEN, MISKIN ROAD, MOUNTAIN ASH, CF45 3TS | | | | | | | | | DATE: 16/04/2014 | | |
|---|---|---|---|---|---|---|---|---|---|---|--|
| 2nd Floor /<br>Kitchen (201)<br>(1) | 1 - 3<br>(1) | Textured coating to ceiling (1) | 3m <sup>2</sup><br>(1) | Sealed<br>(0) | Good<br>Condition<br>(0) | Rare (0) | EE002319 /<br>Chrysotile (1) | 2 + 3 = 5 | Very<br>Low | Manage, label, monitor and inform<br>maintenance personnel prior to<br>relevant works | |

| <b>DESCRIPTION:</b> | Textured coating to ceiling | |
| <b>SAMPLE REF:</b> | EE002319 | |
| <b>RESULT:</b> | Chrysotile | |

| <b>RECOMMENDATIONS:</b> | Manage, label, monitor and inform maintenance personnel prior to relevant works | |

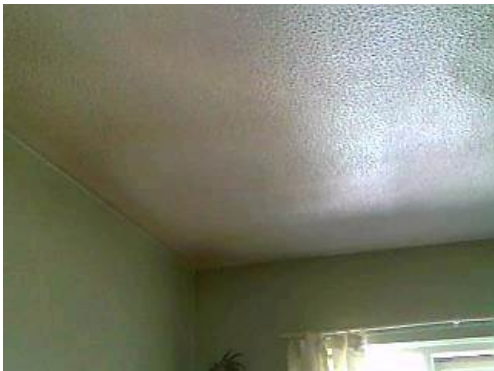
| <b>FLOOR/LOCATION:</b> | 2nd Floor Lounge (202) | |

| SITE ADDRESS: 24 LLYS YR ONNEN, MISKIN ROAD, MOUNTAIN ASH, CF45 3TS | | | | | | | | | DATE: 16/04/2014 | | |
|---|---|---|---|---|---|---|---|---|---|---|--|
| 2nd Floor /<br>Lounge (202)<br>(1) | 1 - 3<br>(1) | Textured coating to ceiling (1) | 9m <sup>2</sup><br>(1) | Sealed<br>(0) | Good<br>Condition<br>(0) | Rare (0) | EE002320 /<br>Chrysotile (1) | 2 + 3 = 5 | Very<br>Low | Manage, label, monitor and inform<br>maintenance personnel prior to<br>relevant works | |

| <b>DESCRIPTION:</b> | Textured coating to ceiling | |
| <b>SAMPLE REF:</b> | EE002320 | |
| <b>RESULT:</b> | Chrysotile | |

| <b>RECOMMENDATIONS:</b> | Manage, label, monitor and inform maintenance personnel prior to relevant works | |

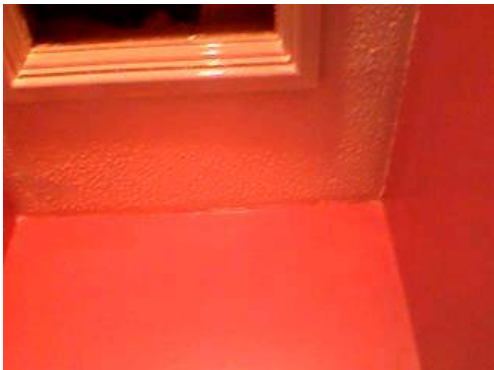
| <b>FLOOR/LOCATION:</b> | 2nd Floor Hall (203) | |

| SITE ADDRESS: 24 LLYS YR ONNEN, MISKIN ROAD, MOUNTAIN ASH, CF45 3TS | | | | | | | | | DATE: 16/04/2014 | | |
|---|---|---|---|---|---|---|---|---|---|---|--|
| 2nd Floor /<br>Hall (203) (1) | 1 - 3<br>(1) | Textured coating to ceiling (1) | 3m <sup>2</sup><br>(1) | Sealed<br>(0) | Good<br>Condition<br>(0) | Rare (0) | EE002321 /<br>Chrysotile (1) | 2 + 3 = 5 | Very<br>Low | Manage, label, monitor and inform<br>maintenance personnel prior to<br>relevant works | |

| <b>DESCRIPTION:</b> | Textured coating to ceiling | |
| <b>RESULT:</b> | Chrysotile | |

| <b>RECOMMENDATIONS:</b> | Manage, label, monitor and inform maintenance personnel prior to relevant works | |

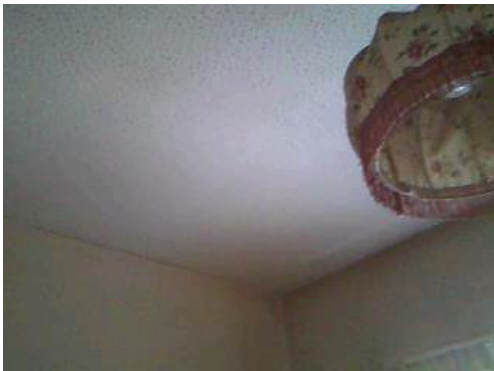
| <b>FLOOR/LOCATION:</b> | 2nd Floor Bedroom (204) | |

| SITE ADDRESS: 24 LLYS YR ONNEN, MISKIN ROAD, MOUNTAIN ASH, CF45 3TS | | | | | | | | DATE: 16/04/2014 | | |
|---|---|---|---|---|---|---|---|---|---|---|
| 2nd Floor / Bedroom (204) (1) | 1 - 3 (1) | Textured coating to ceiling (1) | 4m <sup>2</sup> (1) | Sealed (0) | Good Condition (0) | Rare (0) | EE002322 / <b>Chrysotile</b> (1) | 2 + 3 = 5 | Very Low | Manage, label, monitor and inform maintenance personnel prior to relevant works |

| <b>DESCRIPTION:</b> | Textured coating to ceiling | |
| <b>SAMPLE REF:</b> | EE002322 | |
| <b>RESULT:</b> | Chrysotile | |

| <b>RECOMMENDATIONS:</b> | Manage, label, monitor and inform maintenance personnel prior to relevant works | |

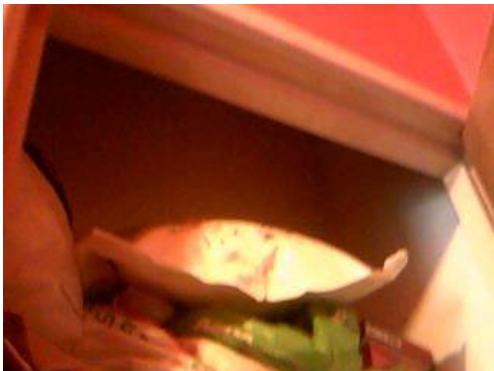
| <b>FLOOR/LOCATION:</b> | 2nd Floor Airing Cupboard (205) | |

| SITE ADDRESS: 24 LLYS YR ONNEN, MISKIN ROAD, MOUNTAIN ASH, CF45 3TS | | | | | | | | DATE: 16/04/2014 | | |
|---|---|---|---|---|---|---|---|---|---|---|
| 2nd Floor / Airing Cupboard (205) (1) | 1 - 3 (1) | Textured coating to ceiling (1) | <1m <sup>2</sup> (1) | Sealed (0) | Good Condition (0) | Rare (0) | Strongly presumed similar to EE002321 / <b>Chrysotile</b> (1) | 2 + 3 = 5 | Very Low | Manage, label, monitor and inform maintenance personnel prior to relevant works |

| <b>DESCRIPTION:</b> | Textured coating to ceiling | |
| <b>SAMPLE REF:</b> | SPST EE002321 | |
| <b>RESULT:</b> | Chrysotile | |

| <b>RECOMMENDATIONS:</b> | Manage, label, monitor and inform maintenance personnel prior to relevant works | |

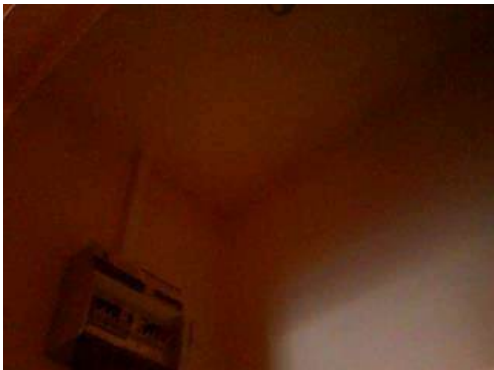
| <b>FLOOR/LOCATION:</b> | 2nd Floor Electrical Cupboard (206) | |

| SITE ADDRESS: 24 LLYS YR ONNEN, MISKIN ROAD, MOUNTAIN ASH, CF45 3TS | | | | | | | | DATE: 16/04/2014 | | |
|---|---|---|---|---|---|---|---|---|---|---|
| 2nd Floor /<br>Electrical<br>Cupboard (206)<br>(1) | 1 - 3<br>(1) | Textured coating to ceiling (1) | 1m <sup>2</sup><br>(1) | Sealed (0) | Good<br>Condition<br>(0) | Rare (0) | Strongly presumed<br>similar to EE002321 /<br>Chrysotile (1) | 2 + 3 = 5 | Very<br>Low | Manage, label, monitor and<br>inform maintenance personnel<br>prior to relevant works |

| <b>DESCRIPTION:</b> | Textured coating to ceiling | |
| <b>RESULT:</b> | Chrysotile | |

| <b>RECOMMENDATIONS:</b> | Manage, label, monitor and inform maintenance personnel prior to relevant works | |

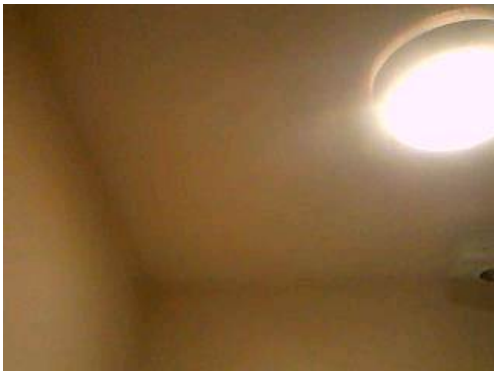
| <b>FLOOR/LOCATION:</b> | 2nd Floor Wet Room (207) | |

| SITE ADDRESS: 24 LLYS YR ONNEN, MISKIN ROAD, MOUNTAIN ASH, CF45 3TS | | | | | | | | DATE: 16/04/2014 | | |
|---|---|---|---|---|---|---|---|---|---|---|
| 2nd Floor / Wet<br>Room (207) (1) | 1 - 3<br>(1) | Textured coating to ceiling (1) | 3m <sup>2</sup><br>(1) | Sealed (0) | Good<br>Condition<br>(0) | Rare (0) | EE002323 /<br>Chrysotile (1) | 2 + 3 = 5 | Very<br>Low | Manage, label, monitor and<br>inform maintenance personnel<br>prior to relevant works |

| <b>DESCRIPTION:</b> | Textured coating to ceiling | |

| <b>RECOMMENDATIONS:</b> | Manage, label, monitor and inform maintenance personnel prior to relevant works | |
