**WALES & WEST HOUSING  
ASSOCIATION  
3 ALEXANDRA GATE  
FFORDD PENGAM  
TREMORFA  
CARDIFF  
CF24 2UD**

**PROJECT NO: J132647**

**DATE: NOVEMBER 2013**

**ASBESTOS MANAGEMENT SURVEY  
OF  
19 LLYS YR ONNEN, MISKIN ROAD, MOUNTAIN ASH, CF453TS**

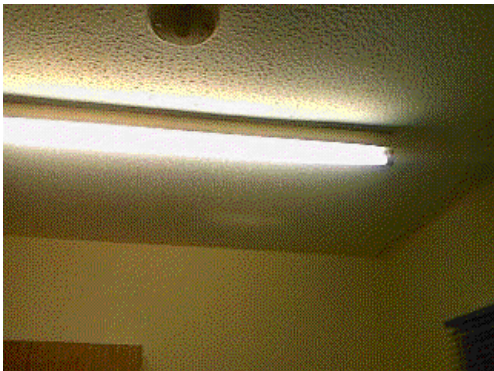
| <b>FLOOR/LOCATION:</b> | 1st Floor Kitchen (101) | |

| SITE ADDRESS: 19 LLYS YR ONNEN, MISKIN ROAD, MOUNTAIN ASH, CF453TS | | | | | | | | DATE: 08/11/2013 to 10/11/2013 | | |
|---|---|---|---|---|---|---|---|---|---|---|
| 1st Floor /<br>Kitchen (101)<br>(1) | 1 - 3<br>(1) | Textured coating to ceiling (1) | 5m <sup>2</sup><br>(1) | Sealed<br>(0) | Good<br>Condition (0) | Low (1) | CZ002179 / <b>Chrysotile (1)</b> | 2 + 4 = 6 | Very<br>Low | Manage, label, monitor and inform<br>maintenance personnel prior to<br>relevant works |

| <b>DESCRIPTION:</b> | Textured coating to ceiling | |
| <b>SAMPLE REF:</b> | CZ002179 | |
| <b>RESULT:</b> | Chrysotile | |

| <b>RECOMMENDATIONS:</b> | Manage, label, monitor and inform maintenance personnel prior to relevant works | |

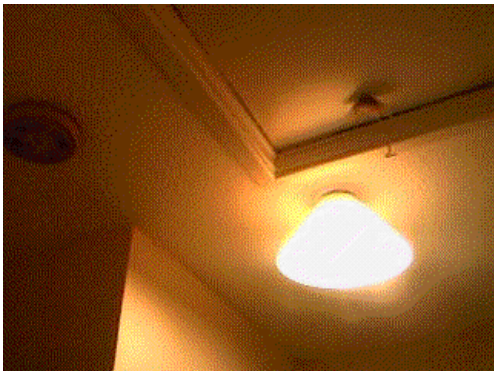
| <b>FLOOR/LOCATION:</b> | 1st Floor Hall (102) | |

| SITE ADDRESS: 19 LLYS YR ONNEN, MISKIN ROAD, MOUNTAIN ASH, CF453TS | | | | | | | | DATE: 08/11/2013 to 10/11/2013 | | |
|---|---|---|---|---|---|---|---|---|---|---|
| 1st Floor /<br>Hall (102) (1) | 1 - 3<br>(1) | Textured coating to ceiling (1) | 4m <sup>2</sup><br>(1) | Sealed<br>(0) | Good<br>Condition (0) | Low (1) | Strongly presumed similar<br>to CZ002179 /<br><b>Chrysotile (1)</b> | 2 + 4 = 6 | Very<br>Low | Manage, label, monitor and inform<br>maintenance personnel prior to<br>relevant works |

| <b>DESCRIPTION:</b> | Textured coating to ceiling | |
| <b>SAMPLE REF:</b> | SPST CZ002179 | |
| <b>RESULT:</b> | Chrysotile | |

| <b>RECOMMENDATIONS:</b> | Manage, label, monitor and inform maintenance personnel prior to relevant works | |

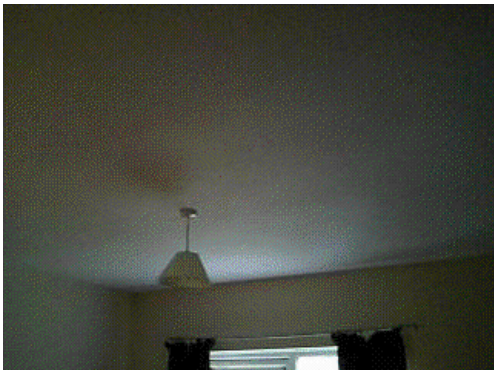
| <b>FLOOR/LOCATION:</b> | 1st Floor Lounge (103) | |

| SITE ADDRESS: 19 LLYS YR ONNEN, MISKIN ROAD, MOUNTAIN ASH, CF453TS | | | | | | | | DATE: 08/11/2013 to 10/11/2013 | | |
|---|---|---|---|---|---|---|---|---|---|---|
| 1st Floor /<br>Lounge (103)<br>(1) | 1 - 3<br>(1) | Textured coating to ceiling (1) | 10m <sup>2</sup><br>(1) | Sealed<br>(0) | Good<br>Condition (0) | Low (1) | Strongly presumed similar<br>to CZ002179 /<br><b>Chrysotile (1)</b> | 2 + 4 = 6 | Very<br>Low | Manage, label, monitor and inform<br>maintenance personnel prior to<br>relevant works |

| <b>DESCRIPTION:</b> | Textured coating to ceiling | |
| <b>RESULT:</b> | Chrysotile | |

| <b>RECOMMENDATIONS:</b> | Manage, label, monitor and inform maintenance personnel prior to relevant works | |

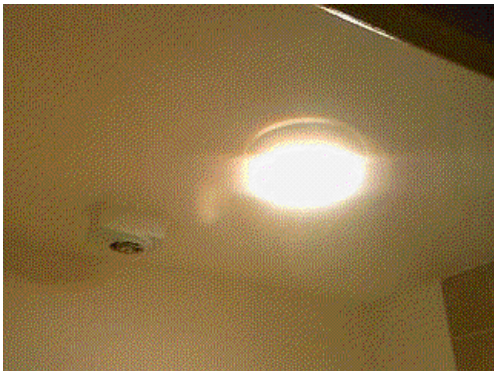
| <b>FLOOR/LOCATION:</b> | 1st Floor Bathroom (104) | |

| SITE ADDRESS: 19 LLYS YR ONNEN, MISKIN ROAD, MOUNTAIN ASH, CF453TS | | | | | | | | DATE: 08/11/2013 to 10/11/2013 | | |
|---|---|---|---|---|---|---|---|---|---|---|
| 1st Floor /<br>Bathroom (104)<br>(1) | 1 - 3<br>(1) | Textured coating to ceiling (1) | 5m <sup>2</sup><br>(1) | Sealed<br>(0) | Good<br>Condition<br>(0) | Low (1) | CZ002180 / <b>Chrysotile</b> (1) | 2 + 4 = 6 | Very<br>Low | Manage, label, monitor and<br>inform maintenance personnel<br>prior to relevant works |

| <b>DESCRIPTION:</b> | Textured coating to ceiling | |
| <b>SAMPLE REF:</b> | CZ002180 | |
| <b>RESULT:</b> | Chrysotile | |

| <b>RECOMMENDATIONS:</b> | Manage, label, monitor and inform maintenance personnel prior to relevant works | |

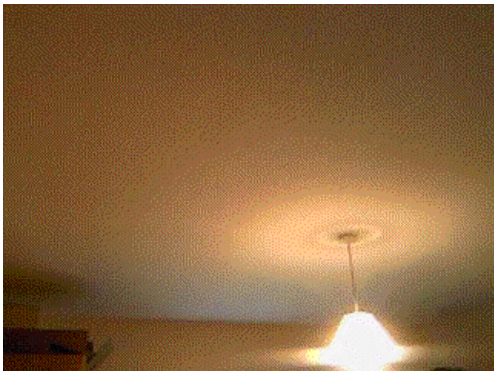
| <b>FLOOR/LOCATION:</b> | 1st Floor Bedroom (105) | |

| SITE ADDRESS: 19 LLYS YR ONNEN, MISKIN ROAD, MOUNTAIN ASH, CF453TS | | | | | | | | DATE: 08/11/2013 to 10/11/2013 | | |
|---|---|---|---|---|---|---|---|---|---|---|
| 1st Floor /<br>Bedroom (105)<br>(1) | 1 - 3<br>(1) | Textured coating to ceiling (1) | 8m <sup>2</sup><br>(1) | Sealed<br>(0) | Good<br>Condition<br>(0) | Low (1) | Strongly presumed similar<br>to CZ002180 /<br><b>Chrysotile</b> (1) | 2 + 4 = 6 | Very<br>Low | Manage, label, monitor and<br>inform maintenance personnel<br>prior to relevant works |

| <b>DESCRIPTION:</b> | Textured coating to ceiling | |
| <b>SAMPLE REF:</b> | SPST CZ002180 | |
| <b>RESULT:</b> | Chrysotile | |

| <b>RECOMMENDATIONS:</b> | Manage, label, monitor and inform maintenance personnel prior to relevant works | |

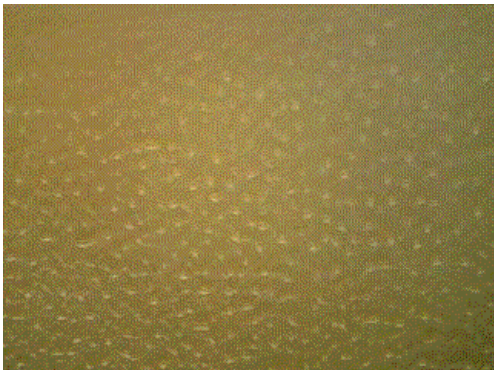
| <b>FLOOR/LOCATION:</b> | 1st Floor Cupboard (106) | |

| SITE ADDRESS: 19 LLYS YR ONNEN, MISKIN ROAD, MOUNTAIN ASH, CF453TS | | | | | | | | DATE: 08/11/2013 to 10/11/2013 | | |
|---|---|---|---|---|---|---|---|---|---|---|
| 1st Floor /<br>Cupboard (106) (1) | 1 - 3<br>(1) | Textured coating to ceiling (1) | 1m <sup>2</sup><br>(1) | Sealed<br>(0) | Good<br>Condition (0) | Low (1) | Strongly presumed similar to<br>CZ002180 / <b>Chrysotile</b> (1) | 2 + 4 = 6 | Very<br>Low | Manage, label, monitor and inform<br>maintenance personnel prior to relevant<br>works |

| <b>DESCRIPTION:</b> | Textured coating to ceiling | |
| <b>RESULT:</b> | Chrysotile | |

| <b>RECOMMENDATIONS:</b> | Manage, label, monitor and inform maintenance personnel prior to relevant works | |

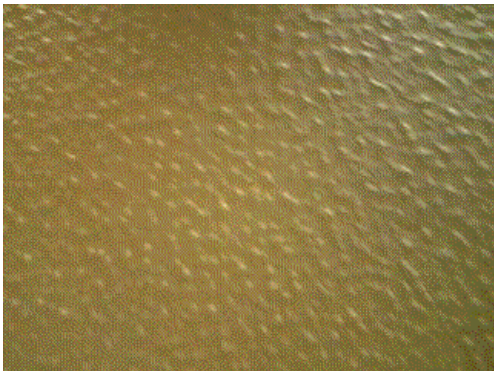
| <b>FLOOR/LOCATION:</b> | 1st Floor Cupboard (107) | |

| SITE ADDRESS: 19 LLYS YR ONNEN, MISKIN ROAD, MOUNTAIN ASH, CF453TS | | | | | | | | DATE: 08/11/2013 to 10/11/2013 | | |
|---|---|---|---|---|---|---|---|---|---|---|
| 1st Floor /<br>Cupboard (107) (1) | 1 - 3<br>(1) | Textured coating to ceiling (1) | 1m <sup>2</sup><br>(1) | Sealed<br>(0) | Good<br>Condition (0) | Low (1) | Strongly presumed similar to<br>CZ002180 / <b>Chrysotile</b> (1) | 2 + 4 = 6 | Very<br>Low | Manage, label, monitor and inform<br>maintenance personnel prior to relevant<br>works |

| <b>DESCRIPTION:</b> | Textured coating to ceiling | |
| <b>SAMPLE REF:</b> | SPST CZ002180 | |
| <b>RESULT:</b> | Chrysotile | |

| <b>RECOMMENDATIONS:</b> | Manage, label, monitor and inform maintenance personnel prior to relevant works | |

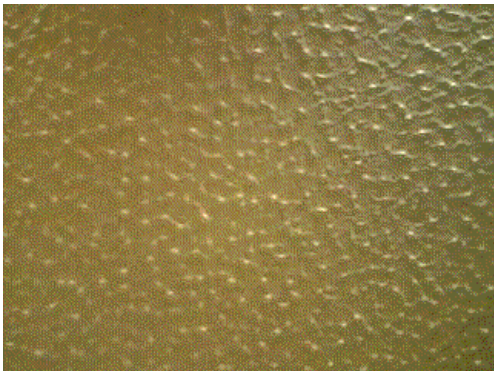
| <b>FLOOR/LOCATION:</b> | 1st Floor Cupboard (108) | |

| SITE ADDRESS: 19 LLYS YR ONNEN, MISKIN ROAD, MOUNTAIN ASH, CF453TS | | | | | | | | DATE: 08/11/2013 to 10/11/2013 | | |
|---|---|---|---|---|---|---|---|---|---|---|
| 1st Floor /<br>Cupboard (108) (1) | 1 - 3<br>(1) | Textured coating to ceiling (1) | 1m <sup>2</sup><br>(1) | Sealed<br>(0) | Good<br>Condition (0) | Low (1) | Strongly presumed similar to<br>CZ002180 / <b>Chrysotile</b> (1) | 2 + 4 = 6 | Very<br>Low | Manage, label, monitor and inform<br>maintenance personnel prior to relevant<br>works |

| <b>DESCRIPTION:</b> | Textured coating to ceiling | |

| <b>RECOMMENDATIONS:</b> | Manage, label, monitor and inform maintenance personnel prior to relevant works | |
