**WALES & WEST HOUSING
ASSOCIATION
3 ALEXANDRA GATE
FFORDD PENGAM
TREMORFA
CARDIFF
CF24 2UD**

PROJECT NO: J132651

DATE: NOVEMBER 2013

**ASBESTOS MANAGEMENT SURVEY
OF
3 LLYS YR ONNEN, MISKIN ROAD, MOUNTAIN ASH, CF453TS**

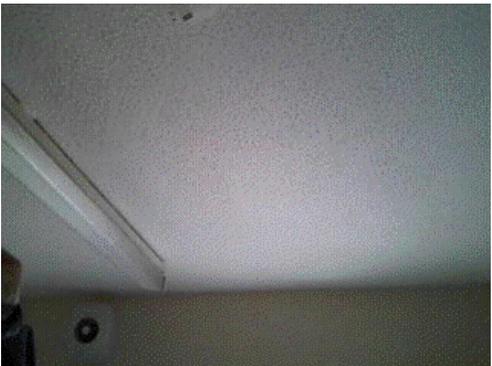
FLOOR/LOCATION:	Ground Floor Kitchen (001)

DESCRIPTION:	Textured coating to ceiling	
RECOMMENDATIONS:	Manage, label, monitor and inform maintenance personnel prior to relevant works	
EXTENT:	<10m ² or <10m pipe run	
SAMPLE REF:	CZ002166	
RESULT:	Chrysotile

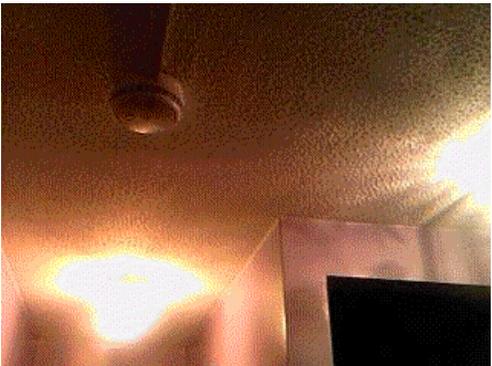
FLOOR/LOCATION:	Ground Floor Hall (002)

Ground Floor / Hall (002) (1)	1 - 3 (1)	Textured coating to ceiling (1)	6m ² (1)	Sealed (0)	Good Condition (0)	Low (1)	Strongly presumed similar to CZ002166 / Chrysotile (1)	2 + 4 = 6	Very Low	Manage, label, monitor and inform maintenance personnel prior to relevant works
Ground Floor / Hall (002)	-	Visually no asbestos identified	-	-	-	-		-	-	No further action required
Ground Floor / Hall (002)		Plasterboard ceiling, solid walls, concrete floor, fixed carpet, exposed copper pipework, metal radiator, timber doors and frames.								
Ground Floor / Toilet (003) (1)	1 - 3 (1)	Textured coating to ceiling (1)	2m ² (1)	Sealed (0)	Good Condition (0)	Low (1)	Strongly presumed similar to CZ002166 / Chrysotile (1)	2 + 4 = 6	Very Low	Manage, label, monitor and inform maintenance personnel prior to relevant works
Indicates parameter for Material Assessment algorithm(MA)			Product type *C Surface Treatment *E Extent of damage *F Asbestos Type *H				Priority Rating: Very low <9 Low 10-12 Medium 13-15 High ≥16

DESCRIPTION:	Textured coating to ceiling	
RECOMMENDATIONS:	Manage, label, monitor and inform maintenance personnel prior to relevant works	
EXTENT:	<10m ² or <10m pipe run	
SAMPLE REF:	SPST CZ002166	
RESULT:	Chrysotile

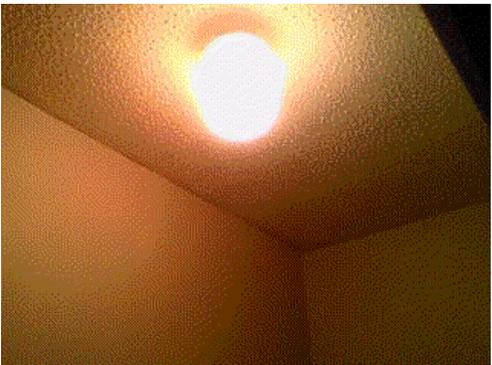
FLOOR/LOCATION:	Ground Floor Toilet (003)

DESCRIPTION:	Textured coating to ceiling	
RECOMMENDATIONS:	Manage, label, monitor and inform maintenance personnel prior to relevant works	
EXTENT:	<10m ² or <10m pipe run	
SAMPLE REF:	SPST CZ002166	
RESULT:	Chrysotile

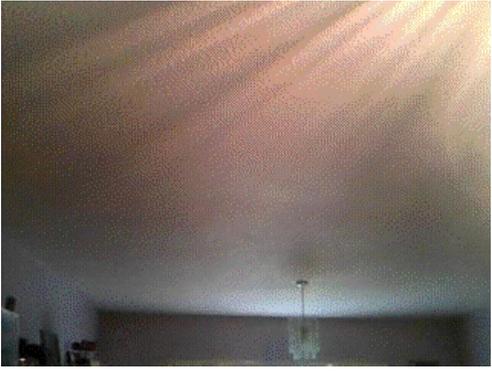
FLOOR/LOCATION:	Ground Floor Lounge (004)

DESCRIPTION:	Textured coating to ceiling	
RECOMMENDATIONS:	Manage, label, monitor and inform maintenance personnel prior to relevant works	
EXTENT:	10 - 50 m ² or 10 - 50m pipe run	
SAMPLE REF:	CZ002167	
RESULT:	Chrysotile

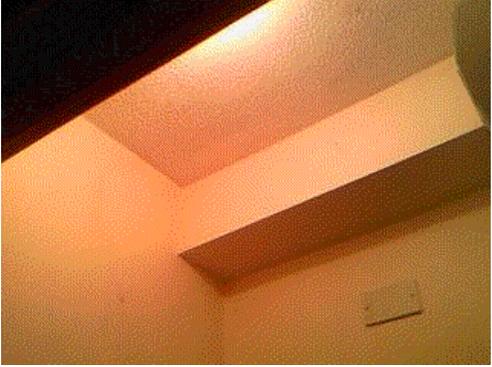
FLOOR/LOCATION:	Ground Floor Cupboard (005)

DESCRIPTION:	Textured coating to ceiling	
RECOMMENDATIONS:	Manage, label, monitor and inform maintenance personnel prior to relevant works	
EXTENT:	<10m ² or <10m pipe run	
SAMPLE REF:	SPST CZ002167	
RESULT:	Chrysotile

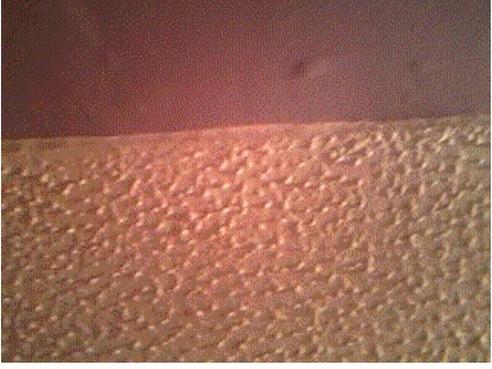
FLOOR/LOCATION:	Ground Floor Cupboard (007)

DESCRIPTION:	Textured coating to ceiling	
RECOMMENDATIONS:	Manage, label, monitor and inform maintenance personnel prior to relevant works	
EXTENT:	<10m ² or <10m pipe run	
SAMPLE REF:	SPST CZ002167	
RESULT:	Chrysotile
