**An Asbestos Management Survey (MA & PA) at
Block 1 - 31
Maes Trisant
CF72 8RQ**

Survey Conducted:	1 August 2023	
Date of approval:	4 Aug 2023	
Our Reference:	J329567	
Surveyed By:	Fiona Williamson	
UPRN:	3674	
Scope of Works:	Management survey to all accessible communal areas of the property.

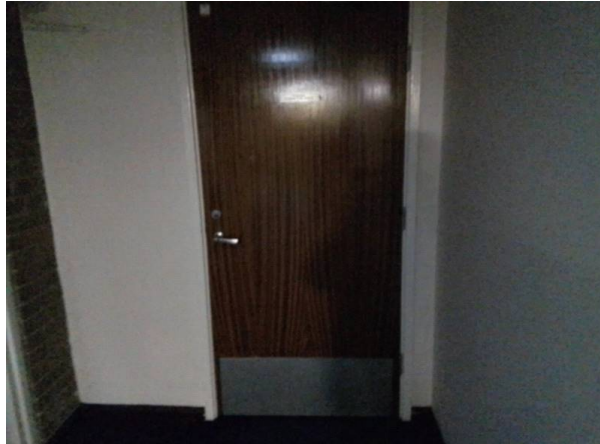
Building:	1 - 31 Maes Trisant	Floor Level:	Basement 1	Item Ref:	J329567-1
Room Name:	(001) Former Laundry				
Sample Ref:	Inaccessible (Presumed)				
Component:	No Access				
Extent:

Conclusions and Actions	
Recommendation:	Further Inspection Required.
Further Information:	None
General Notes: Unable to access as key not available at time of survey

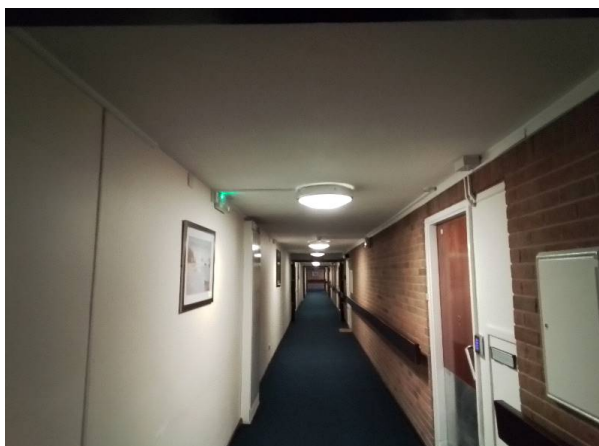
Building:	1 - 31 Maes Trisant	Floor Level:	Basement 1	Item Ref:	J329567-2
Room Name:	(002) Corridor				
Sample Ref:	JZ001100				
Component:	Textured coating to plasterboard ceiling				
Extent:	60m ²

Material Assessment		
Product Type	Extent of damage	Surface Treatment Score
Asbestos Type	Material Assessment Score (MA)	
No Asbestos Detected

Conclusions and Actions	
Recommendation:	No further action required
Further Information:	None
General Notes: Textured coating to plasterboard ceiling. Plaster to brick and brick walls. Carpet to concrete floor. Wooden beading to fire glass panels in wooden fire doors between corridor sections and stairs. Plaster to brick header panels above corridor doors. Wooden doors to flats communal shower and former laundry. Wooden panelling to left and right hand sides of doors to flats (housing letter boxes). Modern wiring running in plastic conduit along walls and ceiling. Modern mastic in gaps between sections of brick work. Modern radiators. Wooden panels to rear of electric meters in glass fibre meter cupboards in walls.

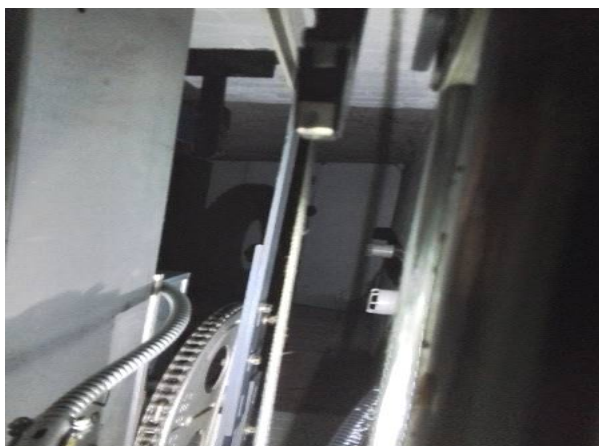
Building:	1 - 31 Maes Trisant	Floor Level:	Basement 1	Item Ref:	J329567-25
Room Name:	(004) Lift Shaft				
Sample Ref:	Presumed				
Component:	Insulation board ceiling panels to shaft				
Extent:	6m ²

Material Assessment		
Product Type	Extent of damage	Surface Treatment Score
Board (2)	Low Damage (1)	2
Asbestos Type	Material Assessment Score (MA)	Medium (8)
Crocidolite (3)

Conclusions and Actions	
Recommendation:	Manage and Inspect
Further Information:	None
General Notes: Limited access as blocked by lift car. Insulation board ceiling panels. Brick walls. Concrete floor. Modern lift car.

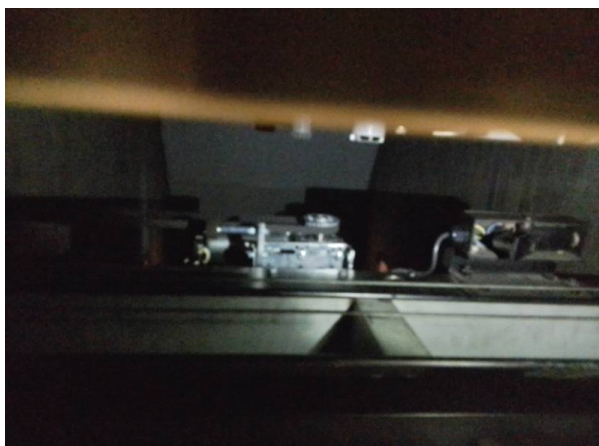
Building:	1 - 31 Maes Trisant	Floor Level:	Basement 1	Item Ref:	J329567-26
Room Name:	(005) Lift Shaft				
Sample Ref:	Presumed				
Component:	Insulation board ceiling panels				
Extent:	6m ²

Material Assessment		
Product Type	Extent of damage	Surface Treatment Score
Board (2)	Low Damage (1)	2
Asbestos Type	Material Assessment Score (MA)	Medium (8)
Crocidolite (3)

Conclusions and Actions	
Recommendation:	Manage and Inspect
Further Information:	None
General Notes: Limited access as blocked by lift car. Insulation board ceiling panels. Brick walls. Concrete floor. Modern lift car.

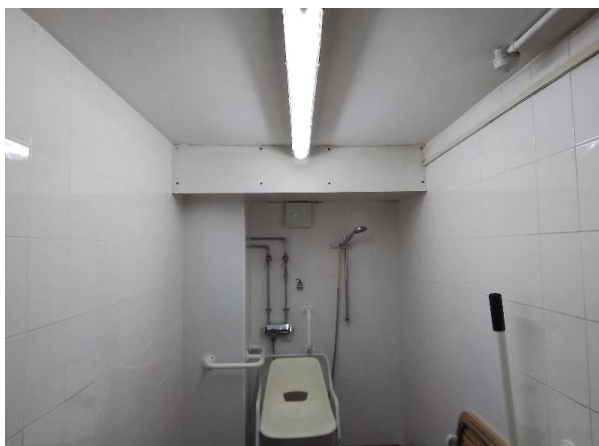
Building:	1 - 31 Maes Trisant	Floor Level:	Basement 1	Item Ref:	J329567-4
Room Name:	(006) Communal Shower				
Sample Ref:					
Component:	No asbestos containing materials found				
Extent:

Conclusions and Actions	
Recommendation:	No further action required
Further Information:	None
General Notes: Concrete ceiling. Ceramic tiled plaster to brick walls. Modern stone tiles to concrete floor. Plasterboard boxing adjacent to door - no access within boxing (excessive damage). Laminated wooden boxing above shower - no access within boxing (excessive damage). uPVC boxing adjacent to shower - no access within boxing (excessive damage). Modern extractor fan in wall. Modern radiator.

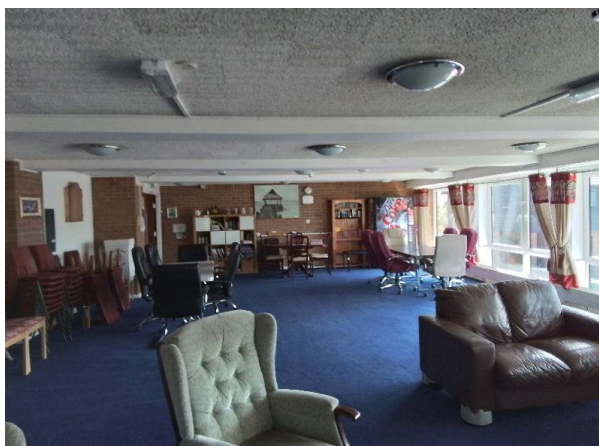
Building:	1 - 31 Maes Trisant	Floor Level:	Ground	Item Ref:	J329567-7
Room Name:	(009) Communal Lounge				
Sample Ref:					
Component:	No asbestos containing materials found				
Extent:

Conclusions and Actions	
Recommendation:	No further action required
Further Information:	None
General Notes: Interlocking non asbestos fibreboard ceiling panels - no access above panels (excessive damage). Plaster to brick walls. Wooden panels to wall behind dart board. Carpet to concrete floor. Wooden beading to glass panels in wooden fire doors to corridor and kitchen. Metal servery hatch in wall to kitchen. uPVC windows and wooden sills. Wooden panels to floor in front of modern heating system running along walls.

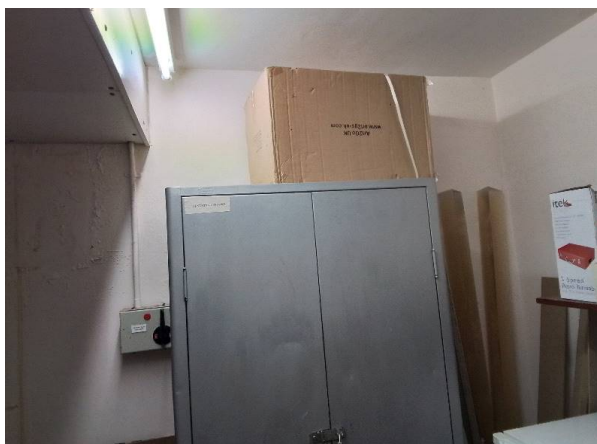
Building:	1 - 31 Maes Trisant	Floor Level:	Ground	Item Ref:	J329567-9
Room Name:	(011) Electrical Cupboard				
Sample Ref:					
Component:	No asbestos containing materials found				
Extent:

Conclusions and Actions	
Recommendation:	No further action required
Further Information:	None
General Notes: Concrete ceiling. Plaster to brick walls. Modern stone tiles to concrete floor. Laminated wooden boxing below ceiling - no access within boxing (excessive damage). Wooden panel to wall above modern electrics on wall. Wooden fire door to kitchen.

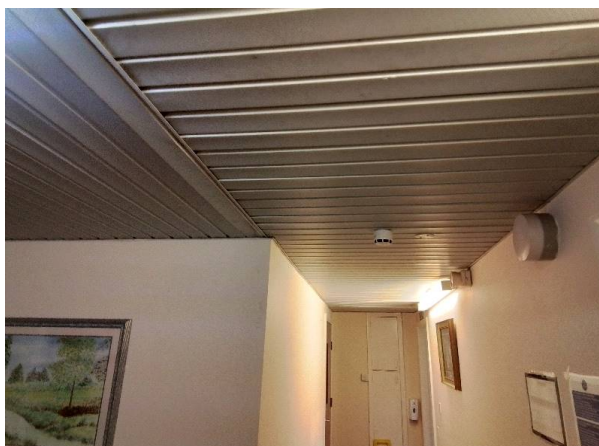
Building:	1 - 31 Maes Trisant	Floor Level:	Ground	Item Ref:	J329567-10
Room Name:	(012) Lobby				
Sample Ref:					
Component:	No asbestos containing materials found				
Extent:

Conclusions and Actions	
Recommendation:	No further action required
Further Information:	None
General Notes: Slotted metal ceiling panels. MMMF insulated metal pipework and modern wiring running in void area above metal ceiling panels. Plaster to brick walls. Modern stone tiles to concrete floor. Wooden beading to fire glass panels in wooden fire doors to kitchen and laundry. Wooden fire doors to corridor, office, guest room, cupboard and WC.

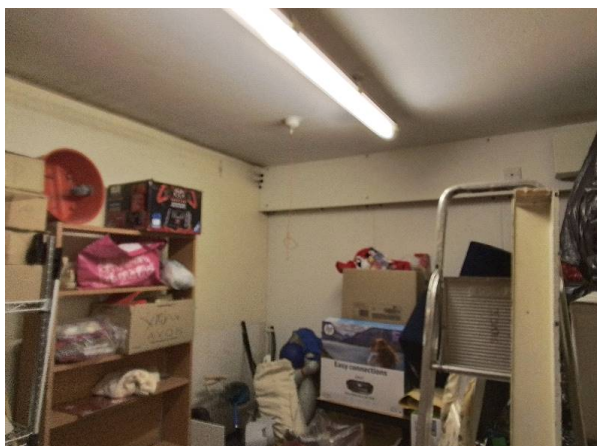
Building:	1 - 31 Maes Trisant	Floor Level:	Ground	Item Ref:	J329567-54
Room Name:	(017) Cupboard				
Sample Ref:					
Component:	No asbestos containing materials found				
Extent:

Conclusions and Actions	
Recommendation:	No further action required
Further Information:	None
General Notes: Concrete ceiling. Plaster to brick walls. Modern stone tiles to concrete floor. Laminated wooden boxing and wall panels to right hand side walls - no access behind panels (excessive damage). Modern extractor fan in laminated wooden boxing.

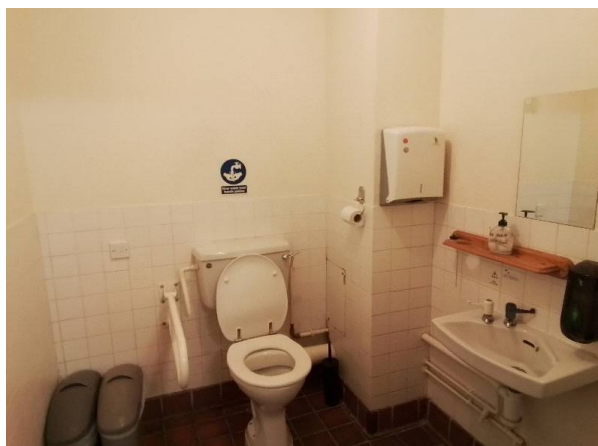
Building:	1 - 31 Maes Trisant	Floor Level:	Ground	Item Ref:	J329567-14
Room Name:	(018) WC				
Sample Ref:					
Component:	No asbestos containing materials found				
Extent:

Conclusions and Actions	
Recommendation:	No further action required
Further Information:	None
General Notes: Concrete ceiling. Plaster to brick walls. Modern stone tiles to concrete floor. Wooden access panel to plasterboard boxing adjacent to toilet - no access within boxing (excessive damage). Ceramic cistern. Wooden fire door to lobby.

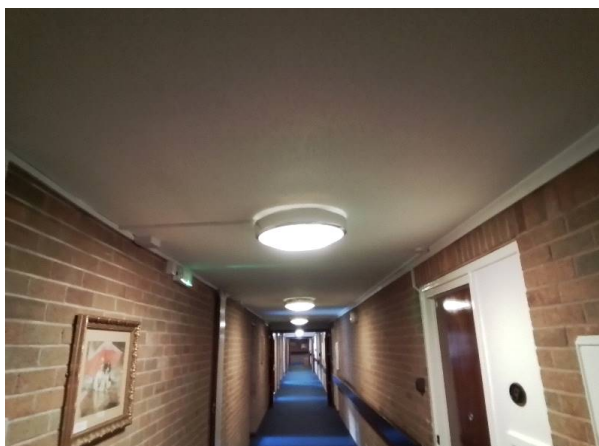
Material Assessment		
Product Type	Extent of damage	Surface Treatment Score
Textured Coating (1)	Low Damage (1)	1
Asbestos Type	Material Assessment Score (MA)	Very Low (4)
Chrysotile (1)

Conclusions and Actions	
Recommendation:	Manage and Inspect
Further Information:	None

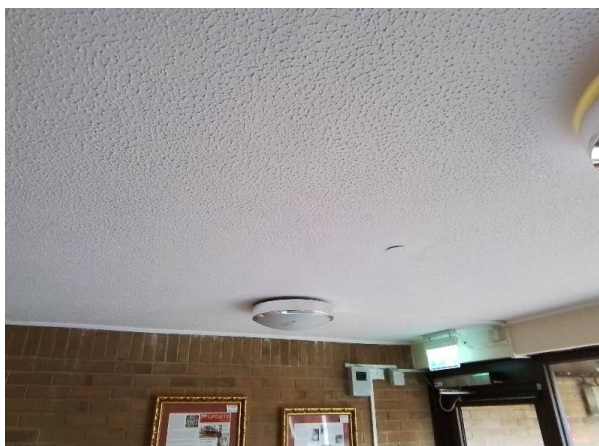
Material Assessment		
Product Type	Extent of damage	Surface Treatment Score
Textured Coating (1)	Low Damage (1)	1
Asbestos Type	Material Assessment Score (MA)	Very Low (4)
Chrysotile (1)

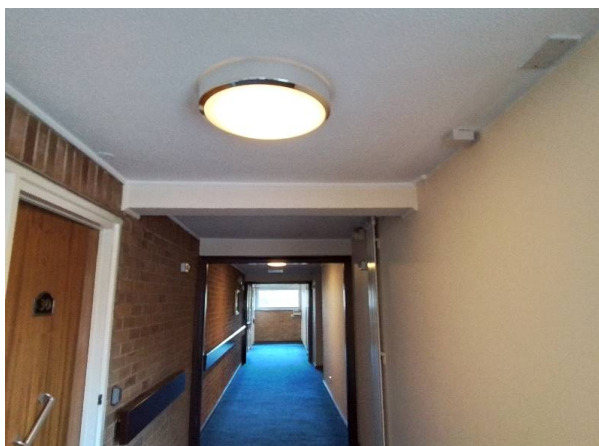
Material Assessment		
Product Type	Extent of damage	Surface Treatment Score
Textured Coating (1)	Low Damage (1)	1
Asbestos Type	Material Assessment Score (MA)	Very Low (4)
Chrysotile (1)

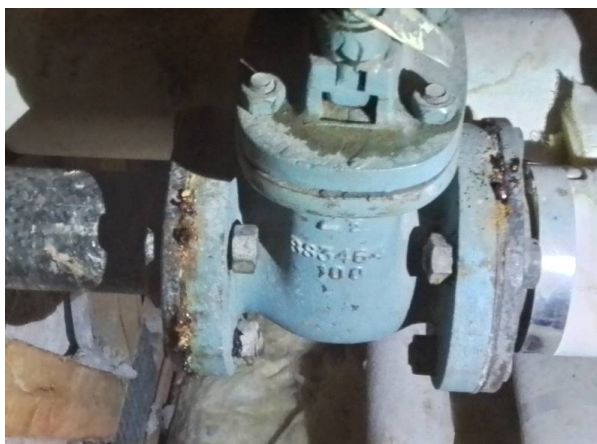
Material Assessment		
Product Type	Extent of damage	Surface Treatment Score
Gasket (2)	Low Damage (1)	1
Asbestos Type	Material Assessment Score (MA)	Low (5)
Chrysotile (1)

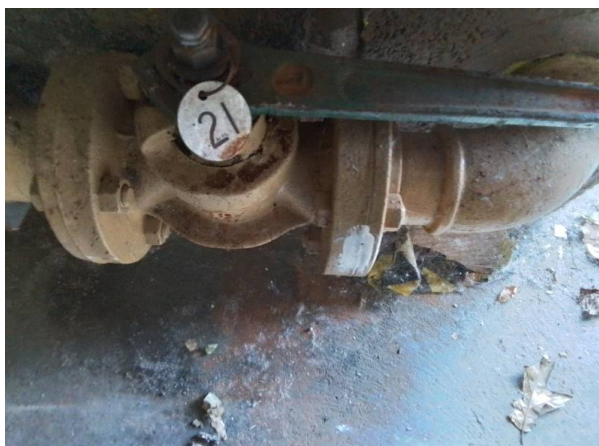
Material Assessment		
Product Type	Extent of damage	Surface Treatment Score
Gasket (2)	Low Damage (1)	1
Asbestos Type	Material Assessment Score (MA)	Low (5)
Chrysotile (1)

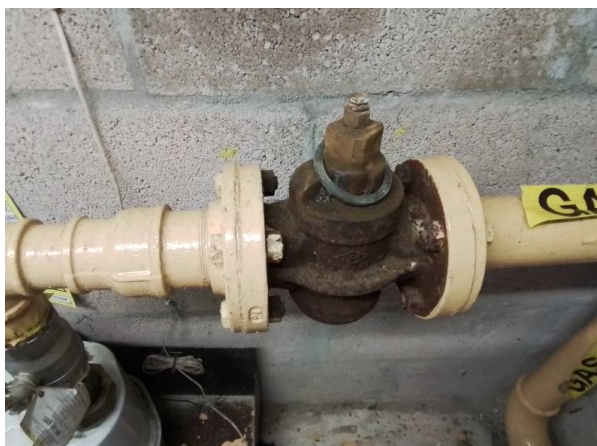
Material Assessment		
Product Type	Extent of damage	Surface Treatment Score
Gasket (2)	Low Damage (1)	1
Asbestos Type	Material Assessment Score (MA)	Low (5)
Chrysotile (1)

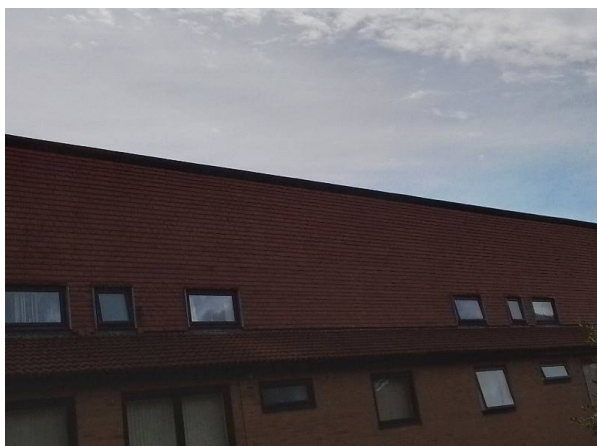
Material Assessment		
Product Type	Extent of damage	Surface Treatment Score
Cement (1)	Low Damage (1)	1
Asbestos Type	Material Assessment Score (MA)	Very Low (4)
Chrysotile (1)
