## Asbestos Management Survey

6 Trem Y Mynydd  
Treherbert  
Treorchy  
Mid Glamorgan  
CF42 5LJ  
UPRN: 6673

Report issue date:	11 Apr 2018

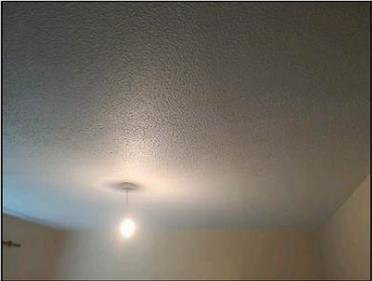
<b>Survey Date:</b>	<b>Lead Surveyor</b>	<b>Survey Type</b>	<b>Floor</b>	<b>Analysis</b>
	4 Apr 2018	James Lidbury	Management Survey	Ground	No Asbestos Detected (0)
	<b>Building</b>	<b>Room</b>	<b>Item</b>	<b>Quantity</b>	
	Main Flat	Bedroom G02	Textured coating to the plasterboard ceiling.	9m <sup>2</sup>	
	<b>Sample No (S,SP,P,As)</b>	<b>Product Type</b>	<b>Surface Treatment</b>	<b>Condition</b>	<b>Accessibility</b>
As AF003522 (SP)	Textured Coating (1)	Completely Sealed (0)	Good Condition (0)	Occasionally likely to be disturbed (1)

Normal Occupancy	Score	Likelihood of disturbance	Score	Exposure Potential	Score	Maintenance Activity	Score
Main type of activity	N/A	Location	N/A	Number of occupants	N/A	Type of Maintenance	N/A
		Accessibility	N/A	Frequency of use	N/A	Frequency of maintenance	N/A
		Amount	N/A	Average Time	N/A		
Average Score	N/A	Average Score	N/A	Average Score	N/A	Average Score	N/A
Average of Priority	N/A						
Material Assessment Score	N/A						
Recommendation	No further action required						
Surveyor comments	N/A

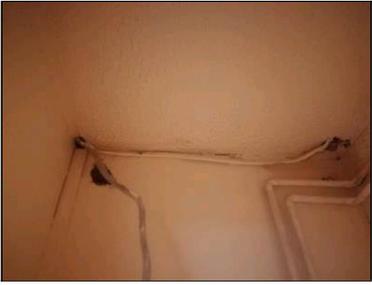
<b>Survey Date:</b>	<b>Lead Surveyor</b>	<b>Survey Type</b>	<b>Floor</b>	<b>Analysis</b>
	4 Apr 2018	James Lidbury	Management Survey	Ground	No Asbestos Detected (0)
	<b>Building</b>	<b>Room</b>	<b>Item</b>	<b>Quantity</b>	
	Main Flat	Airing Cupboard G05	Textured coating to the plasterboard ceiling	0.5m <sup>2</sup>	
	<b>Sample No (S,SP,P,As)</b>	<b>Product Type</b>	<b>Surface Treatment</b>	<b>Condition</b>	<b>Accessibility</b>
As AF003522 (SP)	Textured Coating (1)	Completely Sealed (0)	Medium Damage (2)	Occasionally likely to be disturbed (1)

Normal Occupancy	Score	Likelihood of disturbance	Score	Exposure Potential	Score	Maintenance Activity	Score
Main type of activity	N/A	Location	N/A	Number of occupants	N/A	Type of Maintenance	N/A
		Accessibility	N/A	Frequency of use	N/A	Frequency of maintenance	N/A
		Amount	N/A	Average Time	N/A		
Average Score	N/A	Average Score	N/A	Average Score	N/A	Average Score	N/A
Average of Priority	N/A						
Material Assessment Score	N/A						
Recommendation	No further action required						
Surveyor comments	N/A

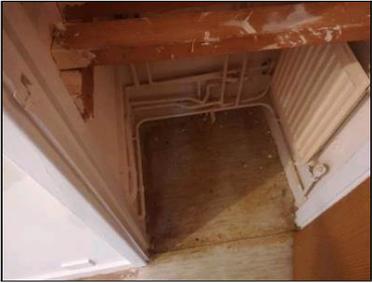
<b>Survey Date:</b>	<b>Lead Surveyor</b>	<b>Survey Type</b>	<b>Floor</b>	<b>Analysis</b>
	4 Apr 2018	James Lidbury	Management Survey	Ground	Chrysotile (1)
	<b>Building</b>	<b>Room</b>	<b>Item</b>	<b>Quantity</b>	
	Main Flat	Airing Cupboard G05	Strongly presumed vinyl tiles and bitumen adhesive beneath fixed top layer of non-suspect cream vinyl.	0.5m <sup>2</sup>	
	<b>Sample No (S,SP,P,As)</b>	<b>Product Type</b>	<b>Surface Treatment</b>	<b>Condition</b>	<b>Accessibility</b>
Visual (SP)	Reinforced Composite (1)	Completely Sealed (0)	Good Condition (0)	Usually inaccessible or unlikely to be disturbed (0)

Normal Occupancy	Score	Likelihood of disturbance	Score	Exposure Potential	Score	Maintenance Activity	Score
Main type of activity	0	Location	2	Number of occupants	1	Type of Maintenance	0
		Accessibility	0	Frequency of use	2	Frequency of maintenance	0
		Amount	1	Average Time	0		
Average Score	0	Average Score	1	Average Score	1	Average Score	0
Average of Priority	<b>2</b>						
Material Assessment Score	<b>2</b>						
Recommendation	Inspection required						
Surveyor comments	Unable to inspect beneath the material due to the potential to damage the overlain non-suspect vinyl.

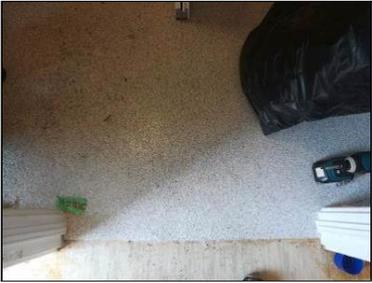
<b>Survey Date:</b>	<b>Lead Surveyor</b>	<b>Survey Type</b>	<b>Floor</b>	<b>Analysis</b>
	4 Apr 2018	James Lidbury	Management Survey	Ground	Chrysotile (1)
	<b>Building</b>	<b>Room</b>	<b>Item</b>	<b>Quantity</b>	
	Main Flat	Bathroom G06	Strongly presumed vinyl tiles and bitumen adhesive beneath fixed top layer of non-suspect grey vinyl.	3m <sup>2</sup>	
	<b>Sample No (S,SP,P,As)</b>	<b>Product Type</b>	<b>Surface Treatment</b>	<b>Condition</b>	<b>Accessibility</b>
Visual (SP)	Reinforced Composite (1)	Completely Sealed (0)	Good Condition (0)	Usually inaccessible or unlikely to be disturbed (0)

Normal Occupancy	Score	Likelihood of disturbance	Score	Exposure Potential	Score	Maintenance Activity	Score
Main type of activity	1	Location	2	Number of occupants	1	Type of Maintenance	0
		Accessibility	0	Frequency of use	3	Frequency of maintenance	0
		Amount	1	Average Time	0		
Average Score	1	Average Score	1	Average Score	2	Average Score	0
Average of Priority	<b>4</b>						
Material Assessment Score	<b>2</b>						
Recommendation	Inspection required						
Surveyor comments	Unable to inspect beneath the material due to the potential to damage the overlain non-suspect vinyl.

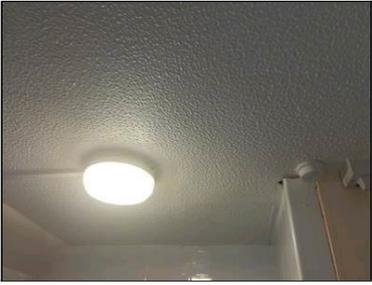
<b>Survey Date:</b>	<b>Lead Surveyor</b>	<b>Survey Type</b>	<b>Floor</b>	<b>Analysis</b>
	4 Apr 2018	James Lidbury	Management Survey	Ground	No Asbestos Detected (0)
	<b>Building</b>	<b>Room</b>	<b>Item</b>	<b>Quantity</b>	
	Main Flat	Bathroom G06	Textured coating to the plasterboard ceiling.	3m <sup>2</sup>	
	<b>Sample No (S,SP,P,As)</b>	<b>Product Type</b>	<b>Surface Treatment</b>	<b>Condition</b>	<b>Accessibility</b>
As AF003522 (SP)	Textured Coating (1)	Completely Sealed (0)	Low Damage (1)	Occasionally likely to be disturbed (1)

Normal Occupancy	Score	Likelihood of disturbance	Score	Exposure Potential	Score	Maintenance Activity	Score
Main type of activity	N/A	Location	N/A	Number of occupants	N/A	Type of Maintenance	N/A
		Accessibility	N/A	Frequency of use	N/A	Frequency of maintenance	N/A
		Amount	N/A	Average Time	N/A		
Average Score	N/A	Average Score	N/A	Average Score	N/A	Average Score	N/A
Average of Priority	N/A						
Material Assessment Score	N/A						
Recommendation	No further action required						
Surveyor comments	N/A
