Asbestos Management Survey with Targeted Refurbishment Survey

17 Trem Y Mynydd
Treherbert
Treorchy
Mid Glamorgan
CF42 5LJ
UPRN: 6684

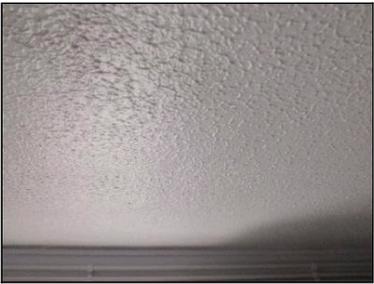
Survey Date:	Lead Surveyor	Survey Type	Floor	Analysis
	19 Jun 2018	Dave Milton	Refurbishment and Demolition Survey	Ground	
	Building	Room	Item	Quantity	
	Flat 17, Block 16, 34,17, 35	Kitchen G01	Textured coating to plasterboard ceiling.	5m ²	
	Sample No (S,SP,P,As)	Product Type	Surface Treatment	Condition	Accessibility
AO000531 (S)	Textured Coating (1)	Completely Sealed (0)	Good Condition (0)	Occasionally likely to be disturbed (1)

Normal Occupancy	Score	Likelihood of disturbance	Score	Exposure Potential	Score	Maintenance Activity	Score
Main type of activity	N/A	Location	N/A	Number of occupants	N/A	Type of Maintenance	N/A
		Accessibility	N/A	Frequency of use	N/A	Frequency of maintenance	N/A
		Amount	N/A	Average Time	N/A		
Average Score	N/A	Average Score	N/A	Average Score	N/A	Average Score	N/A
Average of Priority	N/A						
Material Assessment Score	N/A						
Recommendation	No further action required						
Surveyor comments	Please refer to Section 6.2 of this report and project desktop study (additional inspection required if going beyond suspect material).

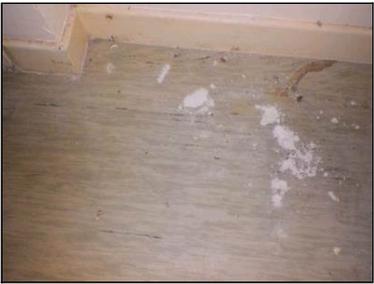
Survey Date:	Lead Surveyor	Survey Type	Floor	Analysis
	19 Jun 2018	Dave Milton	Management Survey	Ground	Chrysotile (1)
	Building	Room	Item	Quantity	
	Flat 17, Block 16, 34,17, 35	Understairs cupboard G02	Strongly presumed vinyl tiles to concrete floor beneath fixed non-suspect beige vinyl flooring.	3m ²	
	Sample No (S,SP,P,As)	Product Type	Surface Treatment	Condition	Accessibility
Visual (SP)	Reinforced Composite (1)	Completely Sealed (0)	Good Condition (0)	Usually inaccessible or unlikely to be disturbed (0)

Normal Occupancy	Score	Likelihood of disturbance	Score	Exposure Potential	Score	Maintenance Activity	Score
Main type of activity	1	Location	2	Number of occupants	1	Type of Maintenance	1
		Accessibility	0	Frequency of use	3	Frequency of maintenance	1
		Amount	1	Average Time	0		
Average Score	1	Average Score	1	Average Score	2	Average Score	1
Average of Priority	5						
Material Assessment Score	2						
Recommendation	Inspection required						
Surveyor comments	No access at the time of the survey due to the potential to damage fixtures and fittings.

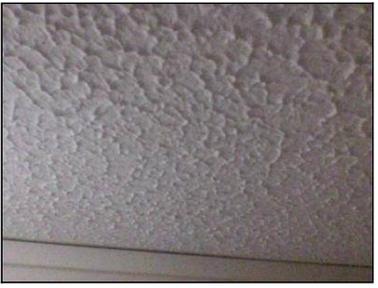
Survey Date:	Lead Surveyor	Survey Type	Floor	Analysis	
	19 Jun 2018	Dave Milton	Management Survey	Ground		No Asbestos Detected (0)
	Building	Room	Item	Quantity		
	Flat 17, Block 16, 34,17, 35	Understairs cupboard G02	Textured coating to plasterboard ceiling.	3m ²		
	Sample No (S,SP,P,As)	Product Type	Surface Treatment	Condition	Accessibility	
AO000532 (S)	Textured Coating (1)	Completely Sealed (0)	Good Condition (0)	Occasionally likely to be disturbed (1)

Normal Occupancy	Score	Likelihood of disturbance	Score	Exposure Potential	Score	Maintenance Activity	Score
Main type of activity	N/A	Location	N/A	Number of occupants	N/A	Type of Maintenance	N/A
		Accessibility	N/A	Frequency of use	N/A	Frequency of maintenance	N/A
		Amount	N/A	Average Time	N/A		
Average Score	N/A	Average Score	N/A	Average Score	N/A	Average Score	N/A
Average of Priority	N/A						
Material Assessment Score	N/A						
Recommendation	No further action required						
Surveyor comments	N/A

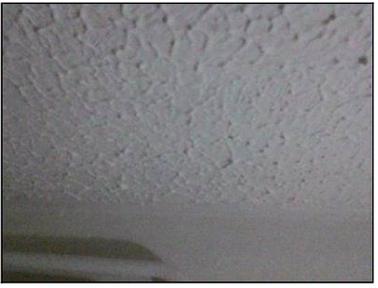
Survey Date:	Lead Surveyor	Survey Type	Floor	Analysis	
	19 Jun 2018	Dave Milton	Management Survey	Ground		No Asbestos Detected (0)
	Building	Room	Item	Quantity		
	Flat 17, Block 16, 34,17, 35	Airing cupboard G03	Textured coating to plasterboard ceiling.	1m ²		
	Sample No (S,SP,P,As)	Product Type	Surface Treatment	Condition	Accessibility	
As AO000531 (SP)	Textured Coating (1)	Completely Sealed (0)	Good Condition (0)	Occasionally likely to be disturbed (1)

Normal Occupancy	Score	Likelihood of disturbance	Score	Exposure Potential	Score	Maintenance Activity	Score
Main type of activity	N/A	Location	N/A	Number of occupants	N/A	Type of Maintenance	N/A
		Accessibility	N/A	Frequency of use	N/A	Frequency of maintenance	N/A
		Amount	N/A	Average Time	N/A		
Average Score	N/A	Average Score	N/A	Average Score	N/A	Average Score	N/A
Average of Priority	N/A						
Material Assessment Score	N/A						
Recommendation	No further action required						
Surveyor comments	N/A

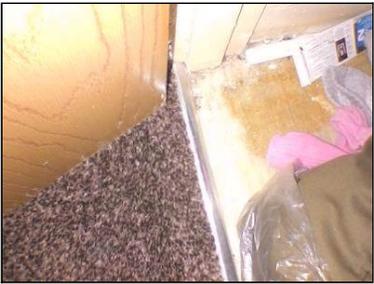
Survey Date:	Lead Surveyor	Survey Type	Floor	Analysis
	19 Jun 2018	Dave Milton	Management Survey	Ground	Chrysotile (1)
	Building	Room	Item	Quantity	
	Flat 17, Block 16, 34,17, 35	Airing cupboard G03	Strongly presumed vinyl tiles to concrete floor beneath fixed non-suspect beige vinyl flooring.	1m ²	
	Sample No (S,SP,P,As)	Product Type	Surface Treatment	Condition	Accessibility
Visual (SP)	Reinforced Composite (1)	Completely Sealed (0)	Good Condition (0)	Usually inaccessible or unlikely to be disturbed (0)

Normal Occupancy	Score	Likelihood of disturbance	Score	Exposure Potential	Score	Maintenance Activity	Score
Main type of activity	1	Location	2	Number of occupants	1	Type of Maintenance	1
		Accessibility	0	Frequency of use	3	Frequency of maintenance	1
		Amount	1	Average Time	0		
Average Score	1	Average Score	1	Average Score	2	Average Score	1
Average of Priority	5						
Material Assessment Score	2						
Recommendation	Inspection required						
Surveyor comments	No access at the time of the survey due to the potential to damage fixtures and fittings.

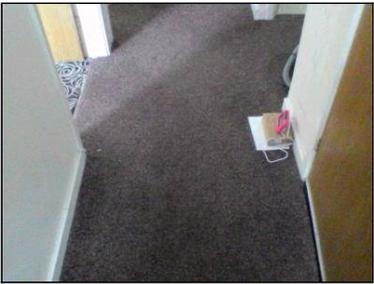
Survey Date:	Lead Surveyor	Survey Type	Floor	Analysis
	19 Jun 2018	Dave Milton	Management Survey	Ground	Chrysotile (1)
	Building	Room	Item	Quantity	
	Flat 17, Block 16, 34,17, 35	Hall G04	Strongly presumed vinyl tiles to concrete floor beneath fitted brown carpet.	6m ²	
	Sample No (S,SP,P,As)	Product Type	Surface Treatment	Condition	Accessibility
Visual (SP)	Reinforced Composite (1)	Completely Sealed (0)	Good Condition (0)	Usually inaccessible or unlikely to be disturbed (0)

Normal Occupancy	Score	Likelihood of disturbance	Score	Exposure Potential	Score	Maintenance Activity	Score
Main type of activity	1	Location	2	Number of occupants	1	Type of Maintenance	1
		Accessibility	0	Frequency of use	3	Frequency of maintenance	1
		Amount	1	Average Time	0		
Average Score	1	Average Score	1	Average Score	2	Average Score	1
Average of Priority	5						
Material Assessment Score	2						
Recommendation	Inspection required						
Surveyor comments	No access at the time of the survey due to the potential to damage fixtures and fittings.

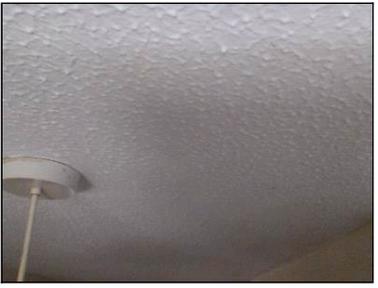
Survey Date:	Lead Surveyor	Survey Type	Floor	Analysis
	19 Jun 2018	Dave Milton	Management Survey	Ground	No Asbestos Detected (0)
	Building	Room	Item	Quantity	
	Flat 17, Block 16, 34,17, 35	Hall G04	Textured coating to plasterboard ceiling.	6m ²	
	Sample No (S,SP,P,As)	Product Type	Surface Treatment	Condition	Accessibility
As AO000531 (SP)	Textured Coating (1)	Completely Sealed (0)	Good Condition (0)	Occasionally likely to be disturbed (1)

Normal Occupancy	Score	Likelihood of disturbance	Score	Exposure Potential	Score	Maintenance Activity	Score
Main type of activity	N/A	Location	N/A	Number of occupants	N/A	Type of Maintenance	N/A
		Accessibility	N/A	Frequency of use	N/A	Frequency of maintenance	N/A
		Amount	N/A	Average Time	N/A		
Average Score	N/A	Average Score	N/A	Average Score	N/A	Average Score	N/A
Average of Priority	N/A						
Material Assessment Score	N/A						
Recommendation	No further action required						
Surveyor comments	N/A

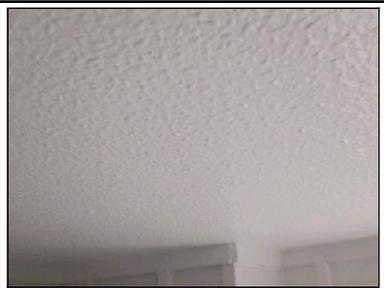
Survey Date:	Lead Surveyor	Survey Type	Floor	Analysis
	19 Jun 2018	Dave Milton	Management Survey	Ground	
	Building	Room	Item	Quantity	
	Flat 17, Block 16, 34,17, 35	Shower room G05	Textured coating to plasterboard ceiling.	4m ²	
	Sample No (S,SP,P,As)	Product Type	Surface Treatment	Condition	Accessibility
As AO000531 (SP)	Textured Coating (1)	Completely Sealed (0)	Good Condition (0)	Occasionally likely to be disturbed (1)

Normal Occupancy	Score	Likelihood of disturbance	Score	Exposure Potential	Score	Maintenance Activity	Score
Main type of activity	N/A	Location	N/A	Number of occupants	N/A	Type of Maintenance	N/A
		Accessibility	N/A	Frequency of use	N/A	Frequency of maintenance	N/A
		Amount	N/A	Average Time	N/A		
Average Score	N/A	Average Score	N/A	Average Score	N/A	Average Score	N/A
Average of Priority	N/A						
Material Assessment Score	N/A						
Recommendation	No further action required						
Surveyor comments	N/A

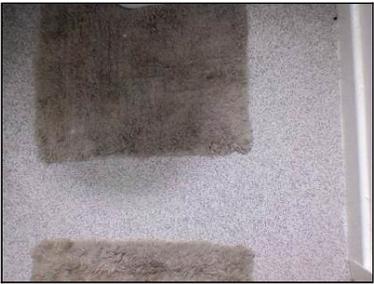
Survey Date:	Lead Surveyor	Survey Type	Floor	Analysis
	19 Jun 2018	Dave Milton	Management Survey	Ground	Chrysotile (1)
	Building	Room	Item	Quantity	
	Flat 17, Block 16, 34,17, 35	Shower room G05	Strongly presumed vinyl tiles to concrete floor beneath fixed non-suspect blue vinyl flooring.	4m ²	
	Sample No (S,SP,P,As)	Product Type	Surface Treatment	Condition	Accessibility
	Visual (SP)	Reinforced Composite (1)	Completely Sealed (0)	Good Condition (0)	Usually inaccessible or unlikely to be disturbed (0)

Normal Occupancy	Score	Likelihood of disturbance	Score	Exposure Potential	Score	Maintenance Activity	Score
Main type of activity	1	Location	2	Number of occupants	1	Type of Maintenance	1
		Accessibility	0	Frequency of use	3	Frequency of maintenance	1
		Amount	1	Average Time	0		
Average Score	1	Average Score	1	Average Score	2	Average Score	1
Average of Priority	5						
Material Assessment Score	2						
Recommendation	Inspection required						
Surveyor comments	No access at the time of the survey due to the potential to damage fixtures and fittings.

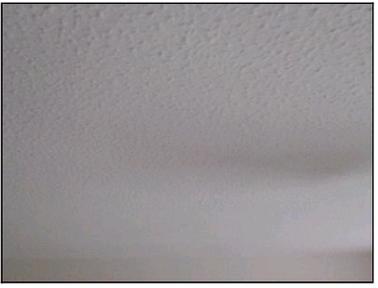
Survey Date:	Lead Surveyor	Survey Type	Floor	Analysis
	19 Jun 2018	Dave Milton	Management Survey	Ground	No Asbestos Detected (0)
	Building	Room	Item	Quantity	
	Flat 17, Block 16, 34,17, 35	Lounge G06	Textured coating to plasterboard ceiling.	9m ²	
	Sample No (S,SP,P,As)	Product Type	Surface Treatment	Condition	Accessibility
As AO000531 (SP)	Textured Coating (1)	Completely Sealed (0)	Good Condition (0)	Occasionally likely to be disturbed (1)

Normal Occupancy	Score	Likelihood of disturbance	Score	Exposure Potential	Score	Maintenance Activity	Score
Main type of activity	N/A	Location	N/A	Number of occupants	N/A	Type of Maintenance	N/A
		Accessibility	N/A	Frequency of use	N/A	Frequency of maintenance	N/A
		Amount	N/A	Average Time	N/A		
Average Score	N/A	Average Score	N/A	Average Score	N/A	Average Score	N/A
Average of Priority	N/A						
Material Assessment Score	N/A						
Recommendation	No further action required						
Surveyor comments	N/A

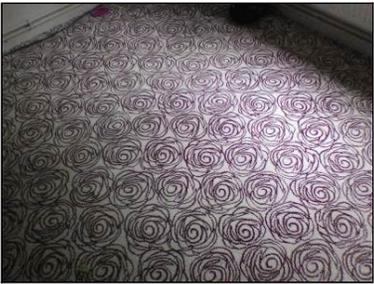
Survey Date:	Lead Surveyor	Survey Type	Floor	Analysis
	19 Jun 2018	Dave Milton	Management Survey	Ground	Chrysotile (1)
	Building	Room	Item	Quantity	
	Flat 17, Block 16, 34,17, 35	Lounge G06	Strongly presumed vinyl tiles to concrete floor beneath fitted black and beige carpet.	9m ²	
	Sample No (S,SP,P,As)	Product Type	Surface Treatment	Condition	Accessibility
Visual (SP)	Reinforced Composite (1)	Completely Sealed (0)	Good Condition (0)	Usually inaccessible or unlikely to be disturbed (0)

Normal Occupancy	Score	Likelihood of disturbance	Score	Exposure Potential	Score	Maintenance Activity	Score
Main type of activity	1	Location	2	Number of occupants	1	Type of Maintenance	1
		Accessibility	0	Frequency of use	3	Frequency of maintenance	1
		Amount	1	Average Time	2		
Average Score	1	Average Score	1	Average Score	2	Average Score	1
Average of Priority	5						
Material Assessment Score	2						
Recommendation	Inspection required						
Surveyor comments	No access at the time of the survey due to the potential to damage fixtures and fittings.

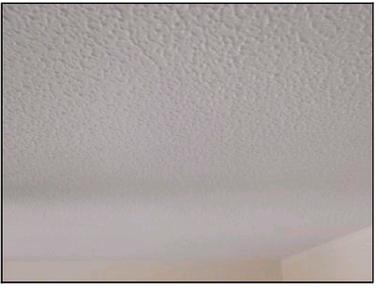
Survey Date:	Lead Surveyor	Survey Type	Floor	Analysis
	19 Jun 2018	Dave Milton	Management Survey	Ground	No Asbestos Detected (0)
	Building	Room	Item	Quantity	
	Flat 17, Block 16, 34,17, 35	Bedroom G07	Textured coating to plasterboard ceiling.	9m ²	
	Sample No (S,SP,P,As)	Product Type	Surface Treatment	Condition	Accessibility
As AO000531 (SP)	Textured Coating (1)	Completely Sealed (0)	Good Condition (0)	Occasionally likely to be disturbed (1)

Normal Occupancy	Score	Likelihood of disturbance	Score	Exposure Potential	Score	Maintenance Activity	Score
Main type of activity	N/A	Location	N/A	Number of occupants	N/A	Type of Maintenance	N/A
		Accessibility	N/A	Frequency of use	N/A	Frequency of maintenance	N/A
		Amount	N/A	Average Time	N/A		
Average Score	N/A	Average Score	N/A	Average Score	N/A	Average Score	N/A
Average of Priority	N/A						
Material Assessment Score	N/A						
Recommendation	No further action required						
Surveyor comments	N/A
