## Management with Targeted Refurbishment Survey to Shower Room

19 Trem y Mynydd  
Taff Street  
Treherbert  
Treorchy  
CF42 5LJ  
UPRN: 6686

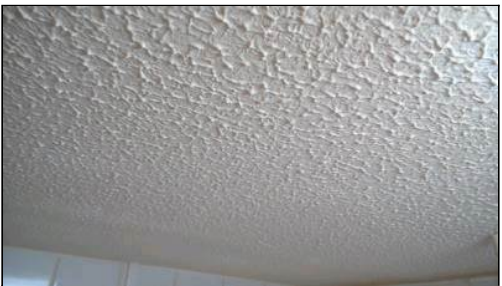
| | Survey Date: | Lead Surveyor | Survey Type | Floor | Analysis |
|---|---|---|---|---|---|
| | 24 Jan 2018 | Dave Milton | Refurbishment and Demolition Survey | 1st | No Asbestos Detected (0) |
| | AE004483 (S) | Textured Coating (1) | Completely Sealed (0) | Good Condition (0) | Occasionally likely to be disturbed (1) |

| Normal Occupancy | Score | Likelihood of disturbance | Score | Exposure Potential | Score | Maintenance Activity | Score |
|---|---|---|---|---|---|---|---|
| Recommendation | No further action required | | | | | | |

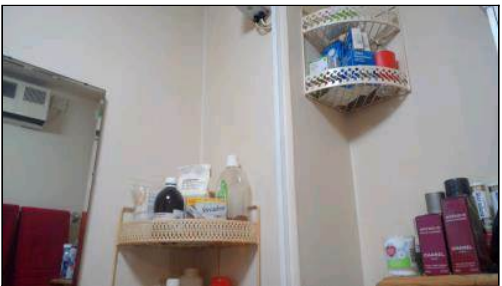
| | 24 Jan 2018 | Dave Milton | Refurbishment and Demolition Survey | 1st | No Asbestos Detected (0) |
| | AE004484 (S) | Insulating Board (0) | Surface Sealed (1) | Good Condition (0) | Occasionally likely to be disturbed (1) |

| Normal Occupancy | Score | Likelihood of disturbance | Score | Exposure Potential | Score | Maintenance Activity | Score |
|---|---|---|---|---|---|---|---|
| Recommendation | No further action required | | | | | | |

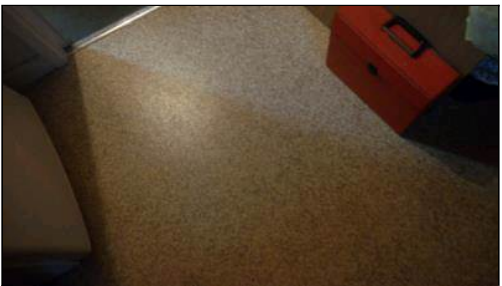
| | Survey Date: | Lead Surveyor | Survey Type | Floor | Analysis |
|---|---|---|---|---|---|
| | 24 Jan 2018 | Dave Milton | Management Survey | 1st | Chrysotile (1) |
| | Visual (SP) | Reinforced Composite (1) | Completely Sealed (0) | Good Condition (0) | Occasionally likely to be disturbed (1) |

| Normal Occupancy | Score | Likelihood of disturbance | Score | Exposure Potential | Score | Maintenance Activity | Score |
|---|---|---|---|---|---|---|---|
| Surveyor comments | No access at the time of the survey due to the potential to damage fixtures and fittings. | | | | | | |

| Normal Occupancy | Score | Likelihood of disturbance | Score | Exposure Potential | Score | Maintenance Activity | Score |
|---|---|---|---|---|---|---|---|
| Recommendation | Inspection required | | | | | | |

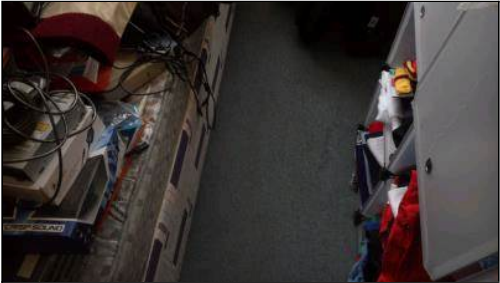
| | Survey Date: | Lead Surveyor | Survey Type | Floor | Analysis |
|---|---|---|---|---|---|
| | 24 Jan 2018 | Dave Milton | Management Survey | 1st | Chrysotile (1) |
| | Visual (SP) | Reinforced Composite (1) | Completely Sealed (0) | Good Condition (0) | Occasionally likely to be disturbed (1) |

| Normal Occupancy | Score | Likelihood of disturbance | Score | Exposure Potential | Score | Maintenance Activity | Score |
|---|---|---|---|---|---|---|---|
| Surveyor comments | No access at the time of the survey due to the potential to damage fixtures and fittings. | | | | | | |

| Normal Occupancy | Score | Likelihood of disturbance | Score | Exposure Potential | Score | Maintenance Activity | Score |
|---|---|---|---|---|---|---|---|
| Recommendation | Inspection required | | | | | | |

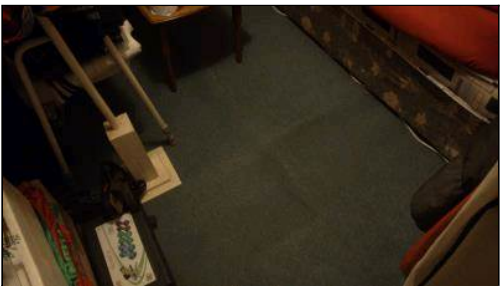
| | Survey Date: | Lead Surveyor | Survey Type | Floor | Analysis |
|---|---|---|---|---|---|
| | 24 Jan 2018 | Dave Milton | Management Survey | 1st | Chrysotile (1) |
| | Visual (SP) | Reinforced Composite (1) | Completely Sealed (0) | Good Condition (0) | Occasionally likely to be disturbed (1) |

| Normal Occupancy | Score | Likelihood of disturbance | Score | Exposure Potential | Score | Maintenance Activity | Score |
|---|---|---|---|---|---|---|---|
| Surveyor comments | No access at the time of the survey due to the potential to damage fixtures and fittings. | | | | | | |

| Normal Occupancy | Score | Likelihood of disturbance | Score | Exposure Potential | Score | Maintenance Activity | Score |
|---|---|---|---|---|---|---|---|
| Recommendation | Inspection required | | | | | | |

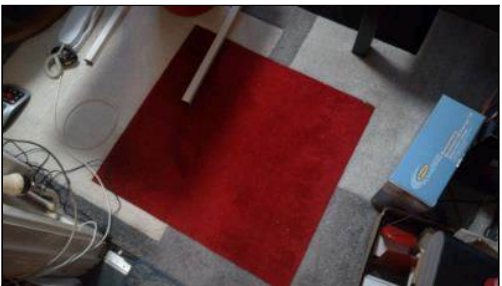
| | Survey Date: | Lead Surveyor | Survey Type | Floor | Analysis |
|---|---|---|---|---|---|
| | 24 Jan 2018 | Dave Milton | Management Survey | 1st | Chrysotile (1) |
| | Visual (SP) | Reinforced Composite (1) | Completely Sealed (0) | Good Condition (0) | Occasionally likely to be disturbed (1) |

| Normal Occupancy | Score | Likelihood of disturbance | Score | Exposure Potential | Score | Maintenance Activity | Score |
|---|---|---|---|---|---|---|---|
| Surveyor comments | No access at the time of the survey due to the potential to damage fixtures and fittings. | | | | | | |

| Normal Occupancy | Score | Likelihood of disturbance | Score | Exposure Potential | Score | Maintenance Activity | Score |
|---|---|---|---|---|---|---|---|
| Recommendation | Inspection required | | | | | | |
