Management Survey with Targeted Refurbishment Survey to the Bathroom

26 Trem y Mynydd
Taff Street
Treherbert
Tregorchy
CF42 5LJ
UPRN: 6693

Report issue date:	13 Feb 2018

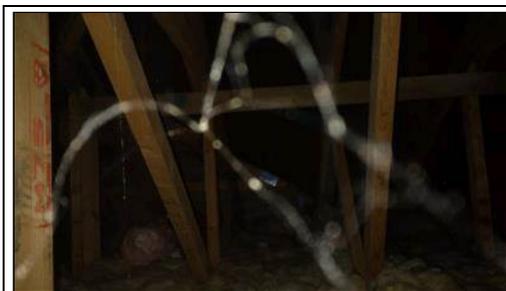
Survey Date:	Lead Surveyor	Survey Type	Floor	Analysis
31 Jan 2018	Dave Milton	Management Survey	Roof	N/A
Building	Room	Item	Quantity	
Main Flat	Loft space R01	No suspect materials identified	N/A	
Sample No (S,SP,P,As)	Product Type	Surface Treatment	Condition	Accessibility
Visual (P)	N/A	N/A	N/A	N/A

Normal Occupancy	Score	Likelihood of disturbance	Score	Exposure Potential	Score	Maintenance Activity	Score
Main type of activity	N/A	Location	N/A	Number of occupants	N/A	Type of Maintenance	N/A
		Accessibility	N/A	Frequency of use	N/A	Frequency of maintenance	N/A
		Amount	N/A	Average Time	N/A		
Average Score	N/A	Average Score	N/A	Average Score	N/A	Average Score	N/A
Average of Priority	N/A						
Material Assessment Score	N/A						
Recommendation	No further action required						
Surveyor comments	N/A

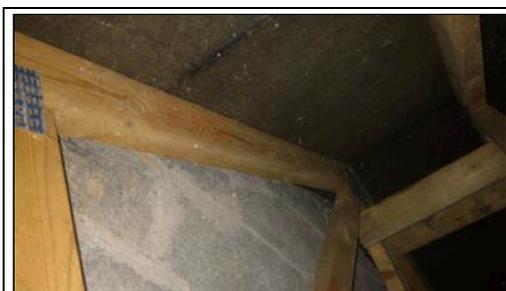
Survey Date:	Lead Surveyor	Survey Type	Floor	Analysis
31 Jan 2018	Dave Milton	Management Survey	Roof	N/A
Building	Room	Item	Quantity	
Main Flat	Loft space 2 R02	No suspect materials identified	N/A	
Sample No (S,SP,P,As)	Product Type	Surface Treatment	Condition	Accessibility
Visual (P)	N/A	N/A	N/A	N/A

Normal Occupancy	Score	Likelihood of disturbance	Score	Exposure Potential	Score	Maintenance Activity	Score
Main type of activity	N/A	Location	N/A	Number of occupants	N/A	Type of Maintenance	N/A
		Accessibility	N/A	Frequency of use	N/A	Frequency of maintenance	N/A
		Amount	N/A	Average Time	N/A		
Average Score	N/A	Average Score	N/A	Average Score	N/A	Average Score	N/A
Average of Priority	N/A						
Material Assessment Score	N/A						
Recommendation	No further action required						
Surveyor comments	N/A

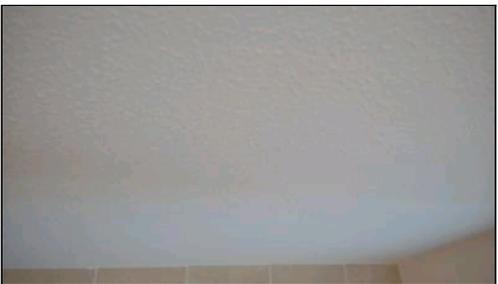
Survey Date:	Lead Surveyor	Survey Type	Floor	Analysis
	31 Jan 2018	Dave Milton	Refurbishment and Demolition Survey	1st	No Asbestos Detected (0)
	Building	Room	Item	Quantity	
	Main Flat	Bathroom 101	Textured coating to plasterboard ceiling.	6m ²	
	Sample No (S,SP,P,As)	Product Type	Surface Treatment	Condition	Accessibility
AE004530 (S)	Textured Coating (1)	Completely Sealed (0)	Good Condition (0)	Occasionally likely to be disturbed (1)

Normal Occupancy	Score	Likelihood of disturbance	Score	Exposure Potential	Score	Maintenance Activity	Score
Main type of activity	N/A	Location	N/A	Number of occupants	N/A	Type of Maintenance	N/A
		Accessibility	N/A	Frequency of use	N/A	Frequency of maintenance	N/A
		Amount	N/A	Average Time	N/A		
Average Score	N/A	Average Score	N/A	Average Score	N/A	Average Score	N/A
Average of Priority	N/A						
Material Assessment Score	N/A						
Recommendation	No further action required						
Surveyor comments	With non-suspect loft space above.

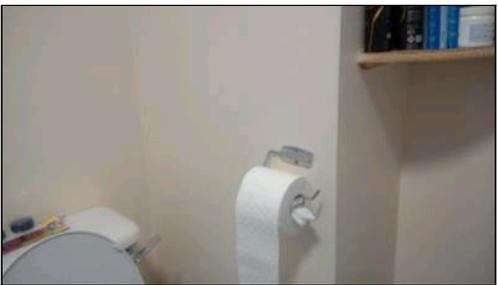
Survey Date:	Lead Surveyor	Survey Type	Floor	Analysis
	31 Jan 2018	Dave Milton	Refurbishment and Demolition Survey	1st	
	Building	Room	Item	Quantity	
	Main Flat	Bathroom 101	Insulating board boxing.	2m ²	
	Sample No (S,SP,P,As)	Product Type	Surface Treatment	Condition	Accessibility
AE004531 (S)	Insulation board (2)	Surface Sealed (1)	Good Condition (0)	Easily disturbed (2)

Normal Occupancy	Score	Likelihood of disturbance	Score	Exposure Potential	Score	Maintenance Activity	Score
Main type of activity	N/A	Location	N/A	Number of occupants	N/A	Type of Maintenance	N/A
		Accessibility	N/A	Frequency of use	N/A	Frequency of maintenance	N/A
		Amount	N/A	Average Time	N/A		
Average Score	N/A	Average Score	N/A	Average Score	N/A	Average Score	N/A
Average of Priority	N/A						
Material Assessment Score	N/A						
Recommendation	No further action required						
Surveyor comments	Please refer to Section 6.2 of this report and project desktop study (additional inspection required if going beyond suspect material).

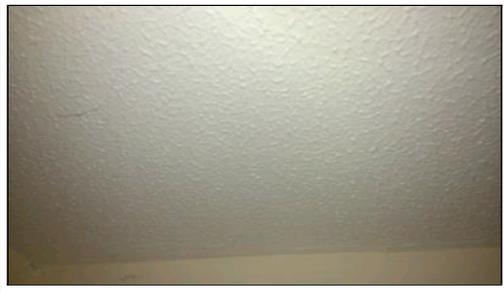
Survey Date:	Lead Surveyor	Survey Type	Floor	Analysis
	31 Jan 2018	Dave Milton	Management Survey	1st	No Asbestos Detected (0)
	Building	Room	Item	Quantity	
	Main Flat	Airing cupboard 102	Textured coating to plasterboard ceiling.	1m ²	
	Sample No (S,SP,P,As)	Product Type	Surface Treatment	Condition	Accessibility
As AE004530 (SP)	Textured Coating (1)	Completely Sealed (0)	Good Condition (0)	Occasionally likely to be disturbed (1)

Normal Occupancy	Score	Likelihood of disturbance	Score	Exposure Potential	Score	Maintenance Activity	Score
Main type of activity	N/A	Location	N/A	Number of occupants	N/A	Type of Maintenance	N/A
		Accessibility	N/A	Frequency of use	N/A	Frequency of maintenance	N/A
		Amount	N/A	Average Time	N/A		
Average Score	N/A	Average Score	N/A	Average Score	N/A	Average Score	N/A
Average of Priority	N/A						
Material Assessment Score	N/A						
Recommendation	No further action required						
Surveyor comments	N/A

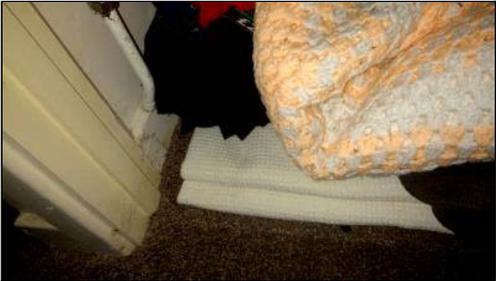
Survey Date:	Lead Surveyor	Survey Type	Floor	Analysis
	31 Jan 2018	Dave Milton	Management Survey	1st	Chrysotile (1)
	Building	Room	Item	Quantity	
	Main Flat	Airing cupboard 102	Strongly presumed vinyl tiles to chipboard floor beneath fitted carpet.	1m ²	
	Sample No (S,SP,P,As)	Product Type	Surface Treatment	Condition	Accessibility
Visual (SP)	Reinforced Composite (1)	Completely Sealed (0)	Good Condition (0)	Usually inaccessible or unlikely to be disturbed (0)

Normal Occupancy	Score	Likelihood of disturbance	Score	Exposure Potential	Score	Maintenance Activity	Score
Main type of activity	1	Location	2	Number of occupants	1	Type of Maintenance	0
		Accessibility	0	Frequency of use	3	Frequency of maintenance	0
		Amount	1	Average Time	0		
Average Score	1	Average Score	1	Average Score	2	Average Score	0
Average of Priority	4						
Material Assessment Score	2						
Recommendation	Inspection required						
Surveyor comments	No access at the time of the survey due to the potential to damage fixtures and fittings.

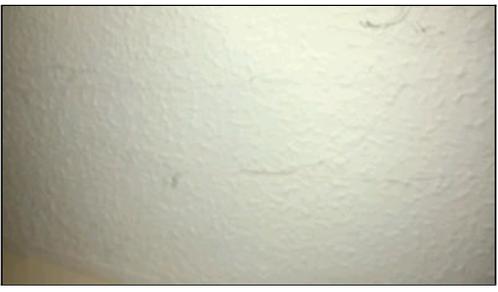
Survey Date:	Lead Surveyor	Survey Type	Floor	Analysis
	31 Jan 2018	Dave Milton	Management Survey	1st	No Asbestos Detected (0)
	Building	Room	Item	Quantity	
	Main Flat	Cupboard 103	Textured coating to plasterboard ceiling.	0.5m ²	
	Sample No (S,SP,P,As)	Product Type	Surface Treatment	Condition	Accessibility
As AE004530 (SP)	Textured Coating (1)	Completely Sealed (0)	Good Condition (0)	Occasionally likely to be disturbed (1)

Normal Occupancy	Score	Likelihood of disturbance	Score	Exposure Potential	Score	Maintenance Activity	Score
Main type of activity	N/A	Location	N/A	Number of occupants	N/A	Type of Maintenance	N/A
		Accessibility	N/A	Frequency of use	N/A	Frequency of maintenance	N/A
		Amount	N/A	Average Time	N/A		
Average Score	N/A	Average Score	N/A	Average Score	N/A	Average Score	N/A
Average of Priority	N/A						
Material Assessment Score	N/A						
Recommendation	No further action required						
Surveyor comments	N/A

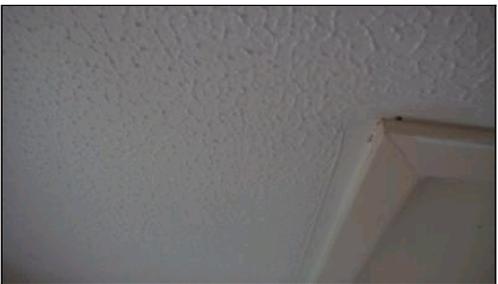
Survey Date:	Lead Surveyor	Survey Type	Floor	Analysis
	31 Jan 2018	Dave Milton	Management Survey	1st	No Asbestos Detected (0)
	Building	Room	Item	Quantity	
	Main Flat	Hall 104	Textured coating to plasterboard ceiling.	10m ²	
	Sample No (S,SP,P,As)	Product Type	Surface Treatment	Condition	Accessibility
As AE004530 (SP)	Textured Coating (1)	Completely Sealed (0)	Good Condition (0)	Occasionally likely to be disturbed (1)

Normal Occupancy	Score	Likelihood of disturbance	Score	Exposure Potential	Score	Maintenance Activity	Score
Main type of activity	N/A	Location	N/A	Number of occupants	N/A	Type of Maintenance	N/A
		Accessibility	N/A	Frequency of use	N/A	Frequency of maintenance	N/A
		Amount	N/A	Average Time	N/A		
Average Score	N/A	Average Score	N/A	Average Score	N/A	Average Score	N/A
Average of Priority	N/A						
Material Assessment Score	N/A						
Recommendation	No further action required						
Surveyor comments	N/A

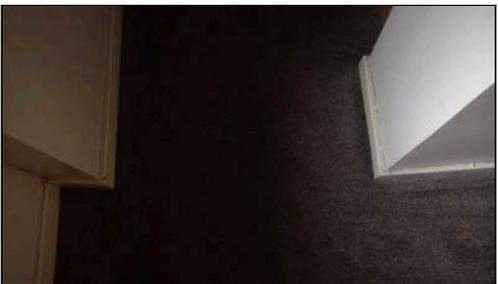
Survey Date:	Lead Surveyor	Survey Type	Floor	Analysis
	31 Jan 2018	Dave Milton	Management Survey	1st	Chrysotile (1)
	Building	Room	Item	Quantity	
	Main Flat	Hall 104	Strongly presumed vinyl tiles to chipboard floor beneath fitted carpet.	8m ²	
	Sample No (S,SP,P,As)	Product Type	Surface Treatment	Condition	Accessibility
Visual (SP)	Reinforced Composite (1)	Completely Sealed (0)	Good Condition (0)	Usually inaccessible or unlikely to be disturbed (0)

Normal Occupancy	Score	Likelihood of disturbance	Score	Exposure Potential	Score	Maintenance Activity	Score
Main type of activity	1	Location	2	Number of occupants	1	Type of Maintenance	0
		Accessibility	0	Frequency of use	3	Frequency of maintenance	0
		Amount	1	Average Time	0		
Average Score	1	Average Score	1	Average Score	2	Average Score	0
Average of Priority	4						
Material Assessment Score	2						
Recommendation	Inspection required						
Surveyor comments	No access at the time of the survey due to the potential to damage fixtures and fittings.

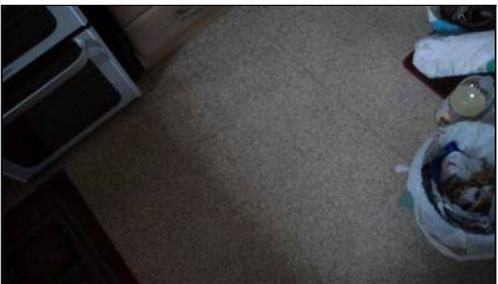
Survey Date:	Lead Surveyor	Survey Type	Floor	Analysis
	31 Jan 2018	Dave Milton	Management Survey	1st	
	Building	Room	Item	Quantity	
	Main Flat	Kitchen 105	Strongly presumed vinyl tiles to chipboard floor beneath fixed non-suspect beige vinyl flooring.	5m ²	
	Sample No (S,SP,P,As)	Product Type	Surface Treatment	Condition	Accessibility
	Visual (SP)	Reinforced Composite (1)	Completely Sealed (0)	Good Condition (0)	Usually inaccessible or unlikely to be disturbed (0)

Normal Occupancy	Score	Likelihood of disturbance	Score	Exposure Potential	Score	Maintenance Activity	Score
Main type of activity	1	Location	2	Number of occupants	1	Type of Maintenance	0
		Accessibility	0	Frequency of use	3	Frequency of maintenance	0
		Amount	1	Average Time	0		
Average Score	1	Average Score	1	Average Score	2	Average Score	0
Average of Priority	4						
Material Assessment Score	2						
Recommendation	Inspection required						
Surveyor comments	No access at the time of the survey due to the potential to damage fixtures and fittings.

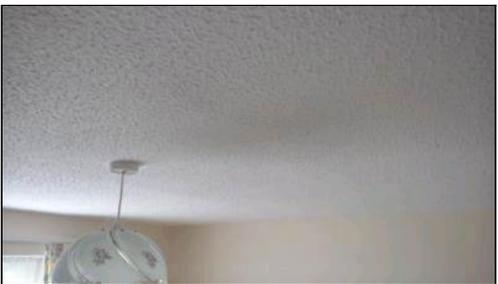
Survey Date:	Lead Surveyor	Survey Type	Floor	Analysis
	31 Jan 2018	Dave Milton	Management Survey	1st	No Asbestos Detected (0)
	Building	Room	Item	Quantity	
	Main Flat	Bedroom 106	Textured coating to plasterboard ceiling.	12m ²	
	Sample No (S,SP,P,As)	Product Type	Surface Treatment	Condition	Accessibility
As AE004530 (SP)	Textured Coating (1)	Completely Sealed (0)	Good Condition (0)	Occasionally likely to be disturbed (1)

Normal Occupancy	Score	Likelihood of disturbance	Score	Exposure Potential	Score	Maintenance Activity	Score
Main type of activity	N/A	Location	N/A	Number of occupants	N/A	Type of Maintenance	N/A
		Accessibility	N/A	Frequency of use	N/A	Frequency of maintenance	N/A
		Amount	N/A	Average Time	N/A		
Average Score	N/A	Average Score	N/A	Average Score	N/A	Average Score	N/A
Average of Priority	N/A						
Material Assessment Score	N/A						
Recommendation	No further action required						
Surveyor comments	N/A

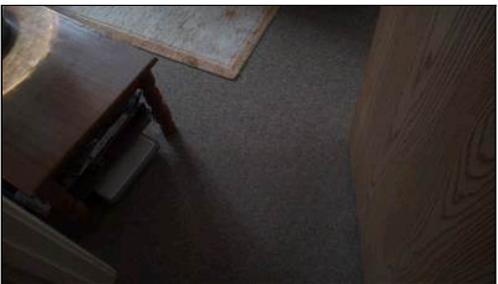
Survey Date:	Lead Surveyor	Survey Type	Floor	Analysis
	31 Jan 2018	Dave Milton	Management Survey	1st	Chrysotile (1)
	Building	Room	Item	Quantity	
	Main Flat	Bedroom 106	Strongly presumed vinyl tiles to chipboard floor beneath fitted carpet.	12m ²	
	Sample No (S,SP,P,As)	Product Type	Surface Treatment	Condition	Accessibility
	Visual (SP)	Reinforced Composite (1)	Completely Sealed (0)	Good Condition (0)	Usually inaccessible or unlikely to be disturbed (0)

Normal Occupancy	Score	Likelihood of disturbance	Score	Exposure Potential	Score	Maintenance Activity	Score
Main type of activity	1	Location	2	Number of occupants	1	Type of Maintenance	0
		Accessibility	0	Frequency of use	3	Frequency of maintenance	0
		Amount	2	Average Time	3		
Average Score	1	Average Score	2	Average Score	3	Average Score	0
Average of Priority	6						
Material Assessment Score	2						
Recommendation	Inspection required						
Surveyor comments	No access at the time of the survey due to the potential to damage fixtures and fittings.

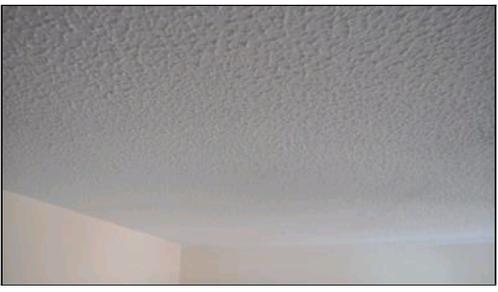
Survey Date:	Lead Surveyor	Survey Type	Floor	Analysis
	31 Jan 2018	Dave Milton	Management Survey	1st	No Asbestos Detected (0)
	Building	Room	Item	Quantity	
	Main Flat	Lounge 107	Textured coating to plasterboard ceiling.	12m ²	
	Sample No (S,SP,P,As)	Product Type	Surface Treatment	Condition	Accessibility
As AE004530 (SP)	Textured Coating (1)	Completely Sealed (0)	Good Condition (0)	Occasionally likely to be disturbed (1)

Normal Occupancy	Score	Likelihood of disturbance	Score	Exposure Potential	Score	Maintenance Activity	Score
Main type of activity	N/A	Location	N/A	Number of occupants	N/A	Type of Maintenance	N/A
		Accessibility	N/A	Frequency of use	N/A	Frequency of maintenance	N/A
		Amount	N/A	Average Time	N/A		
Average Score	N/A	Average Score	N/A	Average Score	N/A	Average Score	N/A
Average of Priority	N/A						
Material Assessment Score	N/A						
Recommendation	No further action required						
Surveyor comments	N/A

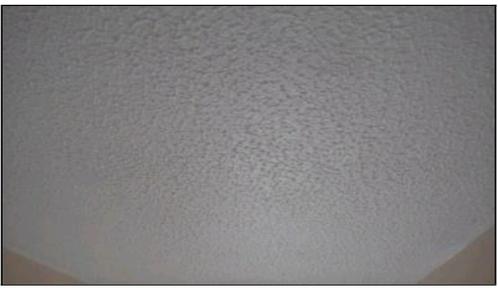
Survey Date:	Lead Surveyor	Survey Type	Floor	Analysis
	31 Jan 2018	Dave Milton	Management Survey	Ground	No Asbestos Detected (0)
	Building	Room	Item	Quantity	
	Main Flat	Lobby G05	Textured coating to plasterboard ceiling.	4m ²	
	Sample No (S,SP,P,As)	Product Type	Surface Treatment	Condition	Accessibility
As AE004530 (SP)	Textured Coating (1)	Completely Sealed (0)	Good Condition (0)	Occasionally likely to be disturbed (1)

Normal Occupancy	Score	Likelihood of disturbance	Score	Exposure Potential	Score	Maintenance Activity	Score
Main type of activity	N/A	Location	N/A	Number of occupants	N/A	Type of Maintenance	N/A
		Accessibility	N/A	Frequency of use	N/A	Frequency of maintenance	N/A
		Amount	N/A	Average Time	N/A		
Average Score	N/A	Average Score	N/A	Average Score	N/A	Average Score	N/A
Average of Priority	N/A						
Material Assessment Score	N/A						
Recommendation	No further action required						
Surveyor comments	N/A
