## Management Survey

28 Trem y Mynydd  
Taff Street  
Treherbert  
Treorchy  
CF42 5JL  
UPRN: 6695

**Kovia**

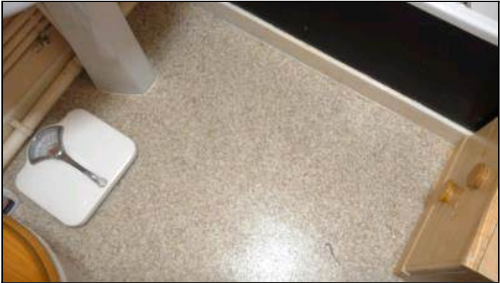
| | Survey Date: | Lead Surveyor | Survey Type | Floor | Analysis |
|---|---|---|---|---|---|
| | 24 Jan 2018 | Dave Milton | Management Survey | 1st | Chrysotile (1) |
| | Visual (SP) | Reinforced Composite (1) | Completely Sealed (0) | Good Condition (0) | Occasionally likely to be disturbed (1) |

| Normal Occupancy | Score | Likelihood of disturbance | Score | Exposure Potential | Score | Maintenance Activity | Score |
|---|---|---|---|---|---|---|---|
| Surveyor comments | No access at the time of the survey due to the potential to damage fixtures and fittings. | | | | | | |

| Normal Occupancy | Score | Likelihood of disturbance | Score | Exposure Potential | Score | Maintenance Activity | Score |
|---|---|---|---|---|---|---|---|
| Recommendation | Inspection required | | | | | | |

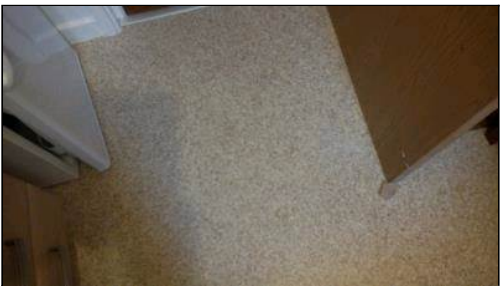
| | Survey Date: | Lead Surveyor | Survey Type | Floor | Analysis |
|---|---|---|---|---|---|
| | 24 Jan 2018 | Dave Milton | Management Survey | 1st | Chrysotile (1) |
| | Visual (SP) | Reinforced Composite (1) | Completely Sealed (0) | Good Condition (0) | Occasionally likely to be disturbed (1) |

| Normal Occupancy | Score | Likelihood of disturbance | Score | Exposure Potential | Score | Maintenance Activity | Score |
|---|---|---|---|---|---|---|---|
| Surveyor comments | No access at the time of the survey due to the potential to damage fixtures and fittings. | | | | | | |

| Normal Occupancy | Score | Likelihood of disturbance | Score | Exposure Potential | Score | Maintenance Activity | Score |
|---|---|---|---|---|---|---|---|
| Recommendation | Inspection required | | | | | | |

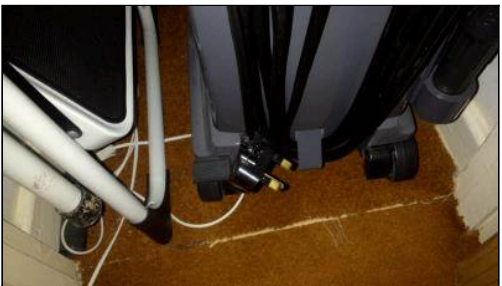
| | Survey Date: | Lead Surveyor | Survey Type | Floor | Analysis |
|---|---|---|---|---|---|
| | 24 Jan 2018 | Dave Milton | Management Survey | 1st | Chrysotile (1) |
| | Visual (SP) | Reinforced Composite (1) | Completely Sealed (0) | Good Condition (0) | Occasionally likely to be disturbed (1) |

| Normal Occupancy | Score | Likelihood of disturbance | Score | Exposure Potential | Score | Maintenance Activity | Score |
|---|---|---|---|---|---|---|---|
| Surveyor comments | No access at the time of the survey due to the potential to damage fixtures and fittings. | | | | | | |

| Normal Occupancy | Score | Likelihood of disturbance | Score | Exposure Potential | Score | Maintenance Activity | Score |
|---|---|---|---|---|---|---|---|
| Recommendation | Inspection required | | | | | | |

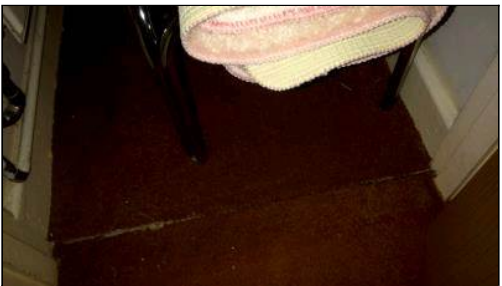
| | Survey Date: | Lead Surveyor | Survey Type | Floor | Analysis |
|---|---|---|---|---|---|
| | 24 Jan 2018 | Dave Milton | Management Survey | 1st | Chrysotile (1) |
| | Visual (SP) | Reinforced Composite (1) | Completely Sealed (0) | Good Condition (0) | Occasionally likely to be disturbed (1) |

| Normal Occupancy | Score | Likelihood of disturbance | Score | Exposure Potential | Score | Maintenance Activity | Score |
|---|---|---|---|---|---|---|---|
| Surveyor comments | No access at the time of the survey due to the potential to damage fixtures and fittings. | | | | | | |

| Normal Occupancy | Score | Likelihood of disturbance | Score | Exposure Potential | Score | Maintenance Activity | Score |
|---|---|---|---|---|---|---|---|
| Recommendation | Inspection required | | | | | | |

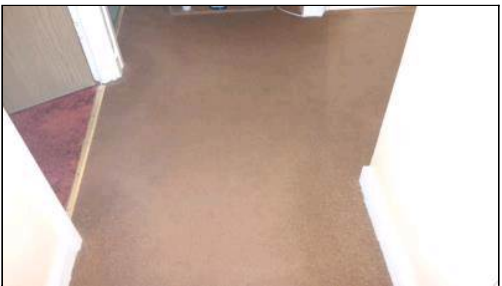
| | Survey Date: | Lead Surveyor | Survey Type | Floor | Analysis |
|---|---|---|---|---|---|
| | 24 Jan 2018 | Dave Milton | Management Survey | 1st | Chrysotile (1) |
| | Visual (SP) | Reinforced Composite (1) | Completely Sealed (0) | Good Condition (0) | Occasionally likely to be disturbed (1) |

| Normal Occupancy | Score | Likelihood of disturbance | Score | Exposure Potential | Score | Maintenance Activity | Score |
|---|---|---|---|---|---|---|---|
| Surveyor comments | No access at the time of the survey due to the potential to damage fixtures and fittings. | | | | | | |

| Normal Occupancy | Score | Likelihood of disturbance | Score | Exposure Potential | Score | Maintenance Activity | Score |
|---|---|---|---|---|---|---|---|
| Recommendation | Inspection required | | | | | | |

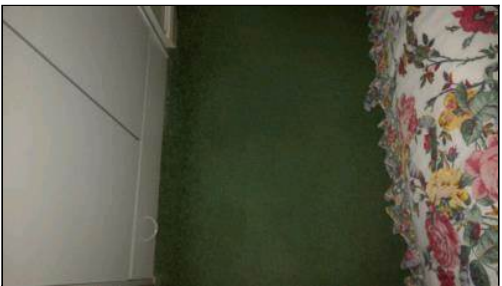
| | Survey Date: | Lead Surveyor | Survey Type | Floor | Analysis |
|---|---|---|---|---|---|
| | 24 Jan 2018 | Dave Milton | Management Survey | 1st | Chrysotile (1) |

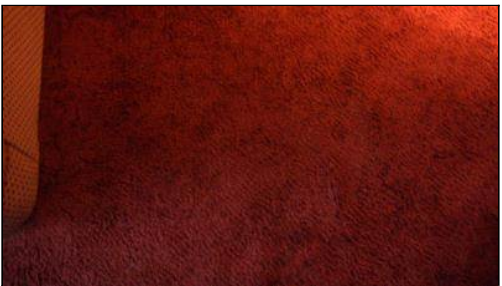
| | Survey Date: | Lead Surveyor | Survey Type | Floor | Analysis |
|---|---|---|---|---|---|
| | 24 Jan 2018 | Dave Milton | Management Survey | 1st | Chrysotile (1) |

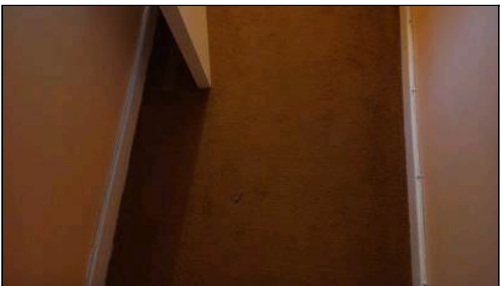
| | Survey Date: | Lead Surveyor | Survey Type | Floor | Analysis |
|---|---|---|---|---|---|
| | 24 Jan 2018 | Dave Milton | Management Survey | 1st | Chrysotile (1) |

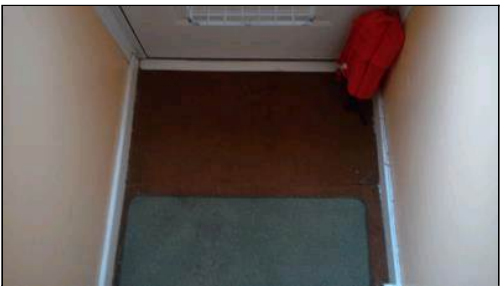
| | Survey Date: | Lead Surveyor | Survey Type | Floor | Analysis |
|---|---|---|---|---|---|
| | 24 Jan 2018 | Dave Milton | Management Survey | Ground | Chrysotile (1) |

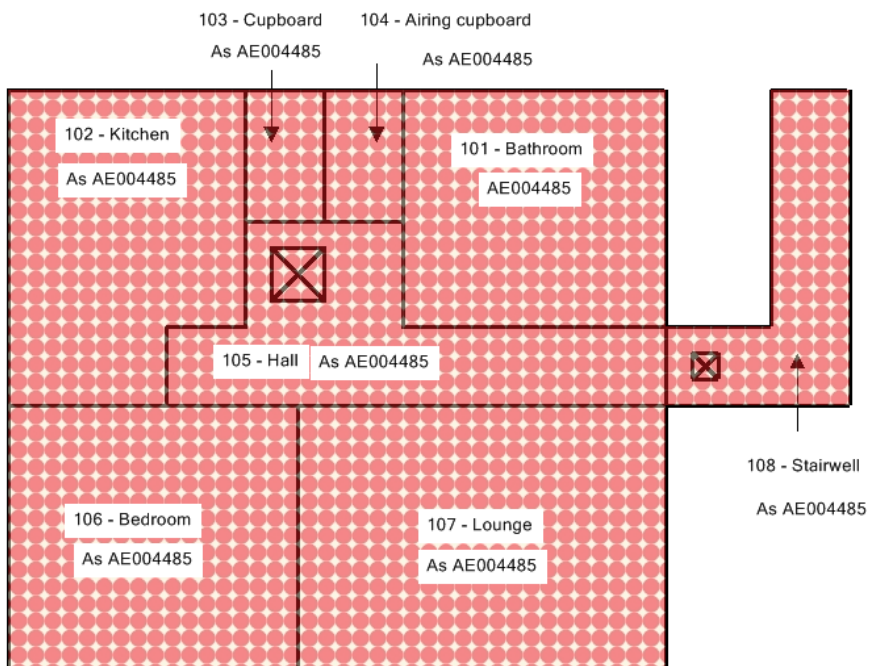
Strongly presumed vinyl tiles throughout

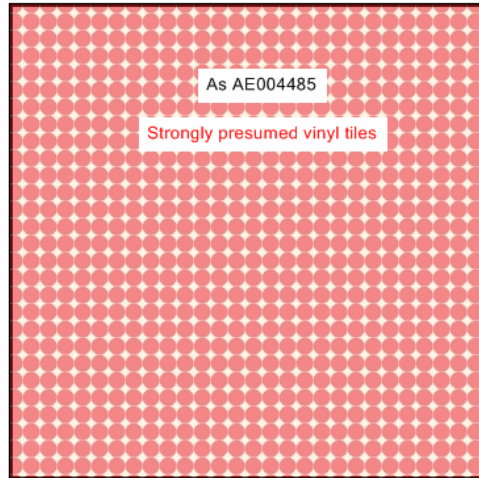
G09 - Lobby

Strongly presumed vinyl tiles
