# KOVIA

### Management Survey

34 Trem y Mynydd  
Taff Street  
Treherbert  
Rhondda  
CF42 5LJ  
UPRN: 6701

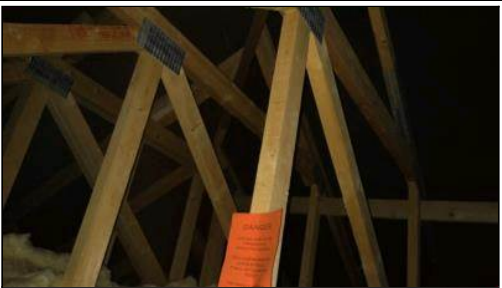
Survey Date:	Lead Surveyor	Survey Type	Floor	Analysis
	3 Jun 2016 to 4 Jun 2016	Sebastian Lawniczak	Management Survey	Roof	N/A
	Building	Room	Item	Quantity	
	Main Flat.	Loft Space 1 R01	No suspect materials identified	N/A	
	Sample No (S,SP,P,As)	Product Type	Surface Treatment	Condition	Accessibility
	Visual (P)	N/A	N/A	N/A	N/A

Normal Occupancy	Score	Likelihood of disturbance	Score	Exposure Potential	Score	Maintenance Activity	Score
Main type of activity	N/A	Location	N/A	Number of occupants	N/A	Type of Maintenance	N/A
		Accessibility	N/A	Frequency of use	N/A	Frequency of maintenance	N/A
		Amount	N/A	Average Time	N/A		
Average Score	N/A	Average Score	N/A	Average Score	N/A	Average Score	N/A
Average of Priority	N/A						
Material Assessment Score	N/A						
Recommendation	No further action required						
Surveyor comments	N/A

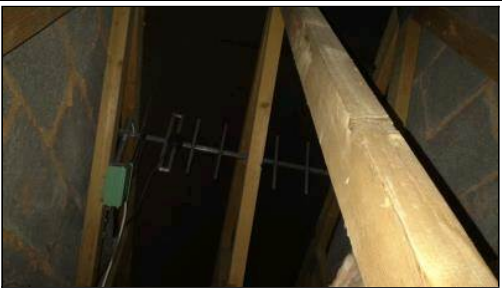
Survey Date:	Lead Surveyor	Survey Type	Floor	Analysis
	3 Jun 2016 to 4 Jun 2016	Sebastian Lawniczak	Management Survey	Roof	N/A
	Building	Room	Item	Quantity	
	Main Flat.	Loft Space 2 R02	No suspect materials identified	N/A	
	Sample No (S,SP,P,As)	Product Type	Surface Treatment	Condition	Accessibility
	Visual (P)	N/A	N/A	N/A	N/A

Normal Occupancy	Score	Likelihood of disturbance	Score	Exposure Potential	Score	Maintenance Activity	Score
Main type of activity	N/A	Location	N/A	Number of occupants	N/A	Type of Maintenance	N/A
		Accessibility	N/A	Frequency of use	N/A	Frequency of maintenance	N/A
		Amount	N/A	Average Time	N/A		
Average Score	N/A	Average Score	N/A	Average Score	N/A	Average Score	N/A
Average of Priority	N/A						
Material Assessment Score	N/A						
Recommendation	No further action required						
Surveyor comments	N/A

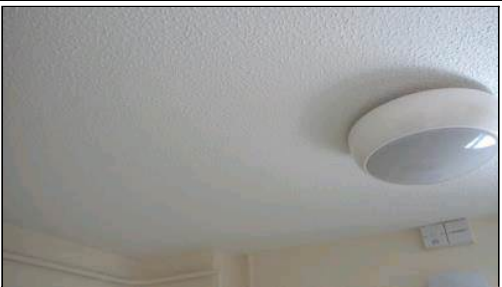
Survey Date:	Lead Surveyor	Survey Type	Floor	Analysis
	3 Jun 2016 to 4 Jun 2016	Sebastian Lawniczak	Management Survey	1st	No Asbestos Detected (0)
	Building	Room	Item	Quantity	
	Main Flat.	Shower Room 101	Textured coating to plasterboard ceiling	5m <sup>2</sup>	
	Sample No (S,SP,P,As)	Product Type	Surface Treatment	Condition	Accessibility
	AE001386 (S)	Textured Coating (1)	Completely Sealed (0)	Good Condition (0)	Occasionally likely to be disturbed (1)

Normal Occupancy	Score	Likelihood of disturbance	Score	Exposure Potential	Score	Maintenance Activity	Score
Main type of activity	N/A	Location	N/A	Number of occupants	N/A	Type of Maintenance	N/A
		Accessibility	N/A	Frequency of use	N/A	Frequency of maintenance	N/A
		Amount	N/A	Average Time	N/A		
Average Score	N/A	Average Score	N/A	Average Score	N/A	Average Score	N/A
Average of Priority	N/A						
Material Assessment Score	N/A						
Recommendation	No further action required						
Surveyor comments	N/A

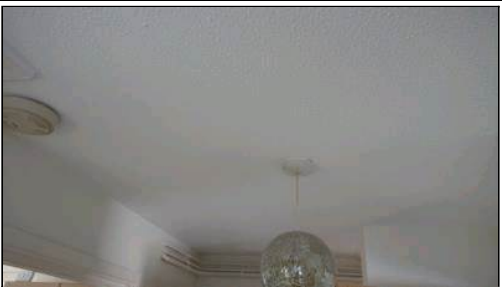
Survey Date:	Lead Surveyor	Survey Type	Floor	Analysis
	3 Jun 2016 to 4 Jun 2016	Sebastian Lawniczak	Management Survey	1st	No Asbestos Detected (0)
	Building	Room	Item	Quantity	
	Main Flat.	Hallway 102	Textured coating to plasterboard ceiling	4m <sup>2</sup>	
	Sample No (S,SP,P,As)	Product Type	Surface Treatment	Condition	Accessibility
	As AE001386 (SP)	Textured Coating (1)	Completely Sealed (0)	Good Condition (0)	Occasionally likely to be disturbed (1)

Normal Occupancy	Score	Likelihood of disturbance	Score	Exposure Potential	Score	Maintenance Activity	Score
Main type of activity	N/A	Location	N/A	Number of occupants	N/A	Type of Maintenance	N/A
		Accessibility	N/A	Frequency of use	N/A	Frequency of maintenance	N/A
		Amount	N/A	Average Time	N/A		
Average Score	N/A	Average Score	N/A	Average Score	N/A	Average Score	N/A
Average of Priority	N/A						
Material Assessment Score	N/A						
Recommendation	No further action required						
Surveyor comments	N/A

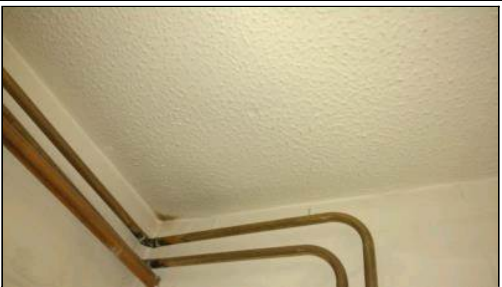
Survey Date:	Lead Surveyor	Survey Type	Floor	Analysis
	3 Jun 2016 to 4 Jun 2016	Sebastian Lawniczak	Management Survey	1st	No Asbestos Detected (0)
	Building	Room	Item	Quantity	
	Main Flat.	Store Cupboard 1 103	Textured coating to plasterboard ceiling	1m <sup>2</sup>	
	Sample No (S,SP,P,As)	Product Type	Surface Treatment	Condition	Accessibility
	As AE001386 (SP)	Textured Coating (1)	Completely Sealed (0)	Good Condition (0)	Occasionally likely to be disturbed (1)

Normal Occupancy	Score	Likelihood of disturbance	Score	Exposure Potential	Score	Maintenance Activity	Score
Main type of activity	N/A	Location	N/A	Number of occupants	N/A	Type of Maintenance	N/A
		Accessibility	N/A	Frequency of use	N/A	Frequency of maintenance	N/A
		Amount	N/A	Average Time	N/A		
Average Score	N/A	Average Score	N/A	Average Score	N/A	Average Score	N/A
Average of Priority	N/A						
Material Assessment Score	N/A						
Recommendation	No further action required						
Surveyor comments	N/A

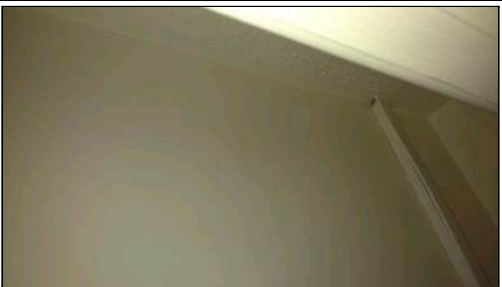
Survey Date:	Lead Surveyor	Survey Type	Floor	Analysis
	3 Jun 2016 to 4 Jun 2016	Sebastian Lawniczak	Management Survey	1st	No Asbestos Detected (0)
	Building	Room	Item	Quantity	
	Main Flat.	Store Cupboard 2 104	Textured coating to plasterboard ceiling	<1m <sup>2</sup>	
	Sample No (S,SP,P,As)	Product Type	Surface Treatment	Condition	Accessibility
	As AE001386 (SP)	Textured Coating (1)	Completely Sealed (0)	Good Condition (0)	Occasionally likely to be disturbed (1)

Normal Occupancy	Score	Likelihood of disturbance	Score	Exposure Potential	Score	Maintenance Activity	Score
Main type of activity	N/A	Location	N/A	Number of occupants	N/A	Type of Maintenance	N/A
		Accessibility	N/A	Frequency of use	N/A	Frequency of maintenance	N/A
		Amount	N/A	Average Time	N/A		
Average Score	N/A	Average Score	N/A	Average Score	N/A	Average Score	N/A
Average of Priority	N/A						
Material Assessment Score	N/A						
Recommendation	No further action required						
Surveyor comments	N/A

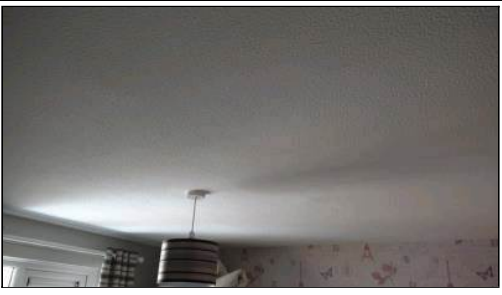
Survey Date:	Lead Surveyor	Survey Type	Floor	Analysis
	3 Jun 2016 to 4 Jun 2016	Sebastian Lawniczak	Management Survey	1st	No Asbestos Detected (0)
	Building	Room	Item	Quantity	
	Main Flat.	Bedroom 105	Textured coating to plasterboard ceiling	9m <sup>2</sup>	
	Sample No (S,SP,P,As)	Product Type	Surface Treatment	Condition	Accessibility
	As AE001386 (SP)	Textured Coating (1)	Completely Sealed (0)	Good Condition (0)	Occasionally likely to be disturbed (1)

Normal Occupancy	Score	Likelihood of disturbance	Score	Exposure Potential	Score	Maintenance Activity	Score
Main type of activity	N/A	Location	N/A	Number of occupants	N/A	Type of Maintenance	N/A
		Accessibility	N/A	Frequency of use	N/A	Frequency of maintenance	N/A
		Amount	N/A	Average Time	N/A		
Average Score	N/A	Average Score	N/A	Average Score	N/A	Average Score	N/A
Average of Priority	N/A						
Material Assessment Score	N/A						
Recommendation	No further action required						
Surveyor comments	N/A

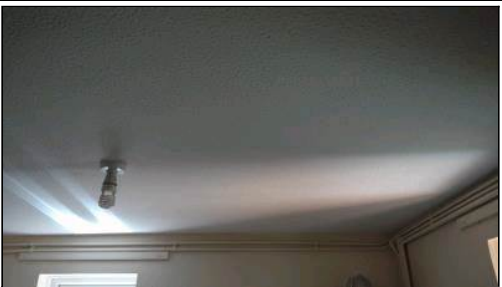
Survey Date:	Lead Surveyor	Survey Type	Floor	Analysis
	3 Jun 2016 to 4 Jun 2016	Sebastian Lawniczak	Management Survey	1st	No Asbestos Detected (0)
	Building	Room	Item	Quantity	
	Main Flat.	Kitchen 106	Textured coating to plasterboard ceiling	8m <sup>2</sup>	
	Sample No (S,SP,P,As)	Product Type	Surface Treatment	Condition	Accessibility
	AE001387 (S)	Textured Coating (1)	Completely Sealed (0)	Good Condition (0)	Occasionally likely to be disturbed (1)

Normal Occupancy	Score	Likelihood of disturbance	Score	Exposure Potential	Score	Maintenance Activity	Score
Main type of activity	N/A	Location	N/A	Number of occupants	N/A	Type of Maintenance	N/A
		Accessibility	N/A	Frequency of use	N/A	Frequency of maintenance	N/A
		Amount	N/A	Average Time	N/A		
Average Score	N/A	Average Score	N/A	Average Score	N/A	Average Score	N/A
Average of Priority	N/A						
Material Assessment Score	N/A						
Recommendation	No further action required						
Surveyor comments	N/A

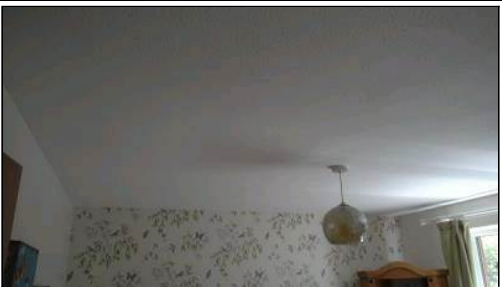
Survey Date:	Lead Surveyor	Survey Type	Floor	Analysis
	3 Jun 2016 to 4 Jun 2016	Sebastian Lawniczak	Management Survey	1st	No Asbestos Detected (0)
	Building	Room	Item	Quantity	
	Main Flat.	Living Room 107	Textured coating to plasterboard ceiling	9m <sup>2</sup>	
	Sample No (S,SP,P,As)	Product Type	Surface Treatment	Condition	Accessibility
	As AE001387 (SP)	Textured Coating (1)	Completely Sealed (0)	Good Condition (0)	Occasionally likely to be disturbed (1)

Normal Occupancy	Score	Likelihood of disturbance	Score	Exposure Potential	Score	Maintenance Activity	Score
Main type of activity	N/A	Location	N/A	Number of occupants	N/A	Type of Maintenance	N/A
		Accessibility	N/A	Frequency of use	N/A	Frequency of maintenance	N/A
		Amount	N/A	Average Time	N/A		
Average Score	N/A	Average Score	N/A	Average Score	N/A	Average Score	N/A
Average of Priority	N/A						
Material Assessment Score	N/A						
Recommendation	No further action required						
Surveyor comments	N/A

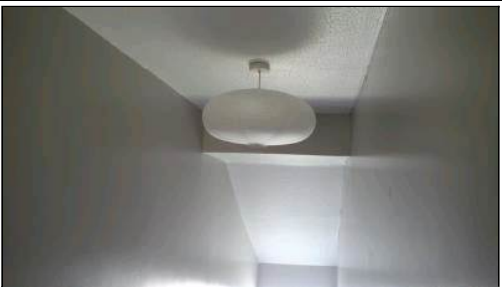
Survey Date:	Lead Surveyor	Survey Type	Floor	Analysis
	3 Jun 2016 to 4 Jun 2016	Sebastian Lawniczak	Management Survey	1st	No Asbestos Detected (0)
	Building	Room	Item	Quantity	
	Main Flat.	Landing and Stairs 108	Textured coating to plasterboard ceiling	6m <sup>2</sup>	
	Sample No (S,SP,P,As)	Product Type	Surface Treatment	Condition	Accessibility
	As AE001387 (SP)	Textured Coating (1)	Completely Sealed (0)	Good Condition (0)	Occasionally likely to be disturbed (1)

Normal Occupancy	Score	Likelihood of disturbance	Score	Exposure Potential	Score	Maintenance Activity	Score
Main type of activity	N/A	Location	N/A	Number of occupants	N/A	Type of Maintenance	N/A
		Accessibility	N/A	Frequency of use	N/A	Frequency of maintenance	N/A
		Amount	N/A	Average Time	N/A		
Average Score	N/A	Average Score	N/A	Average Score	N/A	Average Score	N/A
Average of Priority	N/A						
Material Assessment Score	N/A						
Recommendation	No further action required						
Surveyor comments	N/A
