## Management with Targeted Refurbishment Survey to Bathroom

35 Trem y Mynydd  
Taff Street  
Treherbert  
Treorch  
CF42 5LJ  
UPRN: 6700

Report issue date:	31 Jan 2018

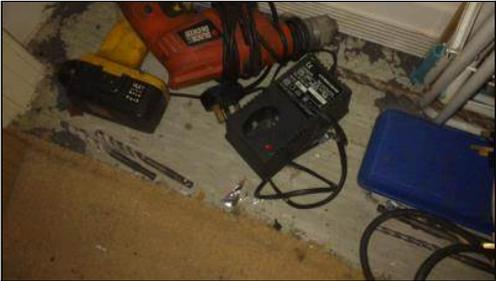
Survey Date:	Lead Surveyor	Survey Type	Floor	Analysis
	26 Jan 2018	Dave Milton	Management Survey	1st	Chrysotile (1)
	Building	Room	Item	Quantity	
	Flat 35	Cupboard 2 104	Strongly presumed vinyl tiles to chipboard floor beneath fixed non-suspect beige vinyl flooring.	0.5m <sup>2</sup>	
	Sample No (S,SP,P,As)	Product Type	Surface Treatment	Condition	Accessibility
	Visual (SP)	Reinforced Composite (1)	Completely Sealed (0)	Good Condition (0)	Occasionally likely to be disturbed (1)

Normal Occupancy	Score	Likelihood of disturbance	Score	Exposure Potential	Score	Maintenance Activity	Score
Main type of activity	1	Location	2	Number of occupants	1	Type of Maintenance	1
		Accessibility	1	Frequency of use	3	Frequency of maintenance	1
		Amount	1	Average Time	0		
Average Score	1	Average Score	2	Average Score	2	Average Score	1
Average of Priority	<b>6</b>						
Material Assessment Score	<b>2</b>						
Recommendation	Inspection required						
Surveyor comments	No access at the time of the survey due to the potential to damage fixtures and fittings.

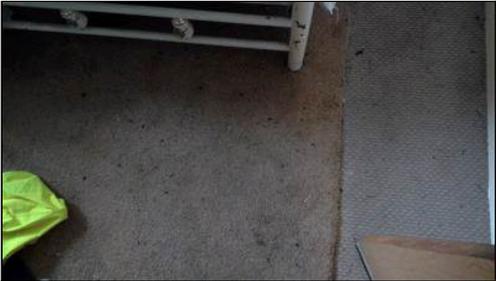
<b>Survey Date:</b>	<b>Lead Surveyor</b>	<b>Survey Type</b>	<b>Floor</b>	<b>Analysis</b>
	26 Jan 2018	Dave Milton	Management Survey	1st	Chrysotile (1)
	<b>Building</b>	<b>Room</b>	<b>Item</b>	<b>Quantity</b>	
	Flat 35	Bedroom 105	Strongly presumed vinyl tiles to chipboard floor beneath fitted beige carpet.	12m <sup>2</sup>	
	<b>Sample No (S,SP,P,As)</b>	<b>Product Type</b>	<b>Surface Treatment</b>	<b>Condition</b>	<b>Accessibility</b>
Visual (SP)	Reinforced Composite (1)	Completely Sealed (0)	Good Condition (0)	Occasionally likely to be disturbed (1)

Normal Occupancy	Score	Likelihood of disturbance	Score	Exposure Potential	Score	Maintenance Activity	Score
Main type of activity	1	Location	2	Number of occupants	1	Type of Maintenance	1
		Accessibility	1	Frequency of use	3	Frequency of maintenance	1
		Amount	2	Average Time	3		
Average Score	1	Average Score	2	Average Score	3	Average Score	1
Average of Priority	<b>7</b>						
Material Assessment Score	<b>2</b>						
Recommendation	Inspection required						
Surveyor comments	No access at the time of the survey due to the potential to damage fixtures and fittings.

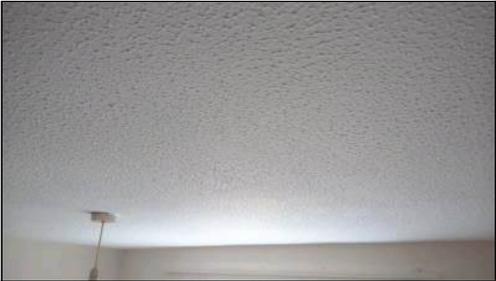
<b>Survey Date:</b>	<b>Lead Surveyor</b>	<b>Survey Type</b>	<b>Floor</b>	<b>Analysis</b>
	26 Jan 2018	Dave Milton	Management Survey	1st	No Asbestos Detected (0)
	<b>Building</b>	<b>Room</b>	<b>Item</b>	<b>Quantity</b>	
	Flat 35	Lounge 106	Textured coating to plasterboard ceiling.	12m <sup>2</sup>	
	<b>Sample No (S,SP,P,As)</b>	<b>Product Type</b>	<b>Surface Treatment</b>	<b>Condition</b>	<b>Accessibility</b>
As AE004504 (SP)	Textured Coating (1)	Completely Sealed (0)	Good Condition (0)	Occasionally likely to be disturbed (1)
