## Management with Targeted Refurbishment Survey to the Bathroom

30 Tremymynydd  
Taff Street  
Treherbert  
CF42 5LJ  
UPRN: 6697

| Type of survey: | Management Survey with part Refurbishment/Demolition (MA and PA) | | |

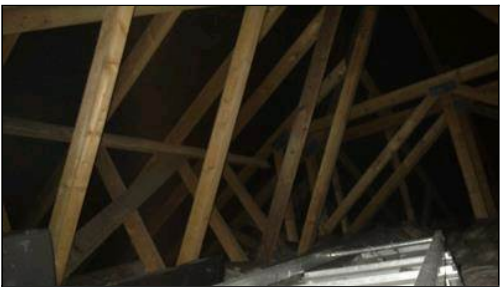
| | Survey Date: | Lead Surveyor | Survey Type | Floor | Analysis |
|---|---|---|---|---|---|
| | 9 May 2016 | Sebastian Lawniczak | Management Survey | Roof | N/A |

| Normal Occupancy | Score | Likelihood of disturbance | Score | Exposure Potential | Score | Maintenance Activity | Score |
|---|---|---|---|---|---|---|---|
| Recommendation | No further action required | | | | | | |

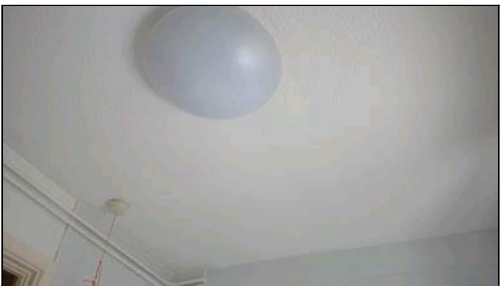
| | Survey Date: | Lead Surveyor | Survey Type | Floor | Analysis |
|---|---|---|---|---|---|
| | 9 May 2016 | Sebastian Lawniczak | Refurbishment and Demolition Survey | 1st | No Asbestos Detected (0) |
| | AE001249 (S) | Textured Coating (1) | Completely Sealed (0) | Good Condition (0) | Occasionally likely to be disturbed (1) |

| Normal Occupancy | Score | Likelihood of disturbance | Score | Exposure Potential | Score | Maintenance Activity | Score |
|---|---|---|---|---|---|---|---|
| Recommendation | No further action required | | | | | | |

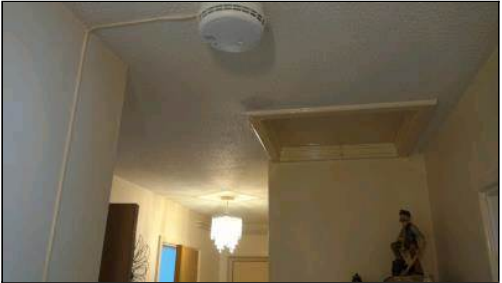
| | Survey Date: | Lead Surveyor | Survey Type | Floor | Analysis |
|---|---|---|---|---|---|
| | 9 May 2016 | Sebastian Lawniczak | Management Survey | 1st | No Asbestos Detected (0) |
| | As AE001249 (SP) | Textured Coating (1) | Completely Sealed (0) | Good Condition (0) | Occasionally likely to be disturbed (1) |

| Normal Occupancy | Score | Likelihood of disturbance | Score | Exposure Potential | Score | Maintenance Activity | Score |
|---|---|---|---|---|---|---|---|
| Recommendation | No further action required | | | | | | |

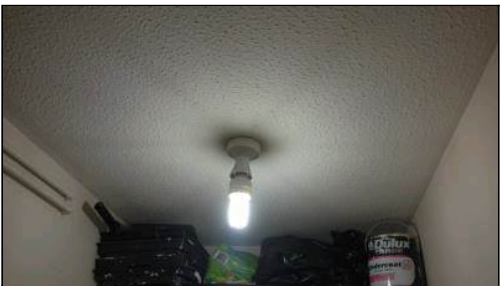
| | 9 May 2016 | Sebastian Lawniczak | Management Survey | 1st | No Asbestos Detected (0) |
| | As AE001249 (SP) | Textured Coating (1) | Completely Sealed (0) | Good Condition (0) | Occasionally likely to be disturbed (1) |

| Recommendation | No further action required | | | | | | |

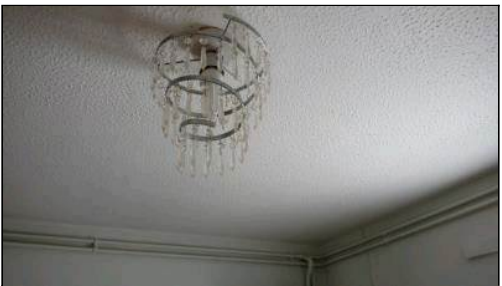
| | Survey Date: | Lead Surveyor | Survey Type | Floor | Analysis |
|---|---|---|---|---|---|
| | 9 May 2016 | Sebastian Lawniczak | Management Survey | 1st | No Asbestos Detected (0) |
| | As AE001249 (SP) | Textured Coating (1) | Completely Sealed (0) | Good Condition (0) | Occasionally likely to be disturbed (1) |

| Normal Occupancy | Score | Likelihood of disturbance | Score | Exposure Potential | Score | Maintenance Activity | Score |
|---|---|---|---|---|---|---|---|
| Recommendation | No further action required | | | | | | |

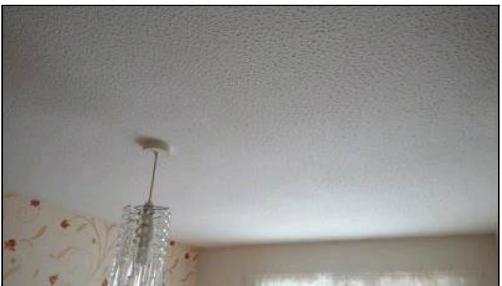
| | 9 May 2016 | Sebastian Lawniczak | Management Survey | 1st | No Asbestos Detected (0) |
| | As AE001249 (SP) | Textured Coating (1) | Completely Sealed (0) | Good Condition (0) | Occasionally likely to be disturbed (1) |

| Recommendation | No further action required | | | | | | |

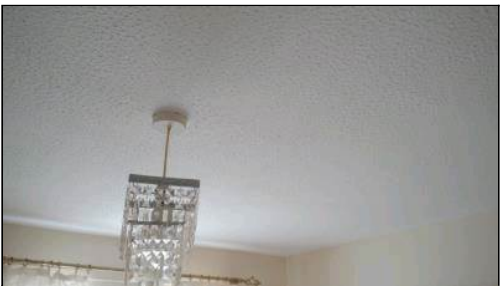
| | Survey Date: | Lead Surveyor | Survey Type | Floor | Analysis |
|---|---|---|---|---|---|
| | 9 May 2016 | Sebastian Lawniczak | Management Survey | 1st | No Asbestos Detected (0) |
| | As AE001249 (SP) | Textured Coating (1) | Completely Sealed (0) | Good Condition (0) | Occasionally likely to be disturbed (1) |

| Normal Occupancy | Score | Likelihood of disturbance | Score | Exposure Potential | Score | Maintenance Activity | Score |
|---|---|---|---|---|---|---|---|
| Recommendation | No further action required | | | | | | |

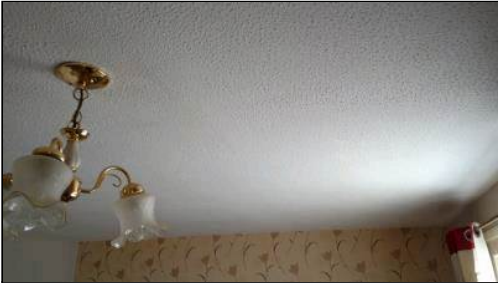
| | Survey Date: | Lead Surveyor | Survey Type | Floor | Analysis |
|---|---|---|---|---|---|
| | 9 May 2016 | Sebastian Lawniczak | Management Survey | 1st | No Asbestos Detected (0) |
| | As AE001249 (SP) | Textured Coating (1) | Completely Sealed (0) | Good Condition (0) | Occasionally likely to be disturbed (1) |

| Normal Occupancy | Score | Likelihood of disturbance | Score | Exposure Potential | Score | Maintenance Activity | Score |
|---|---|---|---|---|---|---|---|
| Recommendation | No further action required | | | | | | |

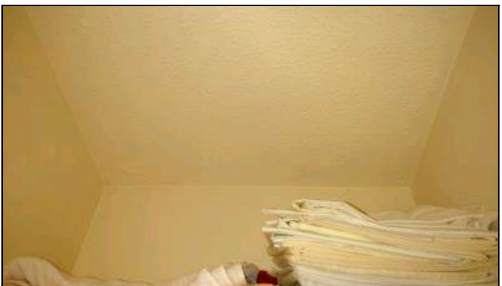
| | Survey Date: | Lead Surveyor | Survey Type | Floor | Analysis |
|---|---|---|---|---|---|
| | 9 May 2016 | Sebastian Lawniczak | Management Survey | 1st | No Asbestos Detected (0) |
| | As AE001249 (SP) | Textured Coating (1) | Completely Sealed (0) | Good Condition (0) | Occasionally likely to be disturbed (1) |

| Normal Occupancy | Score | Likelihood of disturbance | Score | Exposure Potential | Score | Maintenance Activity | Score |
|---|---|---|---|---|---|---|---|
| Recommendation | No further action required | | | | | | |
