Pectel (Wales) Limited

Ty Ddowi
St. Davids Close
Pentre,
CF41 7BG

TYPE II ASBESTOS SURVEY

**ASBESTOS MANAGEMENT SURVEY
OF
ST DAVIDS CLOSE, PENTRE, CF41 7BG**

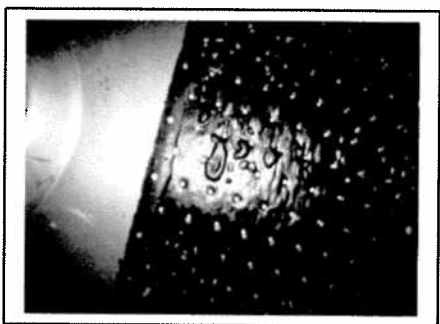
Sample No. 50720RCL034
Location G002
Description Sink Pad

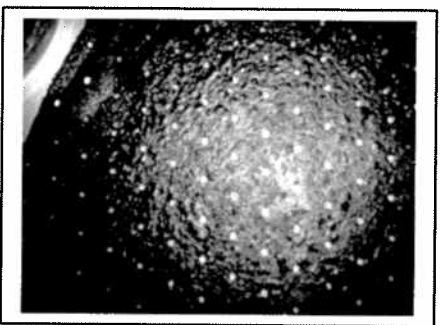
Sample No. 50720RCL036
Location G003
Description Sink Pad

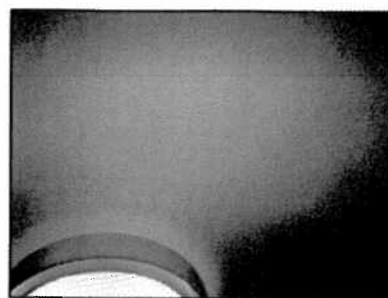
LOCATION: G001

The Textured Coating to Ceiling in Room G001 (Sample No 50720RCL032) contains Chrysotile (White asbestos) and is in good condition. Manestream Ltd recommends that this asbestos-containing material is incorporated into an Asbestos Management Plan and is inspected at regular intervals.

Sample Description:
Textured Coating to Ceiling

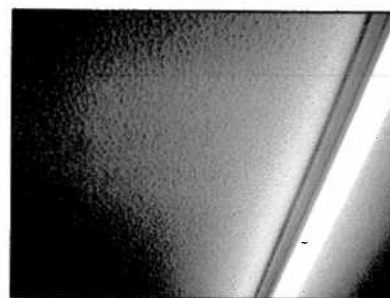
LOCATION: G002

The Textured Coating to Ceiling in Room G002 (Sample No 50720RCL035) contains Chrysotile (White asbestos) and is in good condition. Manestream Ltd recommends that this asbestos-containing material is incorporated into an Asbestos Management Plan and is inspected at regular intervals.

Sample Description:
Textured Coating to Ceiling

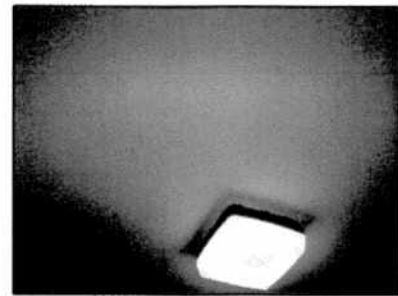
LOCATION: G004

The Textured Coating to Ceiling in Room G004 (Sample No 50720RCL039) contains Chrysotile (White asbestos) and is in good condition. Manestream Ltd recommends that this asbestos-containing material is incorporated into an Asbestos Management Plan and is inspected at regular intervals.

Sample Description:
Textured Coating to Ceiling

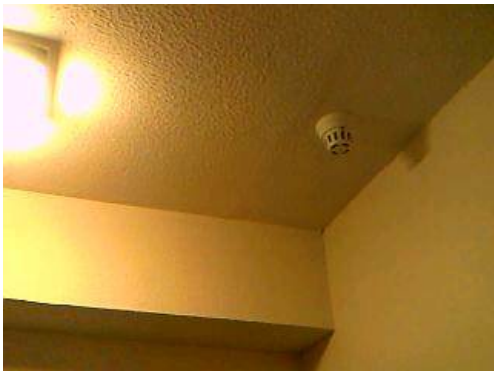
FLOOR/LOCATION:	Ground Floor cupboard (002)

DESCRIPTION:	Textured coating to ceiling	
RECOMMENDATIONS:	Manage, monitor and inform maintenance personnel prior to relevant works	
EXTENT:	<10m² or <10m pipe run	
SAMPLE REF:	DU000242	
RESULT:	Chrysotile

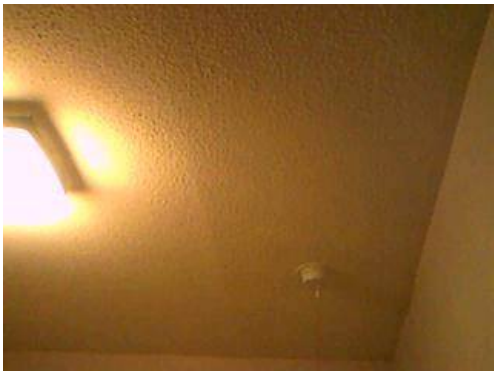
FLOOR/LOCATION:	Ground Floor disabled W.C. (003)

DESCRIPTION:	Textured coating to ceiling	
RECOMMENDATIONS:	Manage, monitor and inform maintenance personnel prior to relevant works	
EXTENT:	<10m² or <10m pipe run	
SAMPLE REF:	SPST DU000242	
RESULT:	Chrysotile

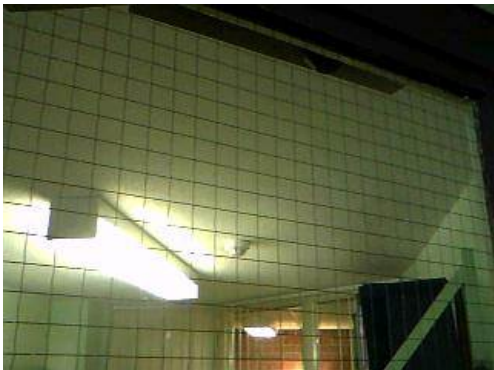
FLOOR/LOCATION:	Ground Floor office (004)

DESCRIPTION:	Textured coating to ceiling	
RECOMMENDATIONS:	Manage, monitor and inform maintenance personnel prior to relevant works	
EXTENT:	<10m² or <10m pipe run	
SAMPLE REF:	SPST DU000242	
RESULT:	Chrysotile

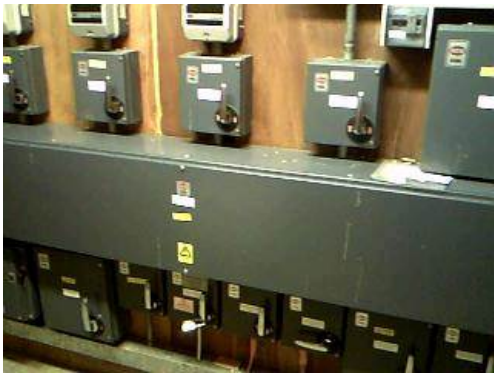
FLOOR/LOCATION:	Ground Floor electrical switch room (005)

DESCRIPTION:	No access due to health and safety reasons	
RECOMMENDATIONS:	Conduct further investigation prior to relevant maintenance / refurbishment works	
EXTENT:	Minor amounts, String, Gaskets	
SAMPLE REF:	Presumed	
RESULT:	Presumed Chrysotile

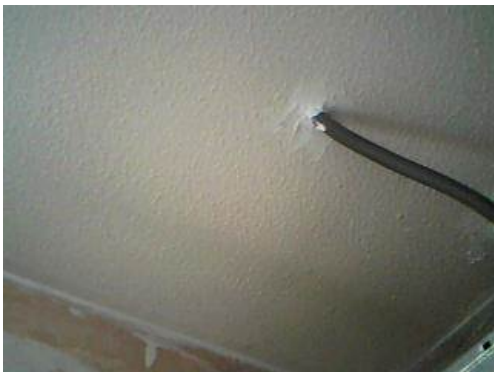
FLOOR/LOCATION:	Ground Floor corridor (006)

DESCRIPTION:	Textured coating to ceiling	
RECOMMENDATIONS:	Manage, monitor and inform maintenance personnel prior to relevant works	
EXTENT:	<10m² or <10m pipe run	
SAMPLE REF:	DU000243	
RESULT:	Chrysotile

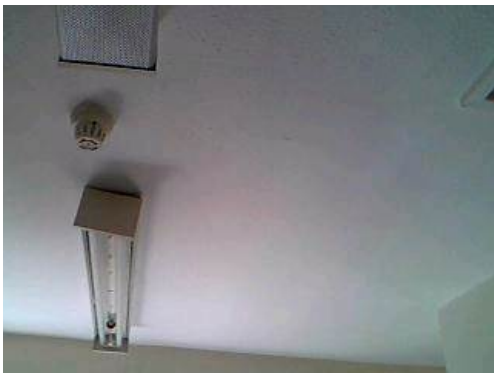
FLOOR/LOCATION:	Ground Floor laundry (007)

DESCRIPTION:	Textured coating to ceiling	
RECOMMENDATIONS:	Manage, monitor and inform maintenance personnel prior to relevant works	
EXTENT:	10 - 50 m² or 10 - 50m pipe run	
SAMPLE REF:	SPST DU000243	
RESULT:	Chrysotile

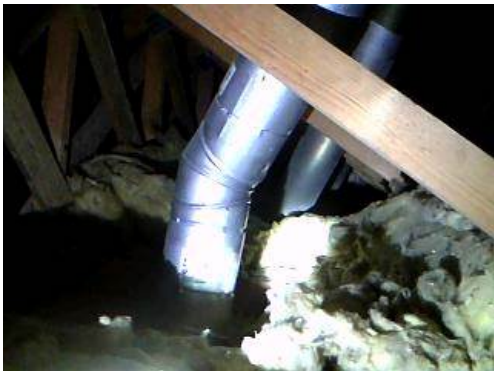
FLOOR/LOCATION:	Ground Floor void above laundry

DESCRIPTION:	Accessed - no suspect materials found	
RECOMMENDATIONS:	Conduct further investigation prior to relevant works	
EXTENT:		
SAMPLE REF:	Presumed	
RESULT:	Presumed

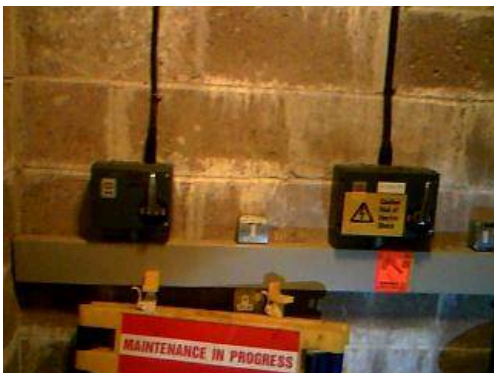
FLOOR/LOCATION:	Ground Floor lift motor room (010)

DESCRIPTION:	No access due to health and safety reasons	
RECOMMENDATIONS:	Conduct further investigation prior to relevant maintenance / refurbishment works	
EXTENT:	Minor amounts, String, Gaskets	
SAMPLE REF:	Presumed	
RESULT:	Presumed Chrysotile

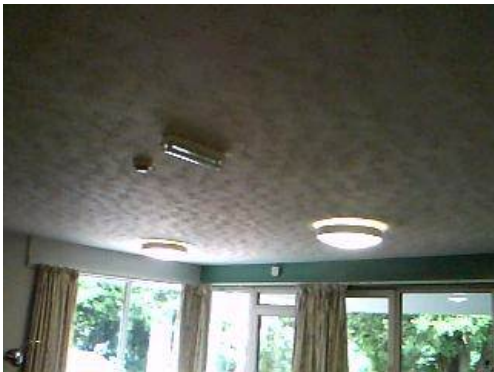
FLOOR/LOCATION:	Ground Floor common lounge (014)

DESCRIPTION:	Textured coating to ceiling	
RECOMMENDATIONS:	Manage, monitor and inform maintenance personnel prior to relevant works	
EXTENT:	10 - 50 m² or 10 - 50m pipe run	
SAMPLE REF:	DU000244	
RESULT:	Chrysotile

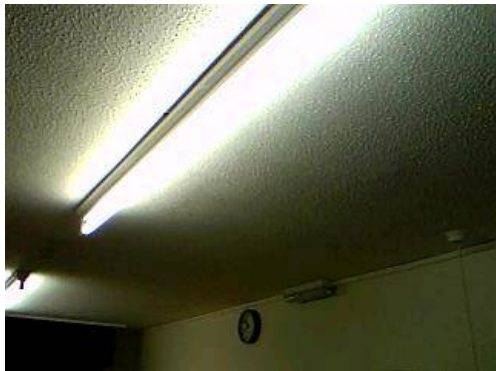
FLOOR/LOCATION:	Ground Floor Kitchen 016

DESCRIPTION:	Textured coating to ceiling	
RECOMMENDATIONS:	Manage, monitor and inform maintenance personnel prior to relevant works	
EXTENT:	<10m² or <10m pipe run	
SAMPLE REF:	DU000293	
RESULT:	Chrysotile

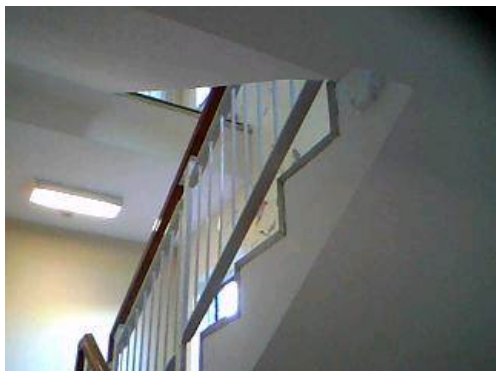
FLOOR/LOCATION:	Ground Floor stairwell 019

DESCRIPTION:	Textured coating to ceiling	
RECOMMENDATIONS:	Manage, monitor and inform maintenance personnel prior to relevant works	
EXTENT:	10 - 50 m² or 10 - 50m pipe run	
SAMPLE REF:	DU000294	
RESULT:	Chrysotile

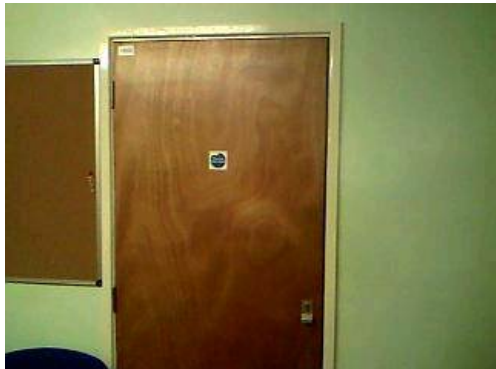
FLOOR/LOCATION:	1st Floor cupboard 111

DESCRIPTION:	Inaccessible	
RECOMMENDATIONS:	Conduct further investigation prior to relevant works	
EXTENT:		
SAMPLE REF:	Presumed	
RESULT:	Presumed

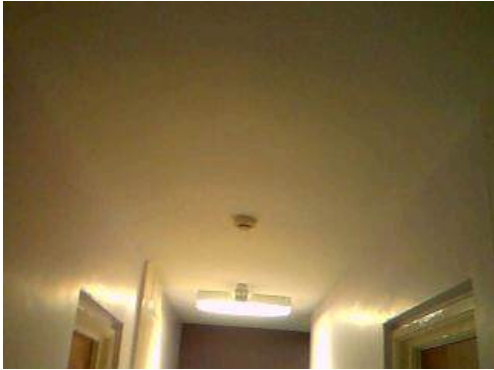
FLOOR/LOCATION:	2nd Floor corridor 201

DESCRIPTION:	Textured coating to ceiling	
RECOMMENDATIONS:	Manage, monitor and inform maintenance personnel prior to relevant works	
EXTENT:	10 - 50 m² or 10 - 50m pipe run	
SAMPLE REF:	DU000297	
RESULT:	Chrysotile

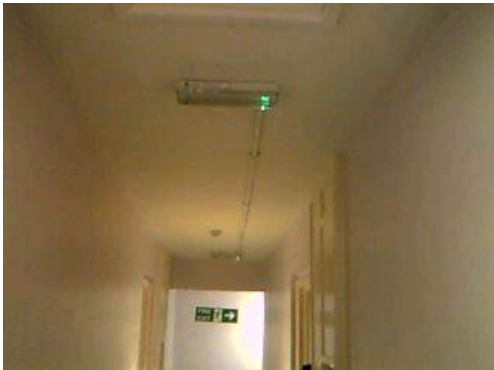
FLOOR/LOCATION:	2nd Floor corridor 202

DESCRIPTION:	Textured coating to ceiling	
RECOMMENDATIONS:	Manage, monitor and inform maintenance personnel prior to relevant works	
EXTENT:	10 - 50 m² or 10 - 50m pipe run	
SAMPLE REF:	SPST DU000297	
RESULT:	Chrysotile

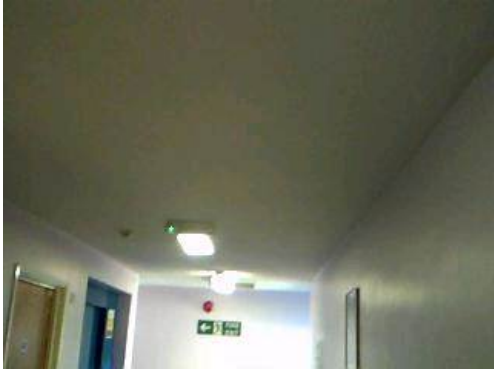
FLOOR/LOCATION:	2nd Floor corridor 203

DESCRIPTION:	Textured coating to ceiling	
RECOMMENDATIONS:	Manage, monitor and inform maintenance personnel prior to relevant works	
EXTENT:	10 - 50 m² or 10 - 50m pipe run	
SAMPLE REF:	SPST DU000297	
RESULT:	Chrysotile

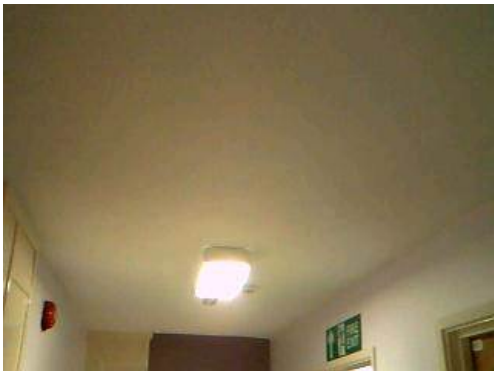
FLOOR/LOCATION:	2nd Floor corridor 204

DESCRIPTION:	Textured coating to ceiling	
RECOMMENDATIONS:	Manage, monitor and inform maintenance personnel prior to relevant works	
EXTENT:	<10m² or <10m pipe run	
SAMPLE REF:	SPST DU000297	
RESULT:	Chrysotile

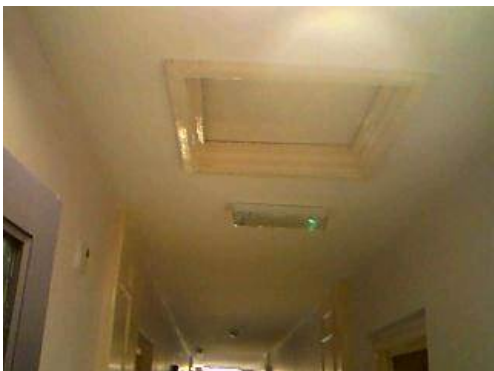
FLOOR/LOCATION:	2nd Floor corridor 205

DESCRIPTION:	Textured coating to ceiling	
RECOMMENDATIONS:	Manage, monitor and inform maintenance personnel prior to relevant works	
EXTENT:	10 - 50 m² or 10 - 50m pipe run	
SAMPLE REF:	SPST DU000297	
RESULT:	Chrysotile

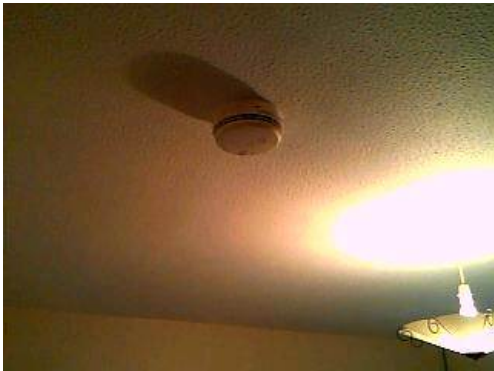
FLOOR/LOCATION:	2nd Floor guest room 206

DESCRIPTION:	Textured coating to ceiling	
RECOMMENDATIONS:	Manage, monitor and inform maintenance personnel prior to relevant works	
EXTENT:	<10m² or <10m pipe run	
SAMPLE REF:	SPST DU000297	
RESULT:	Chrysotile

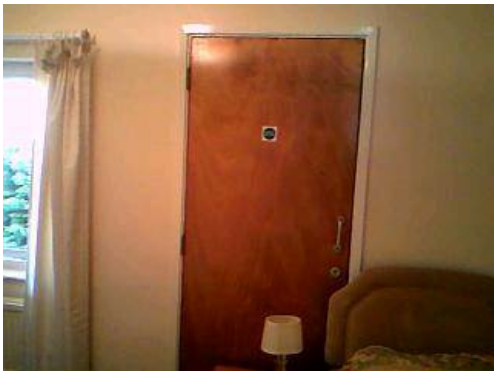
FLOOR/LOCATION:	2nd Floor cupboard 207

DESCRIPTION:	Inaccessible	
RECOMMENDATIONS:	Conduct further investigation prior to relevant works	
EXTENT:		
SAMPLE REF:	Presumed	
RESULT:	Presumed

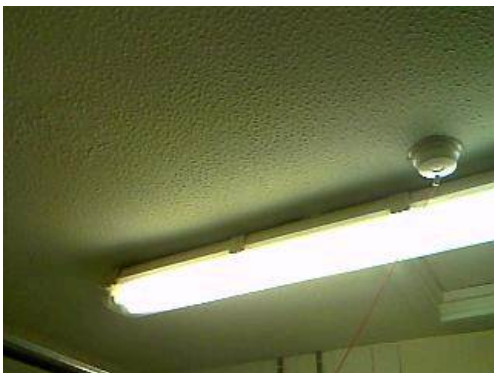
FLOOR/LOCATION:	2nd Floor Bathroom 208

DESCRIPTION:	Textured coating to ceiling	
RECOMMENDATIONS:	Manage, monitor and inform maintenance personnel prior to relevant works	
EXTENT:	<10m² or <10m pipe run	
SAMPLE REF:	SPST DU000297	
RESULT:	Chrysotile

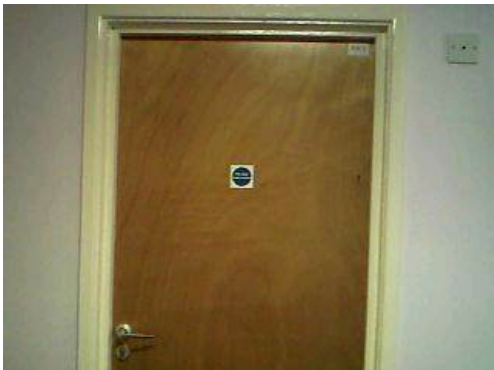
FLOOR/LOCATION:	2nd Floor store cupboard 209

DESCRIPTION:	Inaccessible	
RECOMMENDATIONS:	Conduct further investigation prior to relevant works	
EXTENT:		
SAMPLE REF:	Presumed	
RESULT:	Presumed

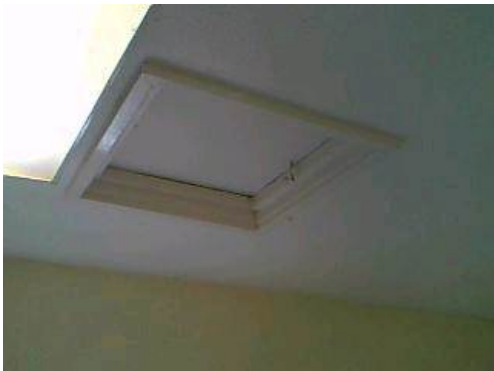
FLOOR/LOCATION:	Roof Void a008

DESCRIPTION:	Inaccessible	
RECOMMENDATIONS:	Conduct further investigation prior to relevant works	
EXTENT:		
SAMPLE REF:	Presumed	
RESULT:	Presumed

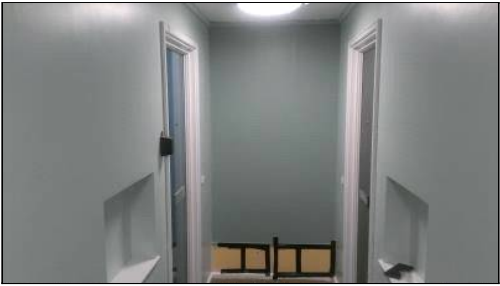
Survey Date:	Lead Surveyor	Survey Type	Floor	Analysis
	12 Mar 2020	Chris Goodman	Refurbishment Survey	Ground	No Asbestos Detected (0)
	Building	Room	Item	Quantity	
	Block 38-41	Corridor G01	Insulating board panel to stud wall at end of corridor between flats 38 & 39, with non-suspect void containing bare copper pipework and plastered block walls beyond.	5m ²	
	Sample No (S,SP,P,As)	Product Type	Surface Treatment	Condition	Accessibility
	AS001530 (S)	Insulating Board (0)	Unsealed (2)	High Damage (3)	Easily disturbed (2)

Normal Occupancy	Score	Likelihood of disturbance	Score	Exposure Potential	Score	Maintenance Activity	Score
Main type of activity	N/A	Location	N/A	Number of occupants	N/A	Type of Maintenance	N/A
		Accessibility	N/A	Frequency of use	N/A	Frequency of maintenance	N/A
		Amount	N/A	Average Time	N/A		
Average Score	N/A	Average Score	N/A	Average Score	N/A	Average Score	N/A
Average of Priority	N/A						
Material Assessment Score	N/A						
Recommendation	No further action required						
Surveyor comments	N/A

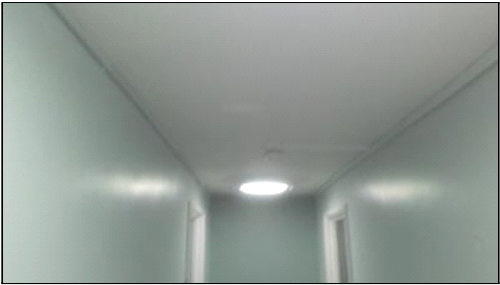
Survey Date:	Lead Surveyor	Survey Type	Floor	Analysis
	12 Mar 2020	Chris Goodman	Refurbishment Survey	Ground	Chrysotile (1)
	Building	Room	Item	Quantity	
	Block 38-41	Corridor G01	Textured coating to fixed plasterboard ceiling.	8m ²	
	Sample No (S,SP,P,As)	Product Type	Surface Treatment	Condition	Accessibility
	AS001531 (S)	Textured Coating (1)	Completely Sealed (0)	Good Condition (0)	Occasionally likely to be disturbed (1)

Normal Occupancy	Score	Likelihood of disturbance	Score	Exposure Potential	Score	Maintenance Activity	Score
Main type of activity	1	Location	2	Number of occupants	1	Type of Maintenance	1
		Accessibility	1	Frequency of use	3	Frequency of maintenance	1
		Amount	1	Average Time	0		
Average Score	1	Average Score	2	Average Score	2	Average Score	1
Average of Priority	6						
Material Assessment Score	2						
Recommendation	Manage in-situ or remove if affected by works						
Surveyor comments	N/A

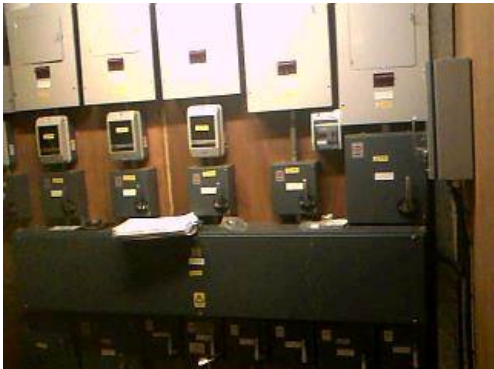
FLOOR/LOCATION:	Ground Floor Electrical Switchboard Room

DESCRIPTION:	Presumed asbestos containing materials within live electrical switch gear	
RECOMMENDATIONS:	Conduct further investigation prior to relevant maintenance / refurbishment works	
EXTENT:	<10m² or <10m pipe run	
SAMPLE REF:	Presumed	
RESULT:	Presumed Crocidolite (or unknown)

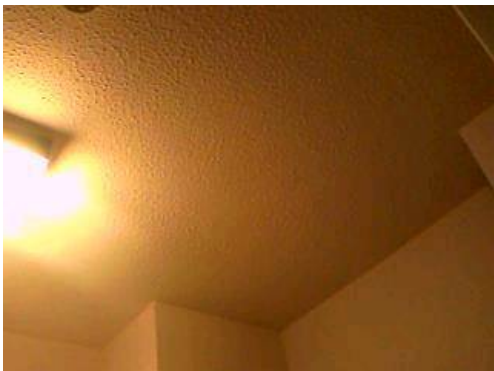
FLOOR/LOCATION:	2nd Floor Store Room adjacent to Flat 24

DESCRIPTION:	Textured coating to ceiling	
RECOMMENDATIONS:	Manage, label, monitor and inform maintenance personnel prior to relevant works	
EXTENT:	<10m² or <10m pipe run	
SAMPLE REF:	EE002869	
RESULT:	Chrysotile

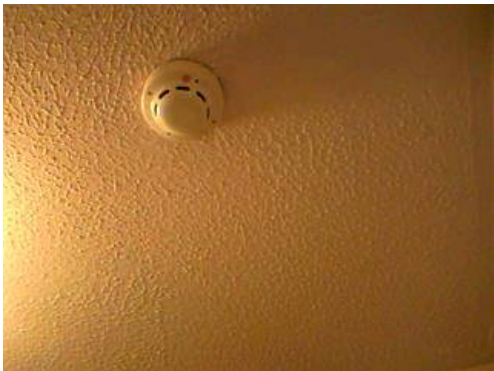
FLOOR/LOCATION:	2nd Floor Telephone / CCTV Room

DESCRIPTION:	Textured coating to ceiling	
RECOMMENDATIONS:	Manage, label, monitor and inform maintenance personnel prior to relevant works	
EXTENT:	<10m² or <10m pipe run	
SAMPLE REF:	EE002873	
RESULT:	Chrysotile

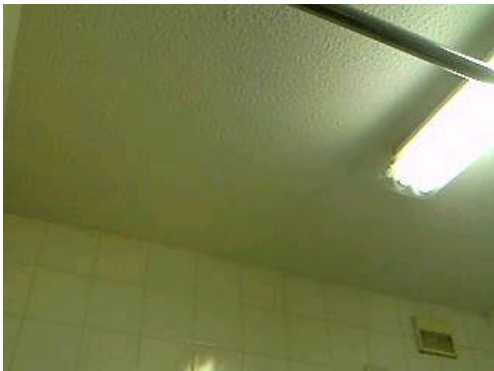
FLOOR/LOCATION:	2nd Floor Wet Room (201)

DESCRIPTION:	Textured coating to ceiling	
RECOMMENDATIONS:	Remove under controlled conditions	
EXTENT:	<10m² or <10m pipe run	
SAMPLE REF:	EE001816	
RESULT:	Chrysotile

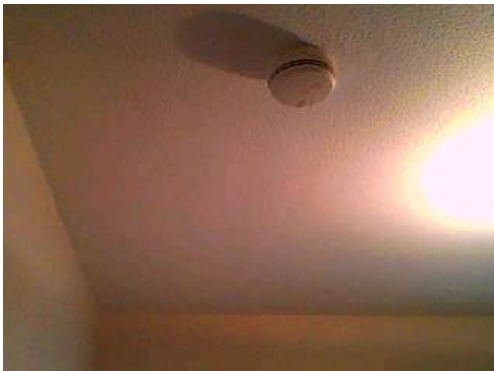
FLOOR/LOCATION:	2nd Floor Guest Room (202)

DESCRIPTION:	Textured coating to ceiling	
RECOMMENDATIONS:	Remove under controlled conditions	
EXTENT:	<10m² or <10m pipe run	
SAMPLE REF:	EE001818	
RESULT:	Chrysotile
