## Management with Targeted Refurbishment Survey to Shower Room

1 Ty Ddewi  
St Davids Close  
Pentre  
Rhondda  
CF41 7BG  
UPRN: 6477

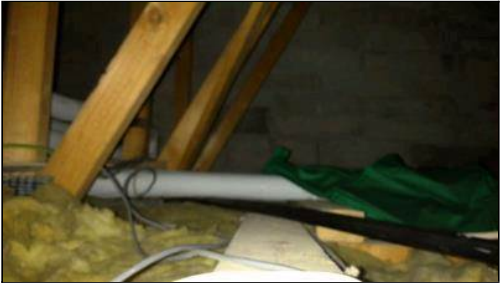
| | Survey Date: | Lead Surveyor | Survey Type | Floor | Analysis |
|---|---|---|---|---|---|
| | 29 Jul 2016 to 30 Jul 2016 | Sebastian Lawniczak | Management Survey | Roof | N/A |
| | Sample No (S,SP,P,As) | Product Type | Surface Treatment | Condition | Accessibility |

| Normal Occupancy | Score | Likelihood of disturbance | Score | Exposure Potential | Score | Maintenance Activity | Score |
|---|---|---|---|---|---|---|---|
| Recommendation | No further action required | | | | | | |

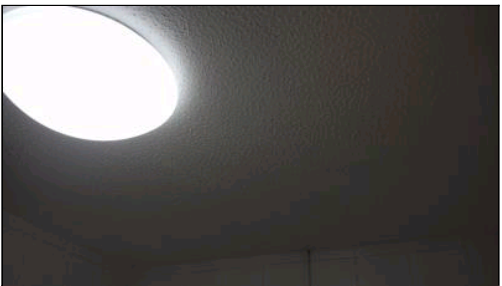
| | Survey Date: | Lead Surveyor | Survey Type | Floor | Analysis |
|---|---|---|---|---|---|
| | 29 Jul 2016 to 30 Jul 2016 | Sebastian Lawniczak | Refurbishment and Demolition Survey | Ground | Chrysotile (1) |
| | AE001637 (S) | Textured Coating (1) | Completely Sealed (0) | Good Condition (0) | Occasionally likely to be disturbed (1) |

| Normal Occupancy | Score | Likelihood of disturbance | Score | Exposure Potential | Score | Maintenance Activity | Score |
|---|---|---|---|---|---|---|---|
| Recommendation | Manage In-situ or removed if affected by works | | | | | | |

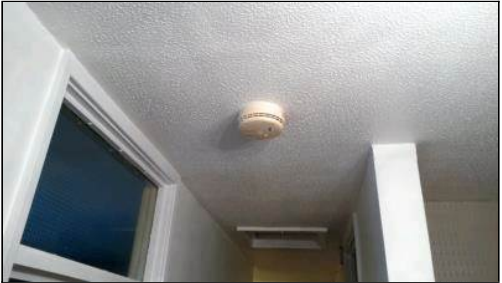
| | 29 Jul 2016 to 30 Jul 2016 | Sebastian Lawniczak | Management Survey | Ground | Chrysotile (1) |
| | As AE001637 (SP) | Textured Coating (1) | Completely Sealed (0) | Good Condition (0) | Occasionally likely to be disturbed (1) |

| Recommendation | Manage and re-inspect | | | | | | |

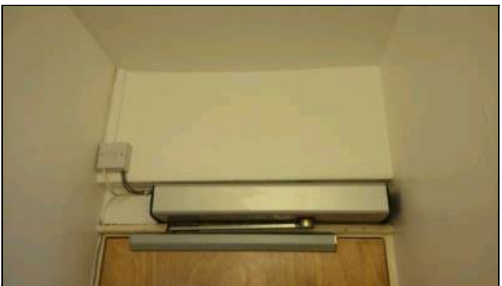
| | Survey Date: | Lead Surveyor | Survey Type | Floor | Analysis |
|---|---|---|---|---|---|
| | 29 Jul 2016 to 30 Jul 2016 | Sebastian Lawniczak | Management Survey | Ground | No Asbestos Detected (0) |
| | AE001638 (S) | Insulation board (2) | Surface Sealed (1) | Good Condition (0) | Occasionally likely to be disturbed (1) |

| Normal Occupancy | Score | Likelihood of disturbance | Score | Exposure Potential | Score | Maintenance Activity | Score |
|---|---|---|---|---|---|---|---|
| Recommendation | No further action required | | | | | | |

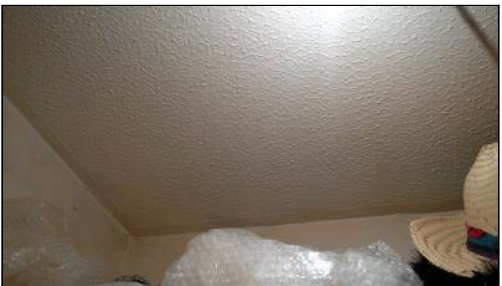
| | Survey Date: | Lead Surveyor | Survey Type | Floor | Analysis |
|---|---|---|---|---|---|
| | 29 Jul 2016 to 30 Jul 2016 | Sebastian Lawniczak | Management Survey | Ground | Chrysotile (1) |
| | As AE001637 (SP) | Textured Coating (1) | Completely Sealed (0) | Good Condition (0) | Occasionally likely to be disturbed (1) |

| Normal Occupancy | Score | Likelihood of disturbance | Score | Exposure Potential | Score | Maintenance Activity | Score |
|---|---|---|---|---|---|---|---|
| Recommendation | Manage and re-inspect | | | | | | |

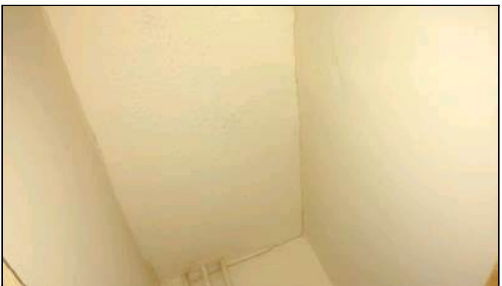
| | 29 Jul 2016 to 30 Jul 2016 | Sebastian Lawniczak | Management Survey | Ground | Chrysotile (1) |
| | As AE001637 (SP) | Textured Coating (1) | Completely Sealed (0) | Good Condition (0) | Occasionally likely to be disturbed (1) |

| Recommendation | Manage and re-inspect | | | | | | |

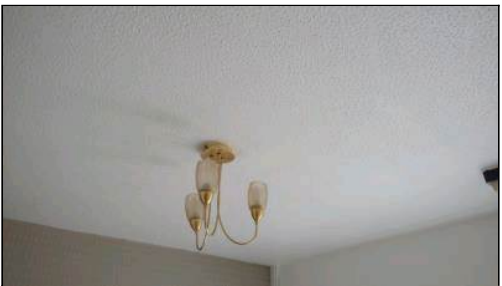
| | 29 Jul 2016 to 30 Jul 2016 | Sebastian Lawniczak | Management Survey | Ground | Chrysotile (1) |
| | As AE001637 (SP) | Textured Coating (1) | Completely Sealed (0) | Good Condition (0) | Occasionally likely to be disturbed (1) |

| Recommendation | Manage and re-inspect | | | | | | |

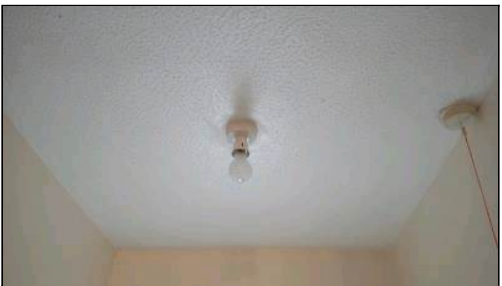
| | Survey Date: | Lead Surveyor | Survey Type | Floor | Analysis |
|---|---|---|---|---|---|
| | 29 Jul 2016 to 30 Jul 2016 | Sebastian Lawniczak | Management Survey | Ground | Chrysotile (1) |
| | As AE001637 (SP) | Textured Coating (1) | Completely Sealed (0) | Good Condition (0) | Occasionally likely to be disturbed (1) |

| Normal Occupancy | Score | Likelihood of disturbance | Score | Exposure Potential | Score | Maintenance Activity | Score |
|---|---|---|---|---|---|---|---|
| Recommendation | Manage and re-inspect | | | | | | |

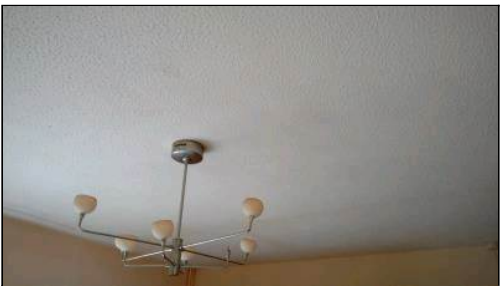
| | 29 Jul 2016 to 30 Jul 2016 | Sebastian Lawniczak | Management Survey | Ground | Chrysotile (1) |
| | As AE001637 (SP) | Textured Coating (1) | Completely Sealed (0) | Good Condition (0) | Occasionally likely to be disturbed (1) |

| Normal Occupancy | Score | Likelihood of disturbance | Score | Exposure Potential | Score | Maintenance Activity | Score |
|---|---|---|---|---|---|---|---|
| Recommendation | Manage and re-inspect | | | | | | |

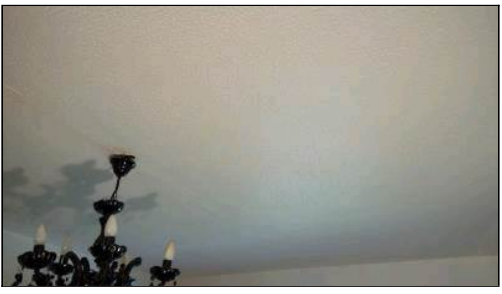
| | Survey Date: | Lead Surveyor | Survey Type | Floor | Analysis |
|---|---|---|---|---|---|
| | 29 Jul 2016 to 30 Jul 2016 | Sebastian Lawniczak | Management Survey | Ground | Chrysotile (1) |
| | AE001639 (S) | Textured Coating (1) | Completely Sealed (0) | Good Condition (0) | Occasionally likely to be disturbed (1) |

| Normal Occupancy | Score | Likelihood of disturbance | Score | Exposure Potential | Score | Maintenance Activity | Score |
|---|---|---|---|---|---|---|---|
| Recommendation | Manage and re-inspect | | | | | | |

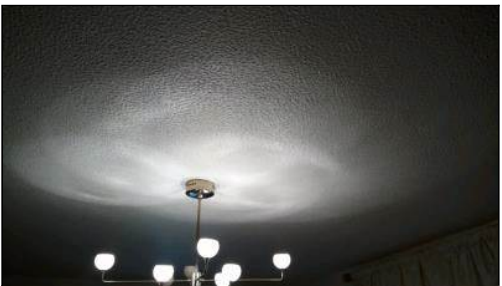
| | 29 Jul 2016 to 30 Jul 2016 | Sebastian Lawniczak | Management Survey | Ground | Chrysotile (1) |
| | As AE001639 (SP) | Textured Coating (1) | Completely Sealed (0) | Good Condition (0) | Occasionally likely to be disturbed (1) |

| Recommendation | Manage and re-inspect | | | | | | |

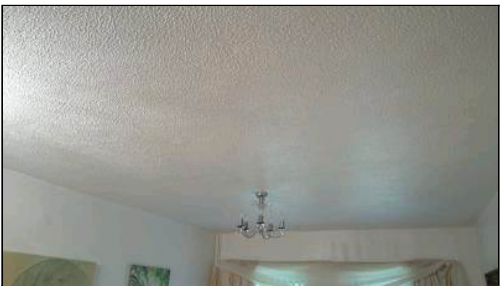
| | 29 Jul 2016 to 30 Jul 2016 | Sebastian Lawniczak | Management Survey | Ground | Chrysotile (1) |
| | As AE001639 (SP) | Textured Coating (1) | Completely Sealed (0) | Good Condition (0) | Occasionally likely to be disturbed (1) |

| Recommendation | Manage and re-inspect | | | | | | |
