## Management with Targeted Refurbishment Survey to Wet Room

5 Ty Ddewi  
St Davids Close  
Pentre  
Rhondda  
CF41 7BG  
UPRN: 6481

| Type of survey: | Management Survey with part Refurbishment/Demolition (MA and PA) | | |

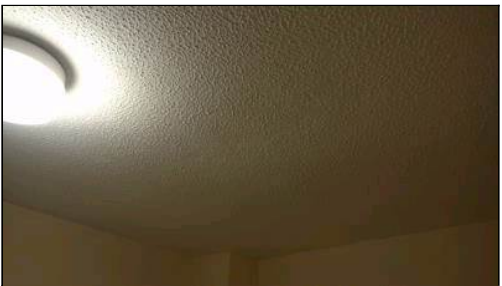
| | Survey Date: | Lead Surveyor | Survey Type | Floor | Analysis |
| | 29 Jul 2016 to 30 Jul 2016 | Sebastian Lawniczak | Management Survey | Ground | Chrysotile (1) |
| | AE001640 (S) | Textured Coating (1) | Completely Sealed (0) | Good Condition (0) | Occasionally likely to be disturbed (1) |

| Normal Occupancy | Score | Likelihood of disturbance | Score | Exposure Potential | Score | Maintenance Activity | Score |
|---|---|---|---|---|---|---|---|
| Recommendation | Manage In-situ or removed if affected by works | | | | | | |

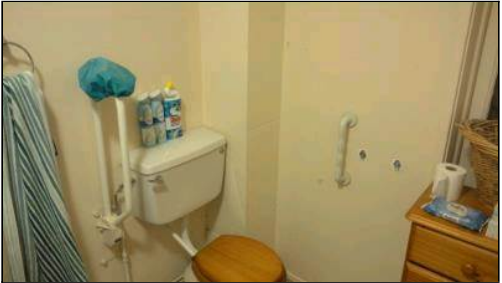
| | Survey Date: | Lead Surveyor | Survey Type | Floor | Analysis |
| | 29 Jul 2016 to 30 Jul 2016 | Sebastian Lawniczak | Management Survey | Ground | No Asbestos Detected (0) |
| | AE001641 (S) | Insulation board (2) | Surface Sealed (1) | Good Condition (0) | Easily disturbed (2) |

| Normal Occupancy | Score | Likelihood of disturbance | Score | Exposure Potential | Score | Maintenance Activity | Score |
|---|---|---|---|---|---|---|---|
| Recommendation | No further action required | | | | | | |

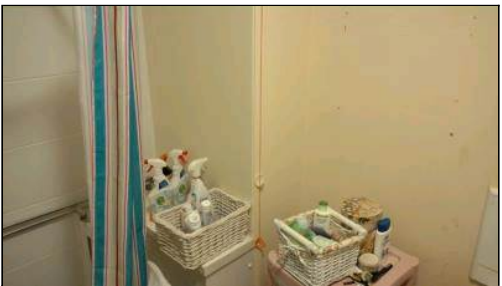
| | Survey Date: | Lead Surveyor | Survey Type | Floor | Analysis |
| | 29 Jul 2016 to 30 Jul 2016 | Sebastian Lawniczak | Management Survey | Ground | No Asbestos Detected (0) |
| | As AE001641 (SP) | Insulation board (2) | Surface Sealed (1) | Good Condition (0) | Easily disturbed (2) |

| Recommendation | No further action required | | | | | | |

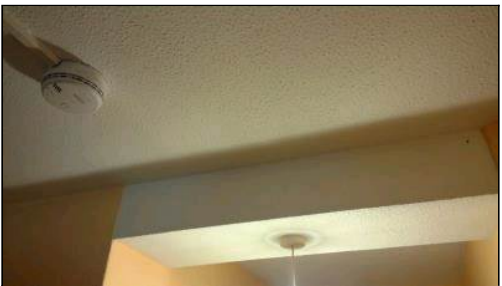
| | Survey Date: | Lead Surveyor | Survey Type | Floor | Analysis |
| | 29 Jul 2016 to 30 Jul 2016 | Sebastian Lawniczak | Management Survey | Ground | Chrysotile (1) |
| | As AE001640 (SP) | Textured Coating (1) | Completely Sealed (0) | Good Condition (0) | Occasionally likely to be disturbed (1) |

| Normal Occupancy | Score | Likelihood of disturbance | Score | Exposure Potential | Score | Maintenance Activity | Score |
|---|---|---|---|---|---|---|---|
| Recommendation | Manage and re-inspect | | | | | | |

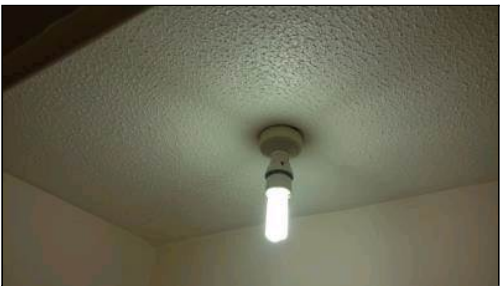
| | Survey Date: | Lead Surveyor | Survey Type | Floor | Analysis |
| | 29 Jul 2016 to 30 Jul 2016 | Sebastian Lawniczak | Management Survey | Ground | Chrysotile (1) |
| | As AE001640 (SP) | Textured Coating (1) | Completely Sealed (0) | Good Condition (0) | Occasionally likely to be disturbed (1) |

| Normal Occupancy | Score | Likelihood of disturbance | Score | Exposure Potential | Score | Maintenance Activity | Score |
|---|---|---|---|---|---|---|---|
| Recommendation | Manage and re-inspect | | | | | | |

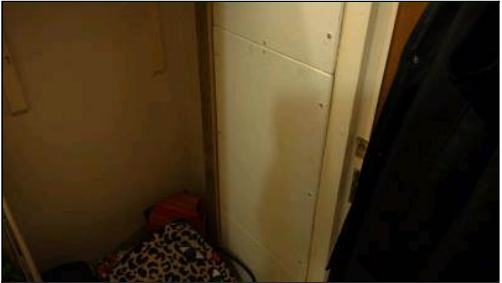
| | Survey Date: | Lead Surveyor | Survey Type | Floor | Analysis |
| | 29 Jul 2016 to 30 Jul 2016 | Sebastian Lawniczak | Management Survey | Ground | No Asbestos Detected (0) |
| | As AE001641 (SP) | Insulation board (2) | Unsealed (2) | Low Damage (1) | Easily disturbed (2) |

| Normal Occupancy | Score | Likelihood of disturbance | Score | Exposure Potential | Score | Maintenance Activity | Score |
|---|---|---|---|---|---|---|---|
| Recommendation | No further action required | | | | | | |

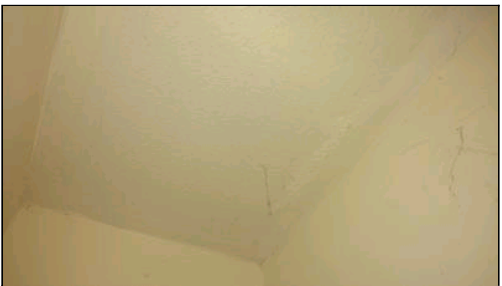
| | Survey Date: | Lead Surveyor | Survey Type | Floor | Analysis |
| | 29 Jul 2016 to 30 Jul 2016 | Sebastian Lawniczak | Management Survey | Ground | Chrysotile (1) |
| | As AE001640 (SP) | Textured Coating (1) | Completely Sealed (0) | Good Condition (0) | Occasionally likely to be disturbed (1) |

| Normal Occupancy | Score | Likelihood of disturbance | Score | Exposure Potential | Score | Maintenance Activity | Score |
|---|---|---|---|---|---|---|---|
| Recommendation | Manage and re-inspect | | | | | | |

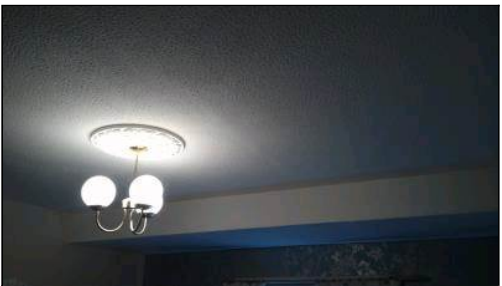
| | Survey Date: | Lead Surveyor | Survey Type | Floor | Analysis |
| | 29 Jul 2016 to 30 Jul 2016 | Sebastian Lawniczak | Management Survey | Ground | Chrysotile (1) |
| | As AE001640 (SP) | Textured Coating (1) | Completely Sealed (0) | Low Damage (1) | Occasionally likely to be disturbed (1) |

| Normal Occupancy | Score | Likelihood of disturbance | Score | Exposure Potential | Score | Maintenance Activity | Score |
|---|---|---|---|---|---|---|---|
| Recommendation | Encapsulate or repair | | | | | | |

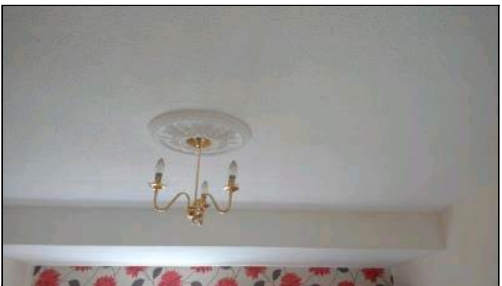
| | Survey Date: | Lead Surveyor | Survey Type | Floor | Analysis |
| | 29 Jul 2016 to 30 Jul 2016 | Sebastian Lawniczak | Management Survey | Ground | Chrysotile (1) |
| | As AE001640 (SP) | Textured Coating (1) | Completely Sealed (0) | Good Condition (0) | Occasionally likely to be disturbed (1) |

| Normal Occupancy | Score | Likelihood of disturbance | Score | Exposure Potential | Score | Maintenance Activity | Score |
|---|---|---|---|---|---|---|---|
| Recommendation | Manage and re-inspect | | | | | | |

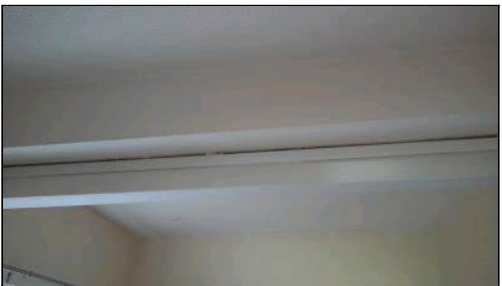
| | Survey Date: | Lead Surveyor | Survey Type | Floor | Analysis |
| | 29 Jul 2016 to 30 Jul 2016 | Sebastian Lawniczak | Management Survey | Ground | Chrysotile (1) |
| | As AE001640 (SP) | Textured Coating (1) | Completely Sealed (0) | Good Condition (0) | Occasionally likely to be disturbed (1) |

| Normal Occupancy | Score | Likelihood of disturbance | Score | Exposure Potential | Score | Maintenance Activity | Score |
|---|---|---|---|---|---|---|---|
| Recommendation | Manage and re-inspect | | | | | | |
