## Management with Targeted Refurbishment Survey to Wet Room

30 Ty Ddewi  
St Davids Close  
Pentre  
Rhondda  
CF41 7BG  
UPRN: 6506

| Type of survey: | Management Survey with part Refurbishment/Demolition (MA and PA) | | |

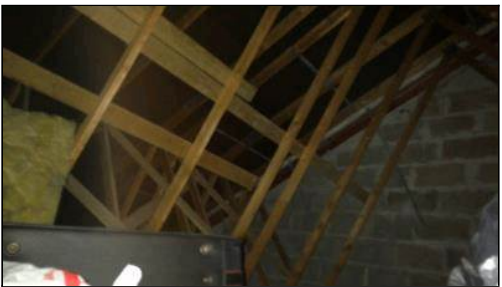
| | Survey Date: | Lead Surveyor | Survey Type | Floor | Analysis |
|---|---|---|---|---|---|
| | 29 Jul 2016 to 30 Jul 2016 | Sebastian Lawniczak | Management Survey | Roof | N/A |

| Normal Occupancy | Score | Likelihood of disturbance | Score | Exposure Potential | Score | Maintenance Activity | Score |
|---|---|---|---|---|---|---|---|
| Recommendation | No further action required | | | | | | |

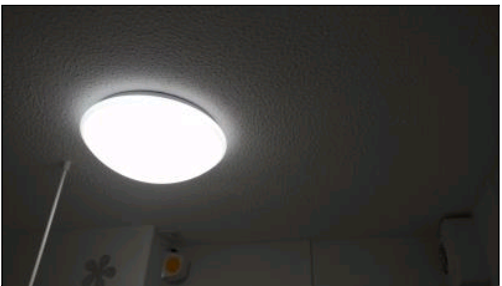
| | 29 Jul 2016 to 30 Jul 2016 | Sebastian Lawniczak | Refurbishment and Demolition Survey | 2nd | Chrysotile (1) |
| | AE001642 (S) | Textured Coating (1) | Completely Sealed (0) | Good Condition (0) | Occasionally likely to be disturbed (1) |

| Recommendation | Manage In-situ or removed if affected by works | | | | | | |

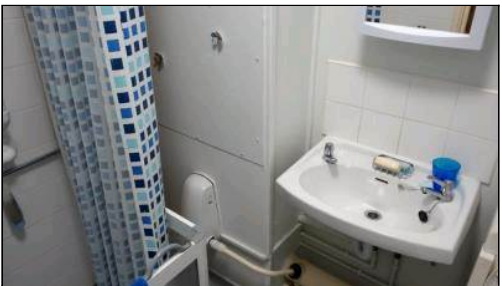
| | 29 Jul 2016 to 30 Jul 2016 | Sebastian Lawniczak | Refurbishment and Demolition Survey | 2nd | No Asbestos Detected (0) |
| | AE001643 (S) | Insulation board (2) | Unsealed (2) | Low Damage (1) | Easily disturbed (2) |

| Recommendation | No further action required | | | | | | |

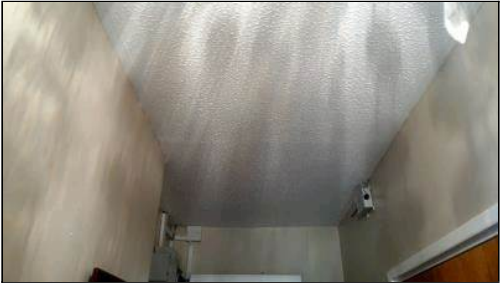
| | Survey Date: | Lead Surveyor | Survey Type | Floor | Analysis |
|---|---|---|---|---|---|
| | 29 Jul 2016 to 30 Jul 2016 | Sebastian Lawniczak | Management Survey | 2nd | Chrysotile (1) |
| | As AE001642 (SP) | Textured Coating (1) | Completely Sealed (0) | Good Condition (0) | Occasionally likely to be disturbed (1) |

| Normal Occupancy | Score | Likelihood of disturbance | Score | Exposure Potential | Score | Maintenance Activity | Score |
|---|---|---|---|---|---|---|---|
| Recommendation | Manage and re-inspect | | | | | | |

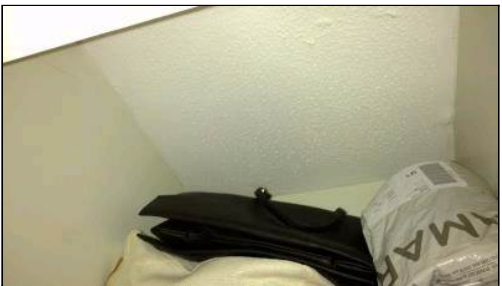
| | 29 Jul 2016 to 30 Jul 2016 | Sebastian Lawniczak | Management Survey | 2nd | Chrysotile (1) |
| | As AE001642 (SP) | Textured Coating (1) | Completely Sealed (0) | Good Condition (0) | Occasionally likely to be disturbed (1) |

| Recommendation | Manage and re-inspect | | | | | | |

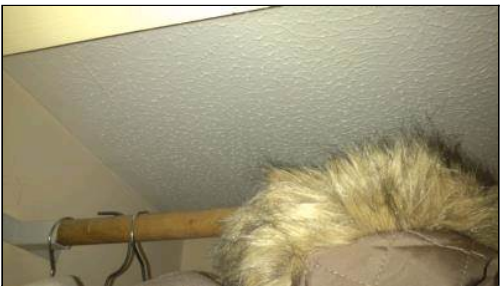
| | 29 Jul 2016 to 30 Jul 2016 | Sebastian Lawniczak | Management Survey | 2nd | Chrysotile (1) |
| | As AE001642 (SP) | Textured Coating (1) | Completely Sealed (0) | Good Condition (0) | Occasionally likely to be disturbed (1) |

| Recommendation | Manage and re-inspect | | | | | | |

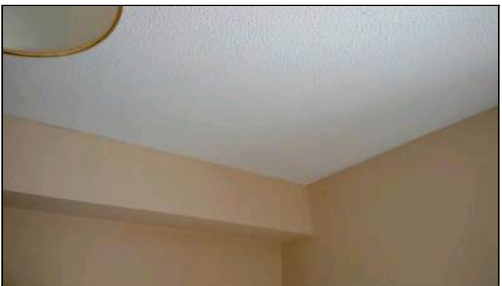
| | Survey Date: | Lead Surveyor | Survey Type | Floor | Analysis |
|---|---|---|---|---|---|
| | 29 Jul 2016 to 30 Jul 2016 | Sebastian Lawniczak | Management Survey | 2nd | Chrysotile (1) |
| | As AE001642 (SP) | Textured Coating (1) | Completely Sealed (0) | Good Condition (0) | Occasionally likely to be disturbed (1) |

| Normal Occupancy | Score | Likelihood of disturbance | Score | Exposure Potential | Score | Maintenance Activity | Score |
|---|---|---|---|---|---|---|---|
| Recommendation | Manage and re-inspect | | | | | | |

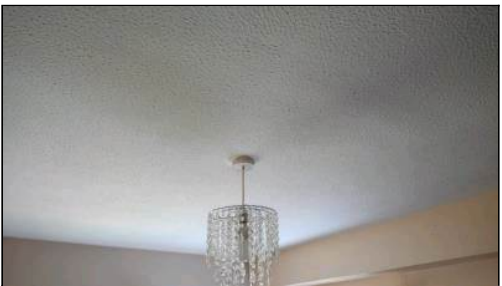
| | Survey Date: | Lead Surveyor | Survey Type | Floor | Analysis |
|---|---|---|---|---|---|
| | 29 Jul 2016 to 30 Jul 2016 | Sebastian Lawniczak | Management Survey | 2nd | Chrysotile (1) |
| | As AE001642 (SP) | Textured Coating (1) | Completely Sealed (0) | Good Condition (0) | Occasionally likely to be disturbed (1) |

| Normal Occupancy | Score | Likelihood of disturbance | Score | Exposure Potential | Score | Maintenance Activity | Score |
|---|---|---|---|---|---|---|---|
| Recommendation | Manage and re-inspect | | | | | | |

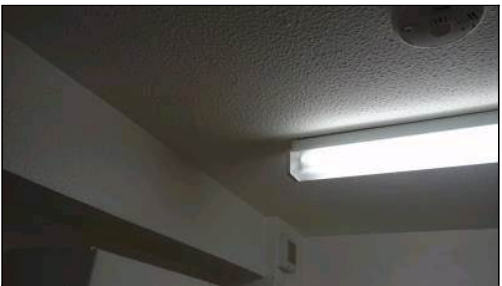
| | Survey Date: | Lead Surveyor | Survey Type | Floor | Analysis |
|---|---|---|---|---|---|
| | 29 Jul 2016 to 30 Jul 2016 | Sebastian Lawniczak | Management Survey | 2nd | Chrysotile (1) |
| | As AE001642 (SP) | Textured Coating (1) | Completely Sealed (0) | Good Condition (0) | Occasionally likely to be disturbed (1) |

| Normal Occupancy | Score | Likelihood of disturbance | Score | Exposure Potential | Score | Maintenance Activity | Score |
|---|---|---|---|---|---|---|---|
| Recommendation | Manage and re-inspect | | | | | | |

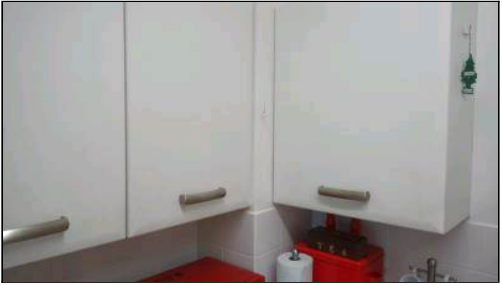
| | Survey Date: | Lead Surveyor | Survey Type | Floor | Analysis |
|---|---|---|---|---|---|
| | 29 Jul 2016 to 30 Jul 2016 | Sebastian Lawniczak | Management Survey | 2nd | No Asbestos Detected (0) |
| | As AE001643 (SP) | Insulation board (2) | Surface Sealed (1) | Good Condition (0) | Easily disturbed (2) |

| Normal Occupancy | Score | Likelihood of disturbance | Score | Exposure Potential | Score | Maintenance Activity | Score |
|---|---|---|---|---|---|---|---|
| Recommendation | No further action required | | | | | | |
