# Management with Targeted Refurbishment Survey to Wet Room

31 Ty Ddewi  
St Davids Close  
Pentre  
Rhondda  
CF41 7BG  
UPRN: 6507

Report issue date:	15 Aug 2016

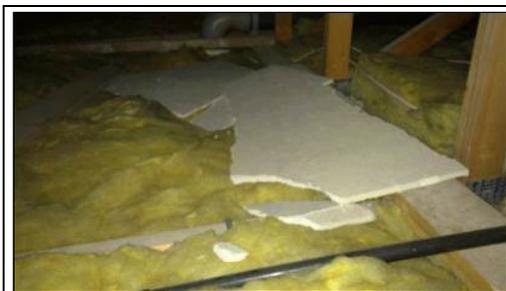
Survey Date:	Lead Surveyor	Survey Type	Floor	Analysis
29 Jul 2016 to 30 Jul 2016	Sebastian Lawniczak	Management Survey	Roof	No Asbestos Detected (0)
Building	Room	Item	Quantity	
Block 1-35. Flat 31.	Loft Space R01	Insulating board panel debris to floor	6m²	
Sample No (S,SP,P,As)	Product Type	Surface Treatment	Condition	Accessibility
AE001646 (S)	Insulation board (2)	Unsealed (2)	High Damage (3)	Easily disturbed (2)

Normal Occupancy	Score	Likelihood of disturbance	Score	Exposure Potential	Score	Maintenance Activity	Score
Main type of activity	N/A	Location	N/A	Number of occupants	N/A	Type of Maintenance	N/A
		Accessibility	N/A	Frequency of use	N/A	Frequency of maintenance	N/A
		Amount	N/A	Average Time	N/A		
Average Score	N/A	Average Score	N/A	Average Score	N/A	Average Score	N/A
Average of Priority	N/A						
Material Assessment Score	N/A						
Recommendation	No further action required						
Surveyor comments	N/A

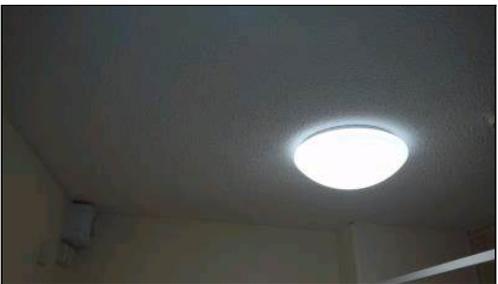
<b>Survey Date:</b>	<b>Lead Surveyor</b>	<b>Survey Type</b>	<b>Floor</b>	<b>Analysis</b>
	29 Jul 2016 to 30 Jul 2016	Sebastian Lawniczak	Refurbishment and Demolition Survey	2nd	
	<b>Building</b>	<b>Room</b>	<b>Item</b>	<b>Quantity</b>	
	Block 1-35. Flat 31.	Wet Room 201	Textured coating to plasterboard ceiling	4m <sup>2</sup>	
	<b>Sample No (S,SP,P,As)</b>	<b>Product Type</b>	<b>Surface Treatment</b>	<b>Condition</b>	<b>Accessibility</b>
AE001644 (S)	Textured Coating (1)	Completely Sealed (0)	Good Condition (0)	Occasionally likely to be disturbed (1)

Normal Occupancy	Score	Likelihood of disturbance	Score	Exposure Potential	Score	Maintenance Activity	Score
Main type of activity	1	Location	2	Number of occupants	1	Type of Maintenance	0
		Accessibility	1	Frequency of use	3	Frequency of maintenance	0
		Amount	1	Average Time	1		
Average Score	1	Average Score	2	Average Score	2	Average Score	0
Average of Priority	<b>5</b>						
Material Assessment Score	<b>2</b>						
Recommendation	<b>Manage In-situ or removed if affected by works</b>						
Surveyor comments	<b>N/A</b>

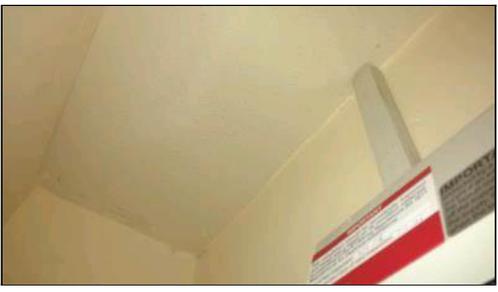
<b>Survey Date:</b>	<b>Lead Surveyor</b>	<b>Survey Type</b>	<b>Floor</b>	<b>Analysis</b>
	29 Jul 2016 to 30 Jul 2016	Sebastian Lawniczak	Management Survey	2nd	Chrysotile (1)
	<b>Building</b>	<b>Room</b>	<b>Item</b>	<b>Quantity</b>	
	Block 1-35. Flat 31.	Store Cupboard 1 202	Textured coating to plasterboard ceiling	1m <sup>2</sup>	
	<b>Sample No (S,SP,P,As)</b>	<b>Product Type</b>	<b>Surface Treatment</b>	<b>Condition</b>	<b>Accessibility</b>
As AE001644 (SP)	Textured Coating (1)	Completely Sealed (0)	Good Condition (0)	Occasionally likely to be disturbed (1)

Normal Occupancy	Score	Likelihood of disturbance	Score	Exposure Potential	Score	Maintenance Activity	Score
Main type of activity	0	Location	2	Number of occupants	1	Type of Maintenance	0
		Accessibility	1	Frequency of use	2	Frequency of maintenance	0
		Amount	1	Average Time	0		
Average Score	0	Average Score	2	Average Score	1	Average Score	0
Average of Priority	<b>3</b>						
Material Assessment Score	<b>2</b>						
Recommendation	<b>Manage and re-inspect</b>						
Surveyor comments	<b>N/A</b>

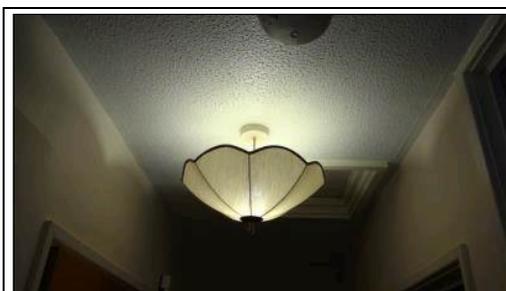
Survey Date:	Lead Surveyor	Survey Type	Floor	Analysis
29 Jul 2016 to 30 Jul 2016	Sebastian Lawniczak	Management Survey	2nd	Chrysotile (1)
Building	Room	Item	Quantity	
Block 1-35. Flat 31.	Hallway 203	Textured coating to plasterboard ceiling	3m <sup>2</sup>	
Sample No (S,SP,P,As)	Product Type	Surface Treatment	Condition	Accessibility
As AE001644 (SP)	Textured Coating (1)	Completely Sealed (0)	Good Condition (0)	Occasionally likely to be disturbed (1)

Normal Occupancy	Score	Likelihood of disturbance	Score	Exposure Potential	Score	Maintenance Activity	Score
Main type of activity	1	Location	2	Number of occupants	1	Type of Maintenance	0
		Accessibility	1	Frequency of use	3	Frequency of maintenance	0
		Amount	1	Average Time	1		
Average Score	1	Average Score	2	Average Score	2	Average Score	0
Average of Priority	<b>5</b>						
Material Assessment Score	<b>2</b>						
Recommendation	<b>Manage and re-inspect</b>						
Surveyor comments	<b>N/A</b>

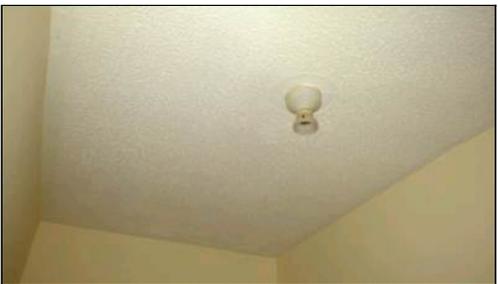
<b>Survey Date:</b>	<b>Lead Surveyor</b>	<b>Survey Type</b>	<b>Floor</b>	<b>Analysis</b>
	29 Jul 2016 to 30 Jul 2016	Sebastian Lawniczak	Management Survey	2nd	Chrysotile (1)
	<b>Building</b>	<b>Room</b>	<b>Item</b>	<b>Quantity</b>	
	Block 1-35. Flat 31.	Store Cupboard 2 204	Textured coating to plasterboard ceiling	2m <sup>2</sup>	
	<b>Sample No (S,SP,P,As)</b>	<b>Product Type</b>	<b>Surface Treatment</b>	<b>Condition</b>	<b>Accessibility</b>
As AE001644 (SP)	Textured Coating (1)	Completely Sealed (0)	Good Condition (0)	Occasionally likely to be disturbed (1)

Normal Occupancy	Score	Likelihood of disturbance	Score	Exposure Potential	Score	Maintenance Activity	Score
Main type of activity	0	Location	2	Number of occupants	1	Type of Maintenance	0
		Accessibility	1	Frequency of use	2	Frequency of maintenance	0
		Amount	1	Average Time	0		
Average Score	0	Average Score	2	Average Score	1	Average Score	0
Average of Priority	<b>3</b>						
Material Assessment Score	<b>2</b>						
Recommendation	<b>Manage and re-inspect</b>						
Surveyor comments	<b>N/A</b>

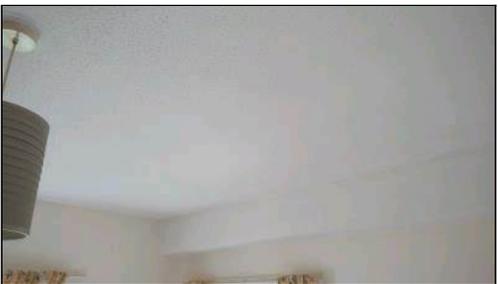
<b>Survey Date:</b>	<b>Lead Surveyor</b>	<b>Survey Type</b>	<b>Floor</b>	<b>Analysis</b>
	29 Jul 2016 to 30 Jul 2016	Sebastian Lawniczak	Management Survey	2nd	Chrysotile (1)
	<b>Building</b>	<b>Room</b>	<b>Item</b>	<b>Quantity</b>	
	Block 1-35. Flat 31.	Bedroom 205	Textured coating to plasterboard ceiling and fixed horizontal boxing to ceiling	9m <sup>2</sup>	
	<b>Sample No (S,SP,P,As)</b>	<b>Product Type</b>	<b>Surface Treatment</b>	<b>Condition</b>	<b>Accessibility</b>
As AE001644 (SP)	Textured Coating (1)	Completely Sealed (0)	Good Condition (0)	Occasionally likely to be disturbed (1)

Normal Occupancy	Score	Likelihood of disturbance	Score	Exposure Potential	Score	Maintenance Activity	Score
Main type of activity	1	Location	2	Number of occupants	1	Type of Maintenance	0
		Accessibility	1	Frequency of use	3	Frequency of maintenance	0
		Amount	1	Average Time	3		
Average Score	1	Average Score	2	Average Score	3	Average Score	0
Average of Priority	<b>6</b>						
Material Assessment Score	<b>2</b>						
Recommendation	<b>Manage and re-inspect</b>						
Surveyor comments	<b>N/A</b>

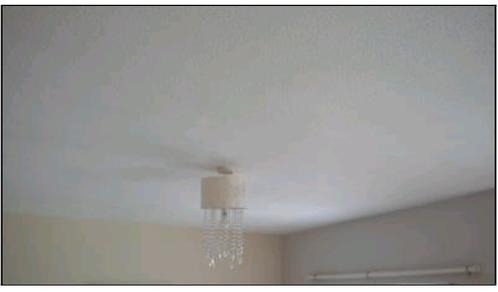
<b>Survey Date:</b>	<b>Lead Surveyor</b>	<b>Survey Type</b>	<b>Floor</b>	<b>Analysis</b>
	29 Jul 2016 to 30 Jul 2016	Sebastian Lawniczak	Management Survey	2nd	Chrysotile (1)
	<b>Building</b>	<b>Room</b>	<b>Item</b>	<b>Quantity</b>	
	Block 1-35. Flat 31.	Living Room 206	Textured coating to plasterboard ceiling	12m <sup>2</sup>	
	<b>Sample No (S,SP,P,As)</b>	<b>Product Type</b>	<b>Surface Treatment</b>	<b>Condition</b>	<b>Accessibility</b>
As AE001644 (SP)	Textured Coating (1)	Completely Sealed (0)	Good Condition (0)	Occasionally likely to be disturbed (1)

Normal Occupancy	Score	Likelihood of disturbance	Score	Exposure Potential	Score	Maintenance Activity	Score
Main type of activity	1	Location	2	Number of occupants	1	Type of Maintenance	0
		Accessibility	1	Frequency of use	3	Frequency of maintenance	0
		Amount	2	Average Time	2		
Average Score	1	Average Score	2	Average Score	2	Average Score	0
Average of Priority	<b>5</b>						
Material Assessment Score	<b>2</b>						
Recommendation	<b>Manage and re-inspect</b>						
Surveyor comments	<b>N/A</b>

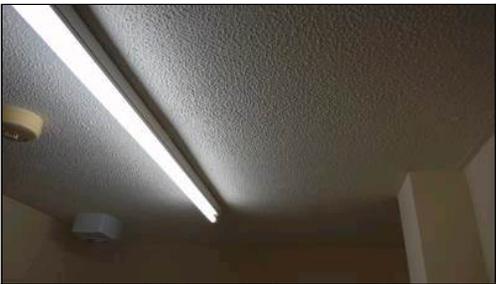
<b>Survey Date:</b>	<b>Lead Surveyor</b>	<b>Survey Type</b>	<b>Floor</b>	<b>Analysis</b>
	29 Jul 2016 to 30 Jul 2016	Sebastian Lawniczak	Management Survey	2nd	Chrysotile (1)
	<b>Building</b>	<b>Room</b>	<b>Item</b>	<b>Quantity</b>	
	Block 1-35. Flat 31.	Kitchen 207	Textured coating to plasterboard ceiling	6m <sup>2</sup>	
	<b>Sample No (S,SP,P,As)</b>	<b>Product Type</b>	<b>Surface Treatment</b>	<b>Condition</b>	<b>Accessibility</b>
As AE001644 (SP)	Textured Coating (1)	Completely Sealed (0)	Good Condition (0)	Occasionally likely to be disturbed (1)

Normal Occupancy	Score	Likelihood of disturbance	Score	Exposure Potential	Score	Maintenance Activity	Score
Main type of activity	1	Location	2	Number of occupants	1	Type of Maintenance	0
		Accessibility	1	Frequency of use	3	Frequency of maintenance	0
		Amount	1	Average Time	1		
Average Score	1	Average Score	2	Average Score	2	Average Score	0
Average of Priority	<b>5</b>						
Material Assessment Score	<b>2</b>						
Recommendation	<b>Manage and re-inspect</b>						
Surveyor comments	<b>N/A</b>

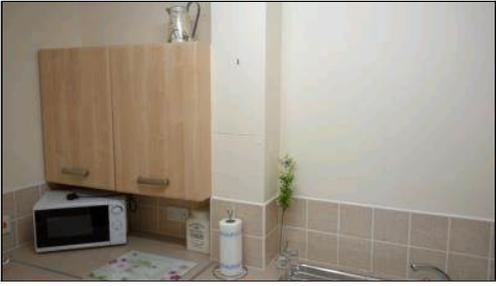
<b>Survey Date:</b>	<b>Lead Surveyor</b>	<b>Survey Type</b>	<b>Floor</b>	<b>Analysis</b>
	29 Jul 2016 to 30 Jul 2016	Sebastian Lawniczak	Management Survey	2nd	No Asbestos Detected (0)
	<b>Building</b>	<b>Room</b>	<b>Item</b>	<b>Quantity</b>	
	Block 1-35. Flat 31.	Kitchen 207	Insulating board panels forming fixed riser boxing	2m <sup>2</sup>	
	<b>Sample No (S,SP,P,As)</b>	<b>Product Type</b>	<b>Surface Treatment</b>	<b>Condition</b>	<b>Accessibility</b>
As AE001645 (SP)	Insulation board (2)	Surface Sealed (1)	Good Condition (0)	Easily disturbed (2)

<b>Normal Occupancy</b>	<b>Score</b>	<b>Likelihood of disturbance</b>	<b>Score</b>	<b>Exposure Potential</b>	<b>Score</b>	<b>Maintenance Activity</b>	<b>Score</b>
<b>Main type of activity</b>	N/A	<b>Location</b>	N/A	<b>Number of occupants</b>	N/A	<b>Type of Maintenance</b>	N/A
		<b>Accessibility</b>	N/A	<b>Frequency of use</b>	N/A	<b>Frequency of maintenance</b>	N/A
		<b>Amount</b>	N/A	<b>Average Time</b>	N/A		
<b>Average Score</b>	N/A	<b>Average Score</b>	N/A	<b>Average Score</b>	N/A	<b>Average Score</b>	N/A
<b>Average of Priority</b>	N/A						
<b>Material Assessment Score</b>	N/A						
<b>Recommendation</b>	No further action required						
<b>Surveyor comments</b>	N/A
