# Management with Targeted Refurbishment Survey to Wet Room

35 Ty Ddewi  
St Davids Close  
Pentre  
Rhondda  
CF41 7BG  
UPRN: 6511

Report issue date:	15 Aug 2016

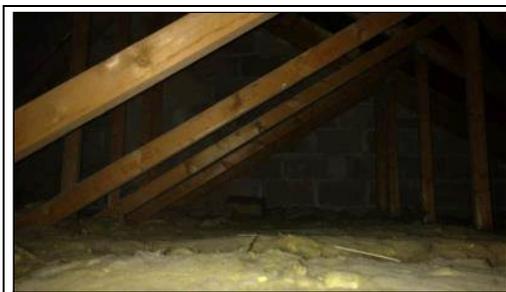
Survey Date:	Lead Surveyor	Survey Type	Floor	Analysis
29 Jul 2016 to 30 Jul 2016	Sebastian Lawniczak	Management Survey	Roof	N/A
Building	Room	Item	Quantity	
Block 1-35. Flat 35.	Loft Space R01	No suspect materials identified	N/A	
Sample No (S,SP,P,As)	Product Type	Surface Treatment	Condition	Accessibility
Visual (P)	N/A	N/A	N/A	N/A

Normal Occupancy	Score	Likelihood of disturbance	Score	Exposure Potential	Score	Maintenance Activity	Score
Main type of activity	N/A	Location	N/A	Number of occupants	N/A	Type of Maintenance	N/A
		Accessibility	N/A	Frequency of use	N/A	Frequency of maintenance	N/A
		Amount	N/A	Average Time	N/A		
Average Score	N/A	Average Score	N/A	Average Score	N/A	Average Score	N/A
Average of Priority	N/A						
Material Assessment Score	N/A						
Recommendation	No further action required						
Surveyor comments	N/A

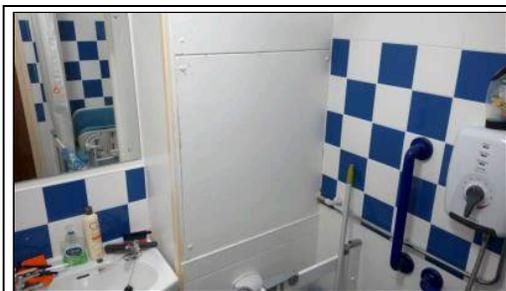
Survey Date:	Lead Surveyor	Survey Type	Floor	Analysis
29 Jul 2016 to 30 Jul 2016	Sebastian Lawniczak	Refurbishment and Demolition Survey	2nd	No Asbestos Detected (0)
Building	Room	Item	Quantity	
Block 1-35. Flat 35.	Wet Room 201	Insulating board panels forming riser boxing	3m <sup>2</sup>	
Sample No (S,SP,P,As)	Product Type	Surface Treatment	Condition	Accessibility
AE001648 (S)	Insulation board (2)	Unsealed (2)	Low Damage (1)	Easily disturbed (2)

Normal Occupancy	Score	Likelihood of disturbance	Score	Exposure Potential	Score	Maintenance Activity	Score
Main type of activity	N/A	Location	N/A	Number of occupants	N/A	Type of Maintenance	N/A
		Accessibility	N/A	Frequency of use	N/A	Frequency of maintenance	N/A
		Amount	N/A	Average Time	N/A		
Average Score	N/A	Average Score	N/A	Average Score	N/A	Average Score	N/A
Average of Priority	N/A						
Material Assessment Score	N/A						
Recommendation	No further action required						
Surveyor comments	N/A

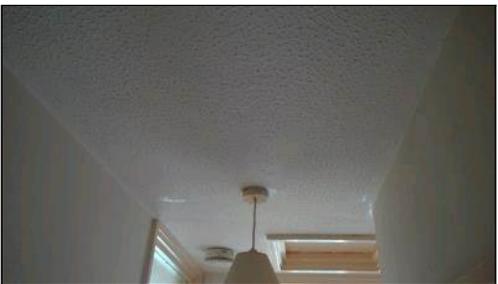
<b>Survey Date:</b>	<b>Lead Surveyor</b>	<b>Survey Type</b>	<b>Floor</b>	<b>Analysis</b>
	29 Jul 2016 to 30 Jul 2016	Sebastian Lawniczak	Management Survey	2nd	Chrysotile (1)
	<b>Building</b>	<b>Room</b>	<b>Item</b>	<b>Quantity</b>	
	Block 1-35. Flat 35.	Hallway 202	Textured coating to plasterboard ceiling	3m <sup>2</sup>	
	<b>Sample No (S,SP,P,As)</b>	<b>Product Type</b>	<b>Surface Treatment</b>	<b>Condition</b>	<b>Accessibility</b>
As AE001647 (SP)	Textured Coating (1)	Completely Sealed (0)	Good Condition (0)	Occasionally likely to be disturbed (1)

Normal Occupancy	Score	Likelihood of disturbance	Score	Exposure Potential	Score	Maintenance Activity	Score
Main type of activity	1	Location	2	Number of occupants	1	Type of Maintenance	0
		Accessibility	1	Frequency of use	3	Frequency of maintenance	0
		Amount	1	Average Time	1		
Average Score	1	Average Score	2	Average Score	2	Average Score	0
Average of Priority	<b>5</b>						
Material Assessment Score	<b>2</b>						
Recommendation	<b>Manage and re-inspect</b>						
Surveyor comments	<b>N/A</b>

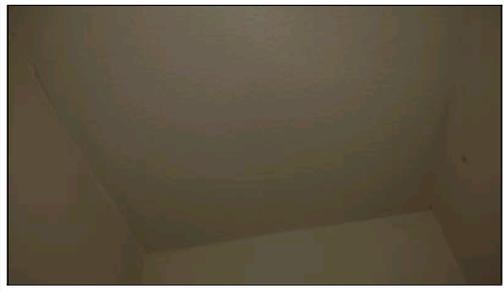
<b>Survey Date:</b>	<b>Lead Surveyor</b>	<b>Survey Type</b>	<b>Floor</b>	<b>Analysis</b>
	29 Jul 2016 to 30 Jul 2016	Sebastian Lawniczak	Management Survey	2nd	Chrysotile (1)
	<b>Building</b>	<b>Room</b>	<b>Item</b>	<b>Quantity</b>	
	Block 1-35. Flat 35.	Store Cupboard 1 203	Textured coating to plasterboard ceiling	1m <sup>2</sup>	
	<b>Sample No (S,SP,P,As)</b>	<b>Product Type</b>	<b>Surface Treatment</b>	<b>Condition</b>	<b>Accessibility</b>
As AE001647 (SP)	Textured Coating (1)	Completely Sealed (0)	Good Condition (0)	Occasionally likely to be disturbed (1)

Normal Occupancy	Score	Likelihood of disturbance	Score	Exposure Potential	Score	Maintenance Activity	Score
Main type of activity	0	Location	2	Number of occupants	1	Type of Maintenance	0
		Accessibility	1	Frequency of use	2	Frequency of maintenance	0
		Amount	1	Average Time	0		
Average Score	0	Average Score	2	Average Score	1	Average Score	0
Average of Priority	<b>3</b>						
Material Assessment Score	<b>2</b>						
Recommendation	<b>Manage and re-inspect</b>						
Surveyor comments	<b>N/A</b>

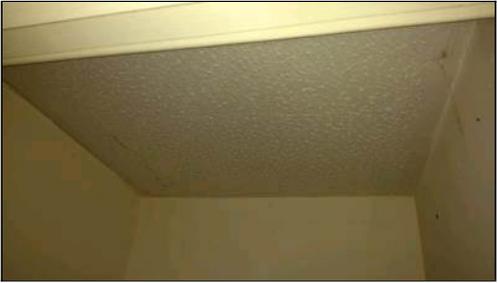
<b>Survey Date:</b>	<b>Lead Surveyor</b>	<b>Survey Type</b>	<b>Floor</b>	<b>Analysis</b>
	29 Jul 2016 to 30 Jul 2016	Sebastian Lawniczak	Management Survey	2nd	Chrysotile (1)
	<b>Building</b>	<b>Room</b>	<b>Item</b>	<b>Quantity</b>	
	Block 1-35. Flat 35.	Store Cupboard 2 204	Textured coating to plasterboard ceiling	1m <sup>2</sup>	
	<b>Sample No (S,SP,P,As)</b>	<b>Product Type</b>	<b>Surface Treatment</b>	<b>Condition</b>	<b>Accessibility</b>
As AE001647 (SP)	Textured Coating (1)	Completely Sealed (0)	Good Condition (0)	Occasionally likely to be disturbed (1)

Normal Occupancy	Score	Likelihood of disturbance	Score	Exposure Potential	Score	Maintenance Activity	Score
Main type of activity	0	Location	2	Number of occupants	1	Type of Maintenance	0
		Accessibility	1	Frequency of use	2	Frequency of maintenance	0
		Amount	1	Average Time	0		
Average Score	0	Average Score	2	Average Score	1	Average Score	0
Average of Priority	<b>3</b>						
Material Assessment Score	<b>2</b>						
Recommendation	<b>Manage and re-inspect</b>						
Surveyor comments	<b>N/A</b>

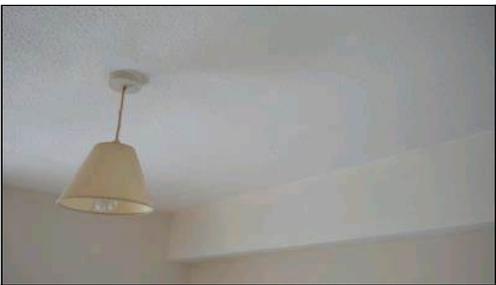
<b>Survey Date:</b>	<b>Lead Surveyor</b>	<b>Survey Type</b>	<b>Floor</b>	<b>Analysis</b>
	29 Jul 2016 to 30 Jul 2016	Sebastian Lawniczak	Management Survey	2nd	Chrysotile (1)
	<b>Building</b>	<b>Room</b>	<b>Item</b>	<b>Quantity</b>	
	Block 1-35. Flat 35.	Bedroom 205	Textured coating to plasterboard ceiling and fixed horizontal boxing to ceiling	6m <sup>2</sup>	
	<b>Sample No (S,SP,P,As)</b>	<b>Product Type</b>	<b>Surface Treatment</b>	<b>Condition</b>	<b>Accessibility</b>
As AE001647 (SP)	Textured Coating (1)	Completely Sealed (0)	Good Condition (0)	Occasionally likely to be disturbed (1)

Normal Occupancy	Score	Likelihood of disturbance	Score	Exposure Potential	Score	Maintenance Activity	Score
Main type of activity	1	Location	2	Number of occupants	1	Type of Maintenance	0
		Accessibility	1	Frequency of use	3	Frequency of maintenance	0
		Amount	1	Average Time	3		
Average Score	1	Average Score	2	Average Score	3	Average Score	0
Average of Priority	<b>6</b>						
Material Assessment Score	<b>2</b>						
Recommendation	<b>Manage and re-inspect</b>						
Surveyor comments	<b>N/A</b>

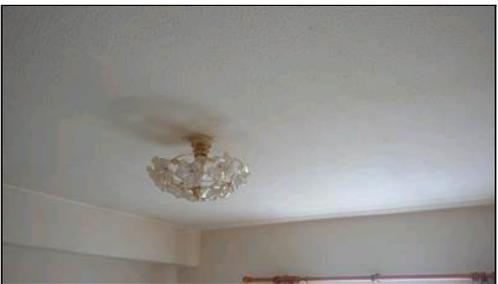
<b>Survey Date:</b>	<b>Lead Surveyor</b>	<b>Survey Type</b>	<b>Floor</b>	<b>Analysis</b>
	29 Jul 2016 to 30 Jul 2016	Sebastian Lawniczak	Management Survey	2nd	Chrysotile (1)
	<b>Building</b>	<b>Room</b>	<b>Item</b>	<b>Quantity</b>	
	Block 1-35. Flat 35.	Living Room 206	Textured coating to plasterboard ceiling and fixed horizontal boxing to ceiling	9m <sup>2</sup>	
	<b>Sample No (S,SP,P,As)</b>	<b>Product Type</b>	<b>Surface Treatment</b>	<b>Condition</b>	<b>Accessibility</b>
As AE001647 (SP)	Textured Coating (1)	Completely Sealed (0)	Good Condition (0)	Occasionally likely to be disturbed (1)

Normal Occupancy	Score	Likelihood of disturbance	Score	Exposure Potential	Score	Maintenance Activity	Score
Main type of activity	1	Location	2	Number of occupants	1	Type of Maintenance	0
		Accessibility	1	Frequency of use	3	Frequency of maintenance	0
		Amount	1	Average Time	2		
Average Score	1	Average Score	2	Average Score	2	Average Score	0
Average of Priority	<b>5</b>						
Material Assessment Score	<b>2</b>						
Recommendation	<b>Manage and re-inspect</b>						
Surveyor comments	<b>N/A</b>

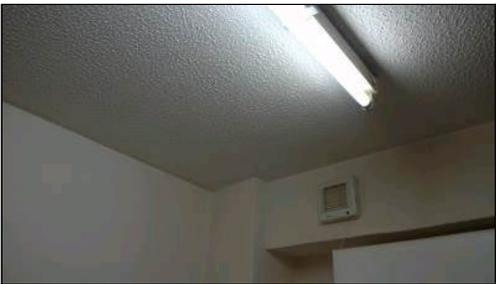
<b>Survey Date:</b>	<b>Lead Surveyor</b>	<b>Survey Type</b>	<b>Floor</b>	<b>Analysis</b>
	29 Jul 2016 to 30 Jul 2016	Sebastian Lawniczak	Management Survey	2nd	Chrysotile (1)
	<b>Building</b>	<b>Room</b>	<b>Item</b>	<b>Quantity</b>	
	Block 1-35. Flat 35.	Kitchen 207	Textured coating to plasterboard ceiling and fixed horizontal boxing to ceiling	5m <sup>2</sup>	
	<b>Sample No (S,SP,P,As)</b>	<b>Product Type</b>	<b>Surface Treatment</b>	<b>Condition</b>	<b>Accessibility</b>
As AE001647 (SP)	Textured Coating (1)	Completely Sealed (0)	Good Condition (0)	Occasionally likely to be disturbed (1)

Normal Occupancy	Score	Likelihood of disturbance	Score	Exposure Potential	Score	Maintenance Activity	Score
Main type of activity	1	Location	2	Number of occupants	1	Type of Maintenance	0
		Accessibility	1	Frequency of use	3	Frequency of maintenance	0
		Amount	1	Average Time	1		
Average Score	1	Average Score	2	Average Score	2	Average Score	0
Average of Priority	<b>5</b>						
Material Assessment Score	<b>2</b>						
Recommendation	<b>Manage and re-inspect</b>						
Surveyor comments	<b>N/A</b>

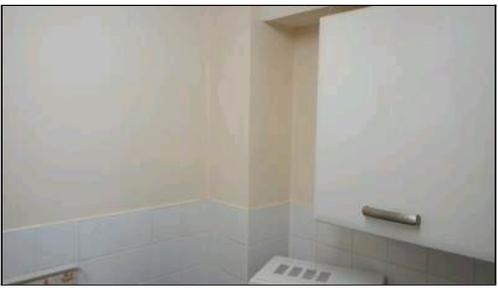
<b>Survey Date:</b>	<b>Lead Surveyor</b>	<b>Survey Type</b>	<b>Floor</b>	<b>Analysis</b>
	29 Jul 2016 to 30 Jul 2016	Sebastian Lawniczak	Management Survey	2nd	No Asbestos Detected (0)
	<b>Building</b>	<b>Room</b>	<b>Item</b>	<b>Quantity</b>	
	Block 1-35. Flat 35.	Kitchen 207	Insulating board panels forming fixed riser boxing	2m <sup>2</sup>	
	<b>Sample No (S,SP,P,As)</b>	<b>Product Type</b>	<b>Surface Treatment</b>	<b>Condition</b>	<b>Accessibility</b>
As AE001648 (SP)	Insulation board (2)	Surface Sealed (1)	Good Condition (0)	Easily disturbed (2)

<b>Normal Occupancy</b>	<b>Score</b>	<b>Likelihood of disturbance</b>	<b>Score</b>	<b>Exposure Potential</b>	<b>Score</b>	<b>Maintenance Activity</b>	<b>Score</b>
Main type of activity	N/A	Location	N/A	Number of occupants	N/A	Type of Maintenance	N/A
		Accessibility	N/A	Frequency of use	N/A	Frequency of maintenance	N/A
		Amount	N/A	Average Time	N/A		
Average Score	N/A	Average Score	N/A	Average Score	N/A	Average Score	N/A
Average of Priority	N/A						
Material Assessment Score	N/A						
Recommendation	No further action required						
Surveyor comments	N/A
