# **Asbestos Survey Report**

**Project Ref. No: 050053**

**38 Ty Ddewi**

**Type 2 survey with project specific Type 3 investigations**

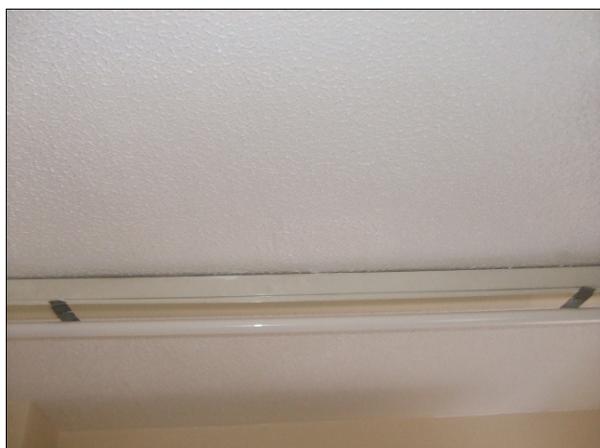
<b>Condition:</b>	Fair	<b>Accessibility:</b>	Low	
<b>Friability:</b>	Low	<b>Exposure:</b>	Public	
<b>Surface:</b>	Fully sealed	<b>Amount:</b>	4 m <sup>2</sup>	
<b>Position:</b>	Internal	<b>RISK:</b>	<b>MINOR (4)</b>

Asbestos textured coating to plasterboard ceiling.

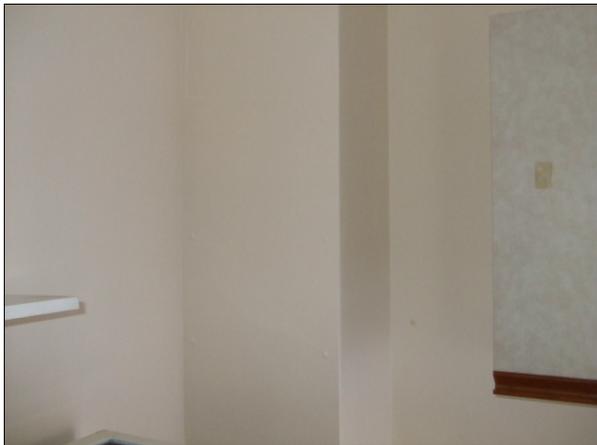
<b>Condition:</b>	Fair	<b>Accessibility:</b>	Low	
<b>Friability:</b>	Medium	<b>Exposure:</b>	Public	
<b>Surface:</b>	Fully sealed	<b>Amount:</b>	2 m <sup>2</sup>	
<b>Position:</b>	Internal	<b>RISK:</b>	<b>NONE</b>

N.A.D.I.S. Insulating board panels forming riser.

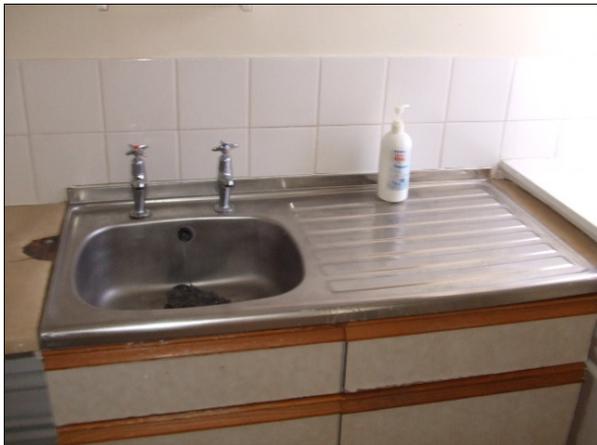
<b>Condition:</b>	Fair	<b>Accessibility:</b>	Low
<b>Friability:</b>	Low	<b>Exposure:</b>	Public
<b>Surface:</b>	Fully sealed	<b>Amount:</b>	<1 m <sup>2</sup>
<b>Position:</b>	Internal	<b>RISK:</b>	<b>NONE</b>

N.A.D.I.S. Bitumen sink pad.

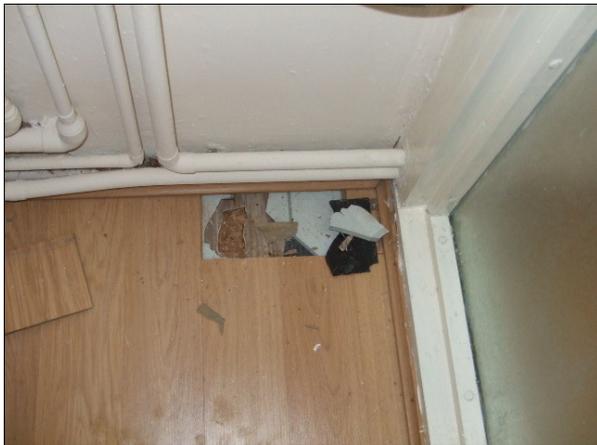
<b>Condition:</b>	Fair	<b>Accessibility:</b>	Low	
<b>Friability:</b>	Low	<b>Exposure:</b>	Public	
<b>Surface:</b>	Fully sealed	<b>Amount:</b>	4 m <sup>2</sup>	
<b>Position:</b>	Internal	<b>RISK:</b>	<b>NONE</b>

N.A.D.I.S. Vinyl lino beneath flooring.

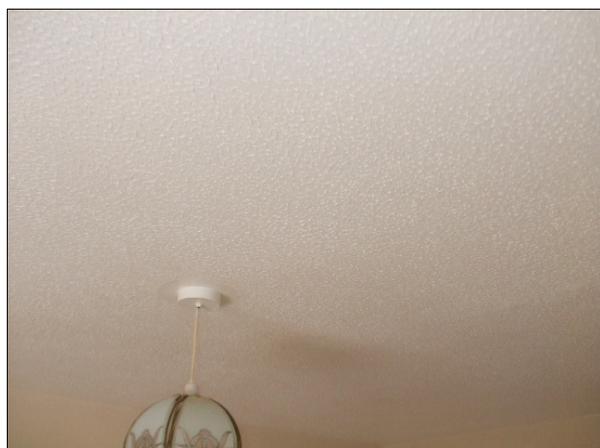
<b>Condition:</b>	Fair	<b>Accessibility:</b>	Low	
<b>Friability:</b>	Low	<b>Exposure:</b>	Public	
<b>Surface:</b>	Fully sealed	<b>Amount:</b>	15 m <sup>2</sup>	
<b>Position:</b>	Internal	<b>RISK:</b>	<b>MINOR (4)</b>

Asbestos textured coating to plasterboard ceiling.

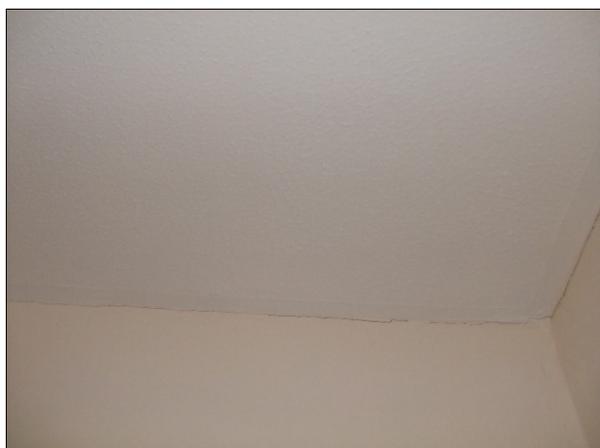
<b>Condition:</b>	Fair	<b>Accessibility:</b>	Low	
<b>Friability:</b>	Low	<b>Exposure:</b>	Public	
<b>Surface:</b>	Fully sealed	<b>Amount:</b>	12 m <sup>2</sup>	
<b>Position:</b>	Internal	<b>RISK:</b>	<b>MINOR (4)</b>

Strongly presumed asbestos textured coating to plasterboard ceiling.

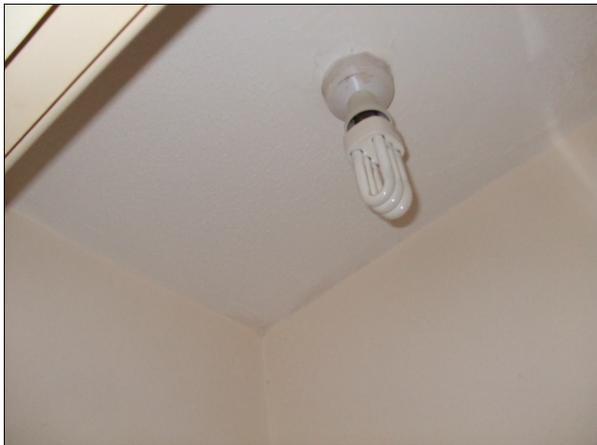
<b>Condition:</b>	Fair	<b>Accessibility:</b>	Low	
<b>Friability:</b>	Low	<b>Exposure:</b>	Public	
<b>Surface:</b>	Fully sealed	<b>Amount:</b>	1 m <sup>2</sup>	
<b>Position:</b>	Internal	<b>RISK:</b>	<b>MINOR (4)</b>

Strongly presumed asbestos textured coating to plasterboard ceiling.

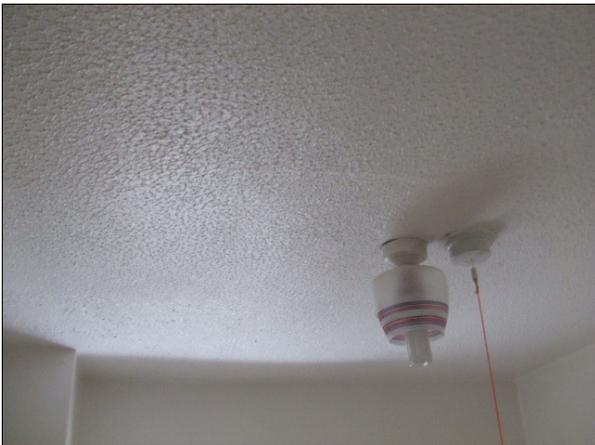
<b>Condition:</b>	Fair	<b>Accessibility:</b>	Low	
<b>Friability:</b>	Low	<b>Exposure:</b>	Public	
<b>Surface:</b>	Fully sealed	<b>Amount:</b>	1 m <sup>2</sup>	
<b>Position:</b>	Internal	<b>RISK:</b>	<b>MINOR (4)</b>

Strongly presumed asbestos textured coating to plasterboard ceiling.

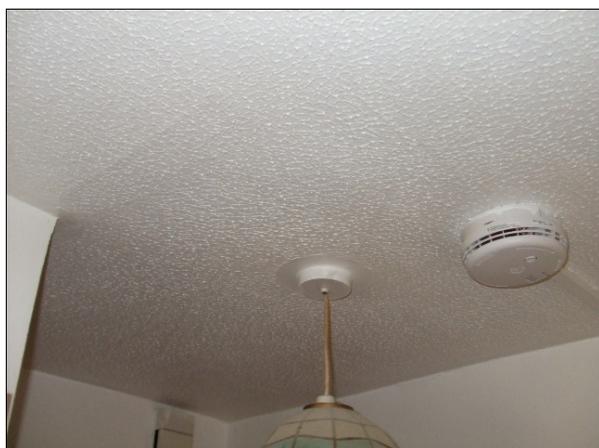
<b>Condition:</b>	Fair	<b>Accessibility:</b>	Low	
<b>Friability:</b>	Low	<b>Exposure:</b>	Public	
<b>Surface:</b>	Fully sealed	<b>Amount:</b>	3 m <sup>2</sup>	
<b>Position:</b>	Internal	<b>RISK:</b>	<b>MINOR (4)</b>

Strongly presumed asbestos textured coating to plasterboard ceiling.

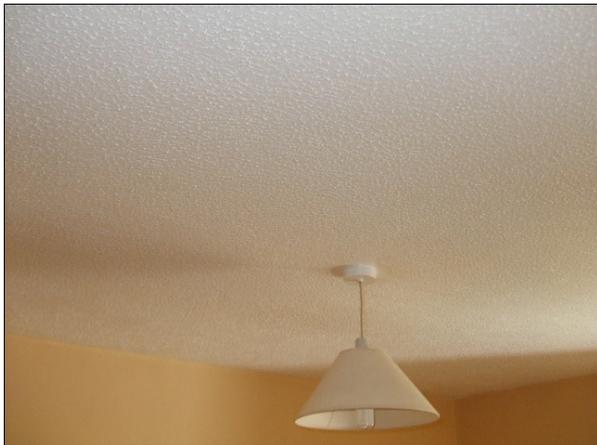
<b>Condition:</b>	Fair	<b>Accessibility:</b>	Low	
<b>Friability:</b>	Low	<b>Exposure:</b>	Public	
<b>Surface:</b>	Fully sealed	<b>Amount:</b>	6 m <sup>2</sup>	
<b>Position:</b>	Internal	<b>RISK:</b>	<b>MINOR (4)</b>

Strongly presumed asbestos textured coating to plasterboard ceiling.

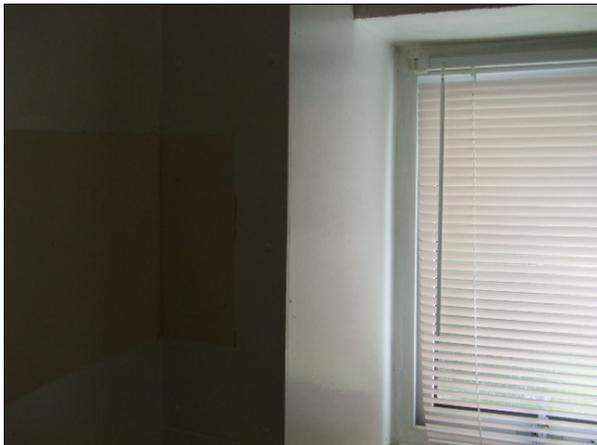
<b>Condition:</b>	Fair	<b>Accessibility:</b>	Medium
<b>Friability:</b>	Medium	<b>Exposure:</b>	Public
<b>Surface:</b>	Fully sealed	<b>Amount:</b>	2 m <sup>2</sup>
<b>Position:</b>	Internal	<b>RISK:</b>	<b>NONE</b>

N.A.D.I.S. Insulating board panels forming riser.

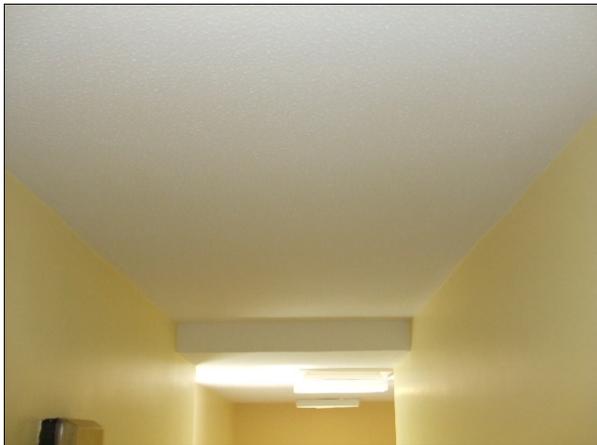
<b>Condition:</b>	Fair	<b>Accessibility:</b>	Low	
<b>Friability:</b>	Low	<b>Exposure:</b>	Public	
<b>Surface:</b>	Fully sealed	<b>Amount:</b>	4 m <sup>2</sup>	
<b>Position:</b>	Internal	<b>RISK:</b>	<b>MINOR (4)</b>

Asbestos textured coating to plasterboard ceiling.

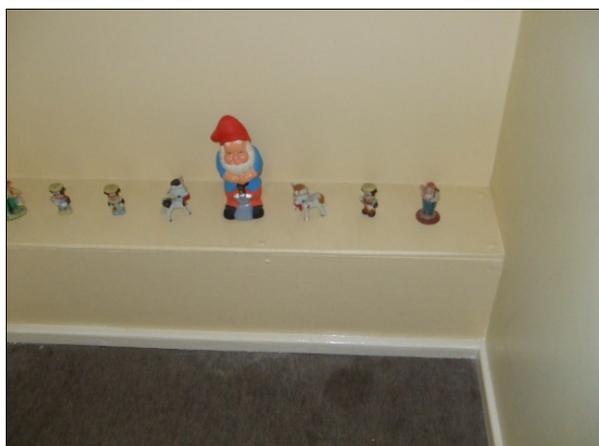
<b>Condition:</b>	Fair	<b>Accessibility:</b>	Medium
<b>Friability:</b>	Medium	<b>Exposure:</b>	Public
<b>Surface:</b>	Fully sealed	<b>Amount:</b>	2 m <sup>2</sup>
<b>Position:</b>	Internal	<b>RISK:</b>	<b>NONE</b>

N.A.D.I.S. Insulating board panels forming riser.

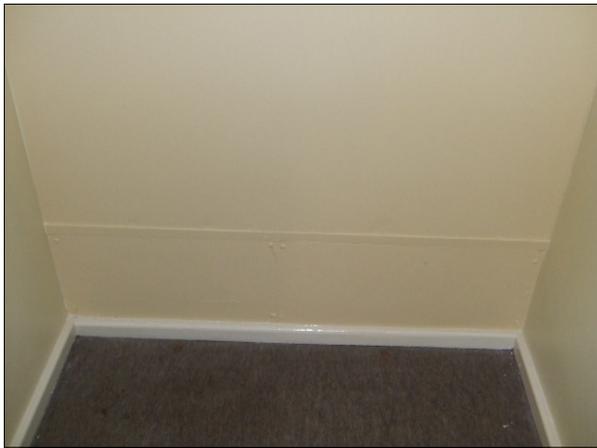
<b>Condition:</b>	Fair	<b>Accessibility:</b>	Medium
<b>Friability:</b>	Medium	<b>Exposure:</b>	Public
<b>Surface:</b>	Fully sealed	<b>Amount:</b>	2 m <sup>2</sup>
<b>Position:</b>	Internal	<b>RISK:</b>	<b>NONE</b>

N.A.D.I.S. Insulating board panels forming riser.

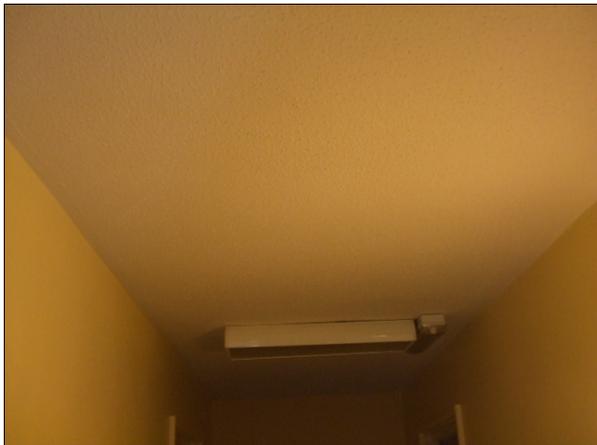
<b>Condition:</b>	Fair	<b>Accessibility:</b>	Low	
<b>Friability:</b>	Low	<b>Exposure:</b>	Public	
<b>Surface:</b>	Fully sealed	<b>Amount:</b>	10 m <sup>2</sup>	
<b>Position:</b>	Internal	<b>RISK:</b>	<b>MINOR (4)</b>

Asbestos textured coating to plasterboard ceiling.

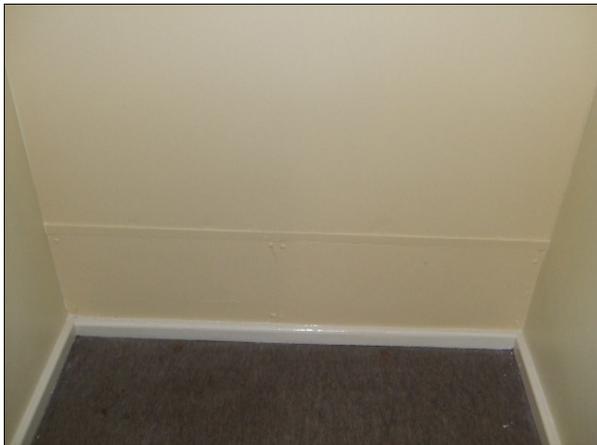
<b>Condition:</b>	Fair	<b>Accessibility:</b>	Medium	
<b>Friability:</b>	Medium	<b>Exposure:</b>	Public	
<b>Surface:</b>	Fully sealed	<b>Amount:</b>	1 m <sup>2</sup>	
<b>Position:</b>	Internal	<b>RISK:</b>	<b>NONE</b>

N.A.D.I.S. Insulating board panels forming boxing.

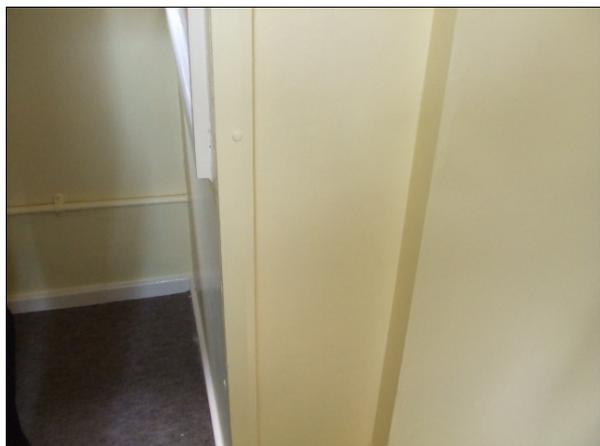
<b>Condition:</b>	Fair	<b>Accessibility:</b>	Medium	
<b>Friability:</b>	Medium	<b>Exposure:</b>	Public	
<b>Surface:</b>	Fully sealed	<b>Amount:</b>	1 m <sup>2</sup>	
<b>Position:</b>	Internal	<b>RISK:</b>	<b>NONE</b>

N.A.D.I.S. Insulating board panels forming boxing.
