## Asbestos Management Survey

26 Cyncoed  
Ynysyawl  
Pontypridd  
Mid Glamorgan  
CF37 3PL  
UPRN: 007931

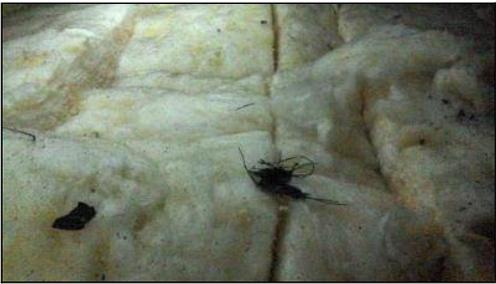
<b>Survey Date:</b>	<b>Lead Surveyor</b>	<b>Survey Type</b>	<b>Floor</b>	<b>Analysis</b>
	9 Dec 2019	Dave Milton	Management Survey	Roof	
	<b>Building</b>	<b>Room</b>	<b>Item</b>	<b>Quantity</b>	No Asbestos Detected (0)
	Block 25-28, Flat 26	Loft Space R01	Bitumen felt debris on top of MMMF insulation	2m <sup>2</sup>	
	<b>Sample No (S,SP,P,As)</b>	<b>Product Type</b>	<b>Surface Treatment</b>	<b>Condition</b>	<b>Accessibility</b>
	AI008233 (S)	Bituminous material (1)	Completely Sealed (0)	High Damage (3)	Occasionally likely to be disturbed (1)

Normal Occupancy	Score	Likelihood of disturbance	Score	Exposure Potential	Score	Maintenance Activity	Score
Main type of activity	N/A	Location	N/A	Number of occupants	N/A	Type of Maintenance	N/A
		Accessibility	N/A	Frequency of use	N/A	Frequency of maintenance	N/A
		Amount	N/A	Average Time	N/A		
Average Score	N/A	Average Score	N/A	Average Score	N/A	Average Score	N/A
Average of Priority	N/A						
Material Assessment Score	N/A						
Recommendation	No further action required						
Surveyor comments	N/A

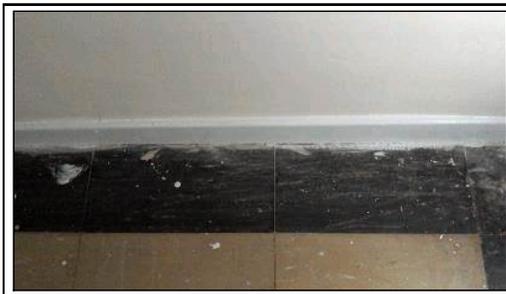
<b>Survey Date:</b>	<b>Lead Surveyor</b>	<b>Survey Type</b>	<b>Floor</b>	<b>Analysis</b>
9 Dec 2019	Dave Milton	Management Survey	1st	Chrysotile (1)
<b>Building</b>	<b>Room</b>	<b>Item</b>	<b>Quantity</b>	
Block 25-28, Flat 26	Bedroom 1 101	Dark brown vinyl tiles to concrete floor	2m <sup>2</sup>	
<b>Sample No (S,SP,P,As)</b>	<b>Product Type</b>	<b>Surface Treatment</b>	<b>Condition</b>	<b>Accessibility</b>
AI008219 (S)	Vinyl floor tiles (1)	Completely Sealed (0)	Good Condition (0)	Routinely disturbed (3)

Normal Occupancy	Score	Likelihood of disturbance	Score	Exposure Potential	Score	Maintenance Activity	Score
Main type of activity	1	Location	2	Number of occupants	1	Type of Maintenance	1
		Accessibility	3	Frequency of use	3	Frequency of maintenance	1
		Amount	1	Average Time	3		
Average Score	1	Average Score	2	Average Score	3	Average Score	1
Average of Priority	7						
Material Assessment Score	2						
Recommendation	Manage and re-inspect						
Surveyor comments	N/A

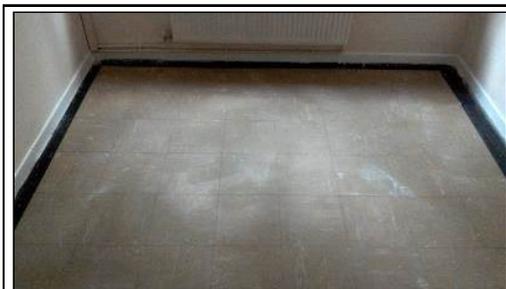
<b>Survey Date:</b>	<b>Lead Surveyor</b>	<b>Survey Type</b>	<b>Floor</b>	<b>Analysis</b>
9 Dec 2019	Dave Milton	Management Survey	1st	Chrysotile (1)
<b>Building</b>	<b>Room</b>	<b>Item</b>	<b>Quantity</b>	
Block 25-28, Flat 26	Bedroom 1 101	Beige vinyl tiles and bitumen adhesive to concrete floor	8m <sup>2</sup>	
<b>Sample No (S,SP,P,As)</b>	<b>Product Type</b>	<b>Surface Treatment</b>	<b>Condition</b>	<b>Accessibility</b>
AI008220 (S)	Vinyl floor tiles (1)	Completely Sealed (0)	Good Condition (0)	Routinely disturbed (3)

Normal Occupancy	Score	Likelihood of disturbance	Score	Exposure Potential	Score	Maintenance Activity	Score
Main type of activity	1	Location	2	Number of occupants	1	Type of Maintenance	1
		Accessibility	3	Frequency of use	3	Frequency of maintenance	1
		Amount	1	Average Time	3		
Average Score	1	Average Score	2	Average Score	3	Average Score	1
Average of Priority	7						
Material Assessment Score	2						
Recommendation	Manage and re-inspect						
Surveyor comments	N/A

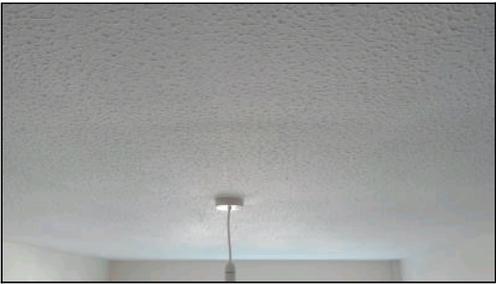
Survey Date:	Lead Surveyor	Survey Type	Floor	Analysis
	9 Dec 2019	Dave Milton	Management Survey	1st	Chrysotile (1)
	Building	Room	Item	Quantity	
	Block 25-28, Flat 26	Bedroom 2 102	Textured coating to plasterboard ceiling	12m <sup>2</sup>	
	Sample No (S,SP,P,As)	Product Type	Surface Treatment	Condition	Accessibility
AI008221 (S)	Textured Coating (1)	Completely Sealed (0)	Good Condition (0)	Occasionally likely to be disturbed (1)

Normal Occupancy	Score	Likelihood of disturbance	Score	Exposure Potential	Score	Maintenance Activity	Score
Main type of activity	1	Location	2	Number of occupants	1	Type of Maintenance	1
		Accessibility	1	Frequency of use	3	Frequency of maintenance	1
		Amount	2	Average Time	3		
Average Score	1	Average Score	2	Average Score	3	Average Score	1
Average of Priority	7						
Material Assessment Score	2						
Recommendation	Manage and re-inspect						
Surveyor comments	N/A

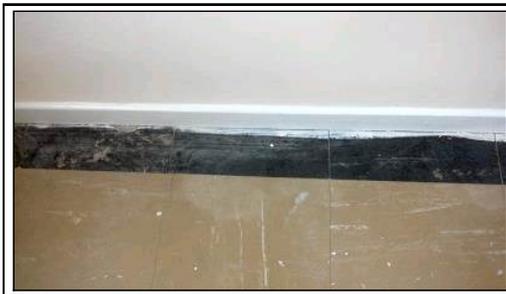
Survey Date:	Lead Surveyor	Survey Type	Floor	Analysis
9 Dec 2019	Dave Milton	Management Survey	1st	Chrysotile (1)
Building	Room	Item	Quantity	
Block 25-28, Flat 26	Bedroom 2 102	Dark brown vinyl tiles to concrete floor	3m <sup>2</sup>	
Sample No (S,SP,P,As)	Product Type	Surface Treatment	Condition	Accessibility
As AI008219 (SP)	Vinyl floor tiles (1)	Completely Sealed (0)	Low Damage (1)	Routinely disturbed (3)

Normal Occupancy	Score	Likelihood of disturbance	Score	Exposure Potential	Score	Maintenance Activity	Score
Main type of activity	1	Location	2	Number of occupants	1	Type of Maintenance	1
		Accessibility	3	Frequency of use	3	Frequency of maintenance	1
		Amount	1	Average Time	3		
Average Score	1	Average Score	2	Average Score	3	Average Score	1
Average of Priority	<b>7</b>						
Material Assessment Score	<b>3</b>						
Recommendation	<b>Manage and re-inspect</b>						
Surveyor comments	<b>N/A</b>

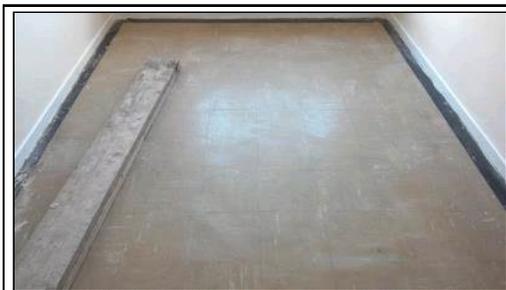
<b>Survey Date:</b>	<b>Lead Surveyor</b>	<b>Survey Type</b>	<b>Floor</b>	<b>Analysis</b>
9 Dec 2019	Dave Milton	Management Survey	1st	Chrysotile (1)
<b>Building</b>	<b>Room</b>	<b>Item</b>	<b>Quantity</b>	
Block 25-28, Flat 26	Bedroom 2 102	Beige vinyl tiles and bitumen adhesive to concrete floor	9m <sup>2</sup>	
<b>Sample No (S,SP,P,As)</b>	<b>Product Type</b>	<b>Surface Treatment</b>	<b>Condition</b>	<b>Accessibility</b>
As AI008220 (SP)	Vinyl floor tiles (1)	Completely Sealed (0)	Good Condition (0)	Routinely disturbed (3)

Normal Occupancy	Score	Likelihood of disturbance	Score	Exposure Potential	Score	Maintenance Activity	Score
Main type of activity	1	Location	2	Number of occupants	1	Type of Maintenance	1
		Accessibility	3	Frequency of use	3	Frequency of maintenance	1
		Amount	1	Average Time	3		
Average Score	1	Average Score	2	Average Score	3	Average Score	1
Average of Priority	7						
Material Assessment Score	2						
Recommendation	Manage and re-inspect						
Surveyor comments	N/A

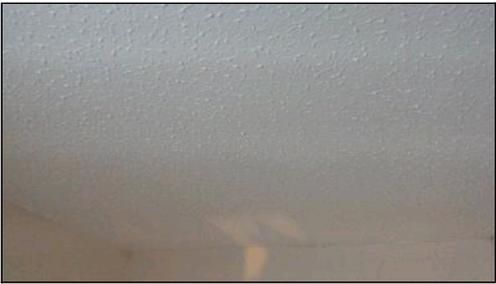
<b>Survey Date:</b>	<b>Lead Surveyor</b>	<b>Survey Type</b>	<b>Floor</b>	<b>Analysis</b>
	9 Dec 2019	Dave Milton	Management Survey	1st	Chrysotile (1)
	<b>Building</b>	<b>Room</b>	<b>Item</b>	<b>Quantity</b>	
	Block 25-28, Flat 26	Cupboard 103	Textured coating to plasterboard ceiling	2m <sup>2</sup>	
	<b>Sample No (S,SP,P,As)</b>	<b>Product Type</b>	<b>Surface Treatment</b>	<b>Condition</b>	<b>Accessibility</b>
	AI008222 (S)	Textured Coating (1)	Completely Sealed (0)	Good Condition (0)	Occasionally likely to be disturbed (1)

Normal Occupancy	Score	Likelihood of disturbance	Score	Exposure Potential	Score	Maintenance Activity	Score
Main type of activity	1	Location	2	Number of occupants	1	Type of Maintenance	1
		Accessibility	1	Frequency of use	3	Frequency of maintenance	1
		Amount	1	Average Time	0		
Average Score	1	Average Score	2	Average Score	2	Average Score	1
Average of Priority	6						
Material Assessment Score	2						
Recommendation	Manage and re-inspect						
Surveyor comments	N/A

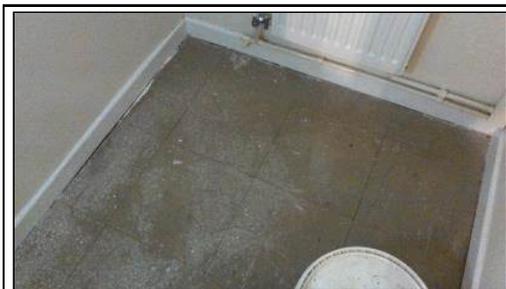
<b>Survey Date:</b>	<b>Lead Surveyor</b>	<b>Survey Type</b>	<b>Floor</b>	<b>Analysis</b>
9 Dec 2019	Dave Milton	Management Survey	1st	Chrysotile (1)
<b>Building</b>	<b>Room</b>	<b>Item</b>	<b>Quantity</b>	
Block 25-28, Flat 26	Cupboard 103	Beige vinyl tiles and bitumen adhesive to concrete floor	2m <sup>2</sup>	
<b>Sample No (S,SP,P,As)</b>	<b>Product Type</b>	<b>Surface Treatment</b>	<b>Condition</b>	<b>Accessibility</b>
As AI008220 (SP)	Vinyl floor tiles (1)	Completely Sealed (0)	Good Condition (0)	Routinely disturbed (3)

Normal Occupancy	Score	Likelihood of disturbance	Score	Exposure Potential	Score	Maintenance Activity	Score
Main type of activity	1	Location	2	Number of occupants	1	Type of Maintenance	1
		Accessibility	3	Frequency of use	3	Frequency of maintenance	1
		Amount	1	Average Time	0		
Average Score	1	Average Score	2	Average Score	2	Average Score	1
Average of Priority	6						
Material Assessment Score	2						
Recommendation	Manage and re-inspect						
Surveyor comments	N/A

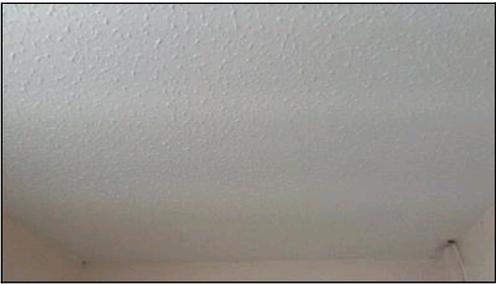
<b>Survey Date:</b>	<b>Lead Surveyor</b>	<b>Survey Type</b>	<b>Floor</b>	<b>Analysis</b>
	9 Dec 2019	Dave Milton	Management Survey	1st	Chrysotile (1)
	<b>Building</b>	<b>Room</b>	<b>Item</b>	<b>Quantity</b>	
	Block 25-28, Flat 26	Cupboard 104	Textured coating to plasterboard ceiling	1m <sup>2</sup>	
	<b>Sample No (S,SP,P,As)</b>	<b>Product Type</b>	<b>Surface Treatment</b>	<b>Condition</b>	<b>Accessibility</b>
AI008223 (S)	Textured Coating (1)	Completely Sealed (0)	Good Condition (0)	Occasionally likely to be disturbed (1)

Normal Occupancy	Score	Likelihood of disturbance	Score	Exposure Potential	Score	Maintenance Activity	Score
Main type of activity	1	Location	2	Number of occupants	1	Type of Maintenance	1
		Accessibility	1	Frequency of use	3	Frequency of maintenance	1
		Amount	1	Average Time	0		
Average Score	1	Average Score	2	Average Score	2	Average Score	1
Average of Priority	6						
Material Assessment Score	2						
Recommendation	Manage and re-inspect						
Surveyor comments	N/A

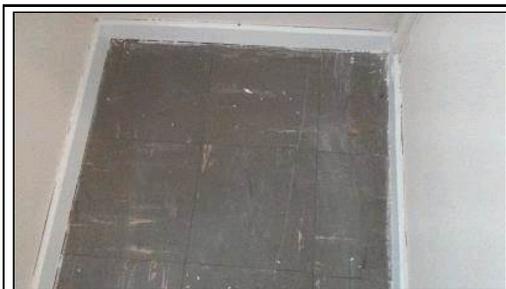
<b>Survey Date:</b>	<b>Lead Surveyor</b>	<b>Survey Type</b>	<b>Floor</b>	<b>Analysis</b>
9 Dec 2019	Dave Milton	Management Survey	1st	Chrysotile (1)
<b>Building</b>	<b>Room</b>	<b>Item</b>	<b>Quantity</b>	
Block 25-28, Flat 26	Cupboard 104	Green vinyl tiles and bitumen adhesive to concrete floor	1m <sup>2</sup>	
<b>Sample No (S,SP,P,As)</b>	<b>Product Type</b>	<b>Surface Treatment</b>	<b>Condition</b>	<b>Accessibility</b>
AI008224 (S)	Vinyl floor tiles (1)	Completely Sealed (0)	Low Damage (1)	Routinely disturbed (3)

Normal Occupancy	Score	Likelihood of disturbance	Score	Exposure Potential	Score	Maintenance Activity	Score
Main type of activity	1	Location	2	Number of occupants	1	Type of Maintenance	1
		Accessibility	3	Frequency of use	3	Frequency of maintenance	1
		Amount	1	Average Time	0		
Average Score	1	Average Score	2	Average Score	2	Average Score	1
Average of Priority	6						
Material Assessment Score	3						
Recommendation	Manage and re-inspect						
Surveyor comments	N/A

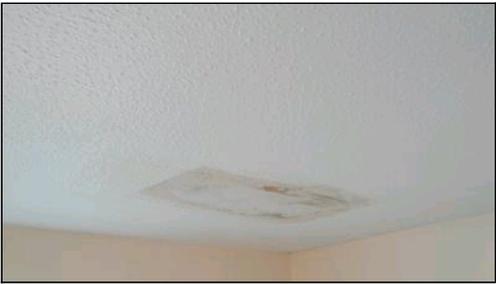
Survey Date:	Lead Surveyor	Survey Type	Floor	Analysis
	9 Dec 2019	Dave Milton	Management Survey	1st	Chrysotile (1)
	Building	Room	Item	Quantity	
	Block 25-28, Flat 26	Lounge 105	Textured coating to plasterboard ceiling	15m <sup>2</sup>	
	Sample No (S,SP,P,As)	Product Type	Surface Treatment	Condition	Accessibility
AI008225 (S)	Textured Coating (1)	Completely Sealed (0)	Medium Damage (2)	Occasionally likely to be disturbed (1)

Normal Occupancy	Score	Likelihood of disturbance	Score	Exposure Potential	Score	Maintenance Activity	Score
Main type of activity	1	Location	2	Number of occupants	1	Type of Maintenance	1
		Accessibility	1	Frequency of use	3	Frequency of maintenance	1
		Amount	2	Average Time	2		
Average Score	1	Average Score	2	Average Score	2	Average Score	1
Average of Priority	6						
Material Assessment Score	4						
Recommendation	Encapsulate or repair						
Surveyor comments	N/A

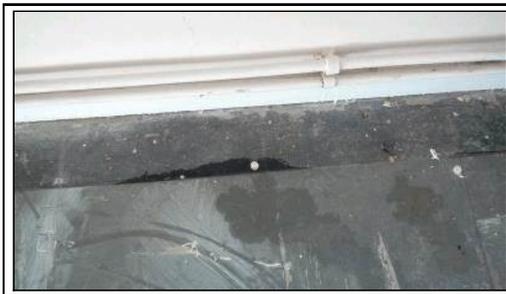
<b>Survey Date:</b>	<b>Lead Surveyor</b>	<b>Survey Type</b>	<b>Floor</b>	<b>Analysis</b>
9 Dec 2019	Dave Milton	Management Survey	1st	Chrysotile (1)
<b>Building</b>	<b>Room</b>	<b>Item</b>	<b>Quantity</b>	
Block 25-28, Flat 26	Lounge 105	Dark brown vinyl tiles to concrete floor	4m <sup>2</sup>	
<b>Sample No (S,SP,P,As)</b>	<b>Product Type</b>	<b>Surface Treatment</b>	<b>Condition</b>	<b>Accessibility</b>
As AI008219 (SP)	Vinyl floor tiles (1)	Completely Sealed (0)	Low Damage (1)	Routinely disturbed (3)

Normal Occupancy	Score	Likelihood of disturbance	Score	Exposure Potential	Score	Maintenance Activity	Score
Main type of activity	1	Location	2	Number of occupants	1	Type of Maintenance	1
		Accessibility	3	Frequency of use	3	Frequency of maintenance	1
		Amount	1	Average Time	2		
Average Score	1	Average Score	2	Average Score	2	Average Score	1
Average of Priority	<b>6</b>						
Material Assessment Score	<b>3</b>						
Recommendation	<b>Manage and re-inspect</b>						
Surveyor comments	<b>N/A</b>

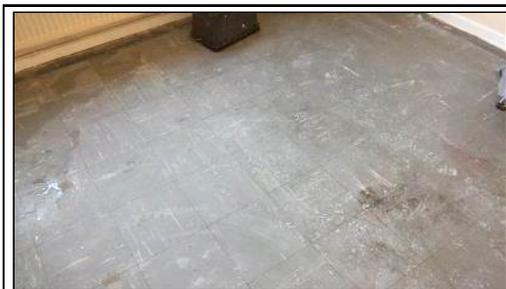
<b>Survey Date:</b>	<b>Lead Surveyor</b>	<b>Survey Type</b>	<b>Floor</b>	<b>Analysis</b>
9 Dec 2019	Dave Milton	Management Survey	1st	Chrysotile (1)
<b>Building</b>	<b>Room</b>	<b>Item</b>	<b>Quantity</b>	
Block 25-28, Flat 26	Lounge 105	Green vinyl tiles and bitumen adhesive to concrete floor	11m <sup>2</sup>	
<b>Sample No (S,SP,P,As)</b>	<b>Product Type</b>	<b>Surface Treatment</b>	<b>Condition</b>	<b>Accessibility</b>
As AI008224 (SP)	Vinyl floor tiles (1)	Completely Sealed (0)	Good Condition (0)	Routinely disturbed (3)

Normal Occupancy	Score	Likelihood of disturbance	Score	Exposure Potential	Score	Maintenance Activity	Score
Main type of activity	1	Location	2	Number of occupants	1	Type of Maintenance	1
		Accessibility	3	Frequency of use	3	Frequency of maintenance	1
		Amount	2	Average Time	2		
Average Score	1	Average Score	3	Average Score	2	Average Score	1
Average of Priority	7						
Material Assessment Score	2						
Recommendation	Manage and re-inspect						
Surveyor comments	N/A

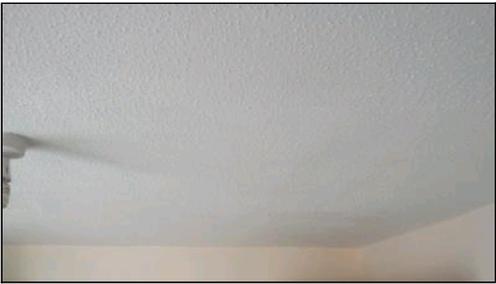
Survey Date:	Lead Surveyor	Survey Type	Floor	Analysis
	9 Dec 2019	Dave Milton	Management Survey	1st	Chrysotile (1)
	Building	Room	Item	Quantity	
	Block 25-28, Flat 26	Kitchen 106	Textured coating to plasterboard ceiling	6m <sup>2</sup>	
	Sample No (S,SP,P,As)	Product Type	Surface Treatment	Condition	Accessibility
AI008226 (S)	Textured Coating (1)	Completely Sealed (0)	Good Condition (0)	Occasionally likely to be disturbed (1)

Normal Occupancy	Score	Likelihood of disturbance	Score	Exposure Potential	Score	Maintenance Activity	Score
Main type of activity	1	Location	2	Number of occupants	1	Type of Maintenance	1
		Accessibility	1	Frequency of use	3	Frequency of maintenance	1
		Amount	1	Average Time	1		
Average Score	1	Average Score	2	Average Score	2	Average Score	1
Average of Priority	6						
Material Assessment Score	2						
Recommendation	Manage and re-inspect						
Surveyor comments	N/A

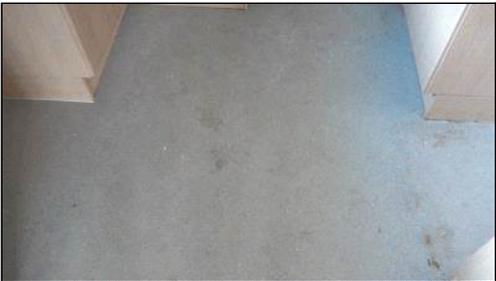
Survey Date:	Lead Surveyor	Survey Type	Floor	Analysis
	9 Dec 2019	Dave Milton	Management Survey	1st	Chrysotile (1)
	Building	Room	Item	Quantity	
	Block 25-28, Flat 26	Kitchen 106	Strongly presumed vinyl tiles to concrete floor	6m <sup>2</sup>	
	Sample No (S,SP,P,As)	Product Type	Surface Treatment	Condition	Accessibility
Visual (SP)	Textured Coating (1)	Completely Sealed (0)	Good Condition (0)	Usually inaccessible or unlikely to be disturbed (0)

Normal Occupancy	Score	Likelihood of disturbance	Score	Exposure Potential	Score	Maintenance Activity	Score
Main type of activity	1	Location	2	Number of occupants	1	Type of Maintenance	0
		Accessibility	0	Frequency of use	3	Frequency of maintenance	0
		Amount	1	Average Time	1		
Average Score	1	Average Score	1	Average Score	2	Average Score	0
Average of Priority	4						
Material Assessment Score	2						
Recommendation	Inspection required						
Surveyor comments	Located beneath fixed non-suspect blue vinyl flooring. No access at the time of the survey due to the potential to cause damage to fixtures and fittings.

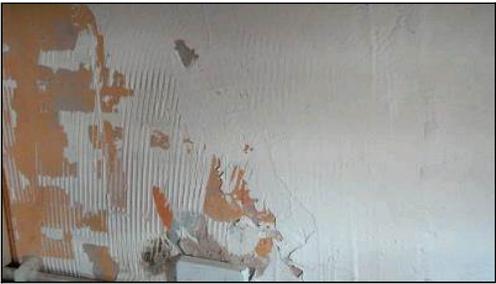
<b>Survey Date:</b>	<b>Lead Surveyor</b>	<b>Survey Type</b>	<b>Floor</b>	<b>Analysis</b>
	9 Dec 2019	Dave Milton	Management Survey	1st	
	<b>Building</b>	<b>Room</b>	<b>Item</b>	<b>Quantity</b>	
	Block 25-28, Flat 26	Kitchen 106	Textured coating to plastered block wall beneath unit	1m <sup>2</sup>	
	<b>Sample No (S,SP,P,As)</b>	<b>Product Type</b>	<b>Surface Treatment</b>	<b>Condition</b>	<b>Accessibility</b>
	AI008227 (S)	Textured Coating (1)	Completely Sealed (0)	Medium Damage (2)	Easily disturbed (2)

Normal Occupancy	Score	Likelihood of disturbance	Score	Exposure Potential	Score	Maintenance Activity	Score
Main type of activity	N/A	Location	N/A	Number of occupants	N/A	Type of Maintenance	N/A
		Accessibility	N/A	Frequency of use	N/A	Frequency of maintenance	N/A
		Amount	N/A	Average Time	N/A		
Average Score	N/A	Average Score	N/A	Average Score	N/A	Average Score	N/A
Average of Priority	N/A						
Material Assessment Score	N/A						
Recommendation	No further action required						
Surveyor comments	N/A

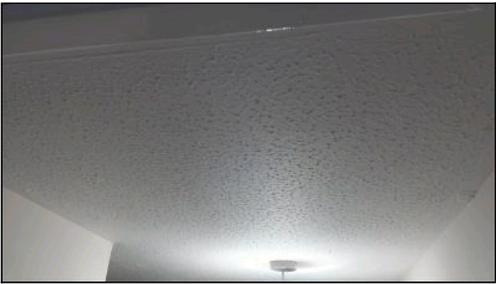
<b>Survey Date:</b>	<b>Lead Surveyor</b>	<b>Survey Type</b>	<b>Floor</b>	<b>Analysis</b>
	9 Dec 2019	Dave Milton	Management Survey	1st	Chrysotile (1)
	<b>Building</b>	<b>Room</b>	<b>Item</b>	<b>Quantity</b>	
	Block 25-28, Flat 26	Landing 107	Textured coating to plasterboard ceiling	5m <sup>2</sup>	
	<b>Sample No (S,SP,P,As)</b>	<b>Product Type</b>	<b>Surface Treatment</b>	<b>Condition</b>	<b>Accessibility</b>
AI008228 (S)	Textured Coating (1)	Completely Sealed (0)	Low Damage (1)	Occasionally likely to be disturbed (1)

Normal Occupancy	Score	Likelihood of disturbance	Score	Exposure Potential	Score	Maintenance Activity	Score
Main type of activity	1	Location	2	Number of occupants	1	Type of Maintenance	1
		Accessibility	1	Frequency of use	3	Frequency of maintenance	1
		Amount	1	Average Time	0		
Average Score	1	Average Score	2	Average Score	2	Average Score	1
Average of Priority	6						
Material Assessment Score	3						
Recommendation	Manage and re-inspect						
Surveyor comments	N/A

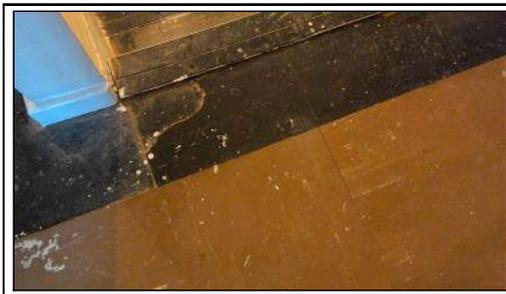
<b>Survey Date:</b>	<b>Lead Surveyor</b>	<b>Survey Type</b>	<b>Floor</b>	<b>Analysis</b>
9 Dec 2019	Dave Milton	Management Survey	1st	Chrysotile (1)
<b>Building</b>	<b>Room</b>	<b>Item</b>	<b>Quantity</b>	
Block 25-28, Flat 26	Landing 107	Dark brown vinyl tiles to concrete floor	2m <sup>2</sup>	
<b>Sample No (S,SP,P,As)</b>	<b>Product Type</b>	<b>Surface Treatment</b>	<b>Condition</b>	<b>Accessibility</b>
As AI008219 (SP)	Vinyl floor tiles (1)	Completely Sealed (0)	Low Damage (1)	Routinely disturbed (3)

Normal Occupancy	Score	Likelihood of disturbance	Score	Exposure Potential	Score	Maintenance Activity	Score
Main type of activity	1	Location	2	Number of occupants	1	Type of Maintenance	1
		Accessibility	3	Frequency of use	3	Frequency of maintenance	1
		Amount	1	Average Time	0		
Average Score	1	Average Score	2	Average Score	2	Average Score	1
Average of Priority	<b>6</b>						
Material Assessment Score	<b>3</b>						
Recommendation	<b>Manage and re-inspect</b>						
Surveyor comments	<b>N/A</b>

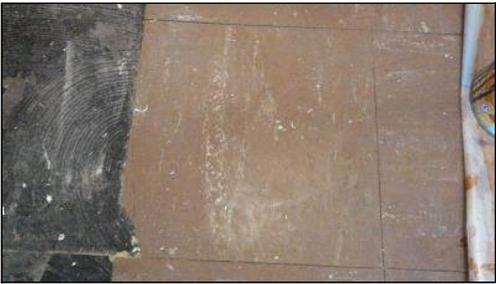
Survey Date:	Lead Surveyor	Survey Type	Floor	Analysis
	9 Dec 2019	Dave Milton	Management Survey	1st	Chrysotile (1)
	Building	Room	Item	Quantity	
	Block 25-28, Flat 26	Landing 107	Beige vinyl tiles and bitumen adhesive to concrete floor	3m <sup>2</sup>	
	Sample No (S,SP,P,As)	Product Type	Surface Treatment	Condition	Accessibility
	As AI008220 (SP)	Vinyl floor tiles (1)	Completely Sealed (0)	Low Damage (1)	Routinely disturbed (3)

Normal Occupancy	Score	Likelihood of disturbance	Score	Exposure Potential	Score	Maintenance Activity	Score
Main type of activity	1	Location	2	Number of occupants	1	Type of Maintenance	1
		Accessibility	3	Frequency of use	3	Frequency of maintenance	1
		Amount	1	Average Time	0		
Average Score	1	Average Score	2	Average Score	2	Average Score	1
Average of Priority	6						
Material Assessment Score	3						
Recommendation	Manage and re-inspect						
Surveyor comments	N/A

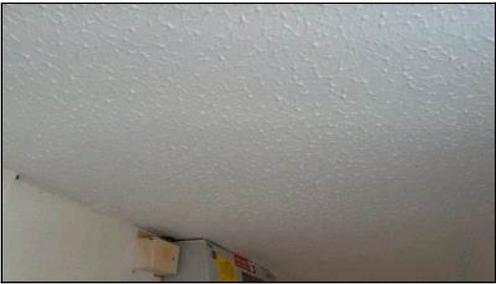
Survey Date:	Lead Surveyor	Survey Type	Floor	Analysis
	9 Dec 2019	Dave Milton	Management Survey	1st	Chrysotile (1)
	Building	Room	Item	Quantity	
	Block 25-28, Flat 26	Electric Cupboard 108	Textured coating to plasterboard ceiling	2m <sup>2</sup>	
	Sample No (S,SP,P,As)	Product Type	Surface Treatment	Condition	Accessibility
AI008229 (S)	Textured Coating (1)	Completely Sealed (0)	Good Condition (0)	Occasionally likely to be disturbed (1)

Normal Occupancy	Score	Likelihood of disturbance	Score	Exposure Potential	Score	Maintenance Activity	Score
Main type of activity	1	Location	2	Number of occupants	1	Type of Maintenance	1
		Accessibility	1	Frequency of use	3	Frequency of maintenance	1
		Amount	1	Average Time	0		
Average Score	1	Average Score	2	Average Score	2	Average Score	1
Average of Priority	6						
Material Assessment Score	2						
Recommendation	Manage and re-inspect						
Surveyor comments	N/A

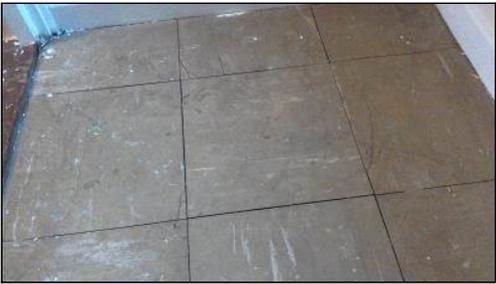
Survey Date:	Lead Surveyor	Survey Type	Floor	Analysis
	9 Dec 2019	Dave Milton	Management Survey	1st	Chrysotile (1)
	Building	Room	Item	Quantity	
	Block 25-28, Flat 26	Electric Cupboard 108	Beige vinyl tiles and bitumen adhesive to concrete floor	2m <sup>2</sup>	
	Sample No (S,SP,P,As)	Product Type	Surface Treatment	Condition	Accessibility
	As AI008220 (SP)	Vinyl floor tiles (1)	Completely Sealed (0)	Low Damage (1)	Routinely disturbed (3)

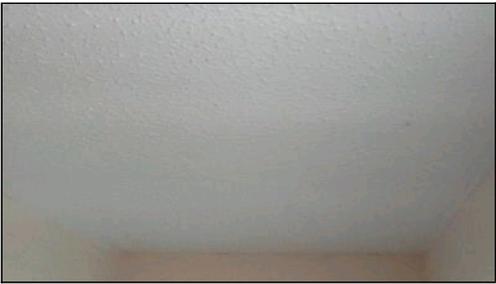
<b>Survey Date:</b>	<b>Lead Surveyor</b>	<b>Survey Type</b>	<b>Floor</b>	<b>Analysis</b>
	9 Dec 2019	Dave Milton	Management Survey	1st	Chrysotile (1)
	<b>Building</b>	<b>Room</b>	<b>Item</b>	<b>Quantity</b>	
	Block 25-28, Flat 26	Toilet 109	Textured coating to plasterboard ceiling	2m <sup>2</sup>	
	<b>Sample No (S,SP,P,As)</b>	<b>Product Type</b>	<b>Surface Treatment</b>	<b>Condition</b>	<b>Accessibility</b>
AI008230 (S)	Textured Coating (1)	Completely Sealed (0)	Good Condition (0)	Occasionally likely to be disturbed (1)

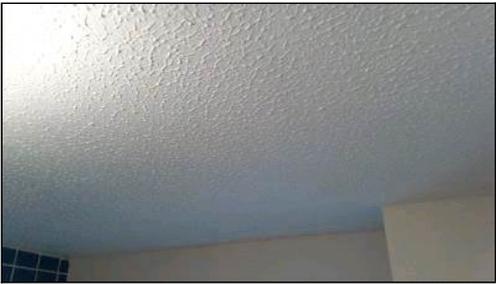
<b>Survey Date:</b>	<b>Lead Surveyor</b>	<b>Survey Type</b>	<b>Floor</b>	<b>Analysis</b>
	9 Dec 2019	Dave Milton	Management Survey	1st	Chrysotile (1)
	<b>Building</b>	<b>Room</b>	<b>Item</b>	<b>Quantity</b>	
	Block 25-28, Flat 26	Bathroom 110	Textured coating to plasterboard ceiling	3m <sup>2</sup>	
	<b>Sample No (S,SP,P,As)</b>	<b>Product Type</b>	<b>Surface Treatment</b>	<b>Condition</b>	<b>Accessibility</b>
	AI008231 (S)	Textured Coating (1)	Completely Sealed (0)	Good Condition (0)	Occasionally likely to be disturbed (1)

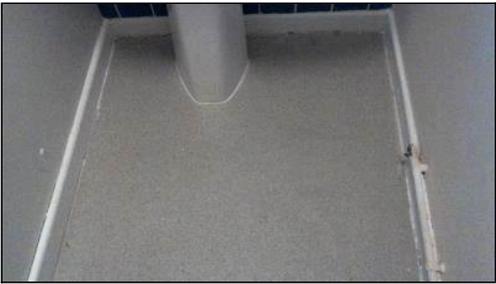
<b>Survey Date:</b>	<b>Lead Surveyor</b>	<b>Survey Type</b>	<b>Floor</b>	<b>Analysis</b>
	9 Dec 2019	Dave Milton	Management Survey	1st	Chrysotile (1)
	<b>Building</b>	<b>Room</b>	<b>Item</b>	<b>Quantity</b>	
	Block 25-28, Flat 26	Bathroom 110	Strongly presumed vinyl tiles to concrete floor	2m <sup>2</sup>	
	<b>Sample No (S,SP,P,As)</b>	<b>Product Type</b>	<b>Surface Treatment</b>	<b>Condition</b>	<b>Accessibility</b>
	Visual (SP)	Textured Coating (1)	Completely Sealed (0)	Good Condition (0)	Usually inaccessible or unlikely to be disturbed (0)

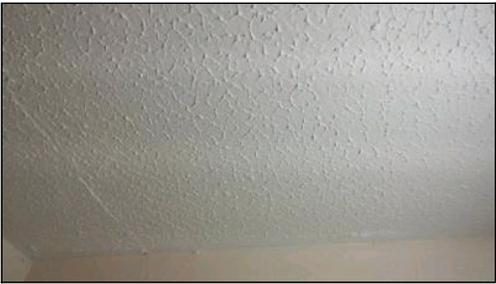
Survey Date:	Lead Surveyor	Survey Type	Floor	Analysis
	9 Dec 2019	Dave Milton	Management Survey	1st	Chrysotile (1)
	Building	Room	Item	Quantity	
	Block 25-28, Flat 26	Boiler Cupboard 111	Textured coating to plasterboard ceiling	1m <sup>2</sup>	
	Sample No (S,SP,P,As)	Product Type	Surface Treatment	Condition	Accessibility
	AI008232 (S)	Textured Coating (1)	Completely Sealed (0)	Good Condition (0)	Occasionally likely to be disturbed (1)

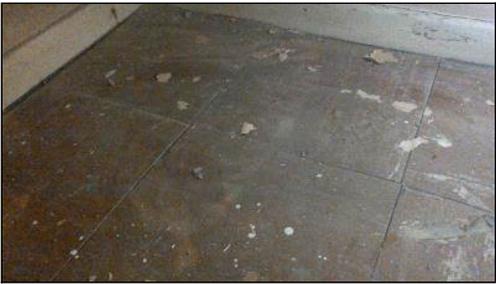
<b>Survey Date:</b>	<b>Lead Surveyor</b>	<b>Survey Type</b>	<b>Floor</b>	<b>Analysis</b>
	9 Dec 2019	Dave Milton	Management Survey	1st	Chrysotile (1)
	<b>Building</b>	<b>Room</b>	<b>Item</b>	<b>Quantity</b>	
	Block 25-28, Flat 26	Boiler Cupboard 111	Beige vinyl tiles and bitumen adhesive to concrete floor	1m <sup>2</sup>	
	<b>Sample No (S,SP,P,As)</b>	<b>Product Type</b>	<b>Surface Treatment</b>	<b>Condition</b>	<b>Accessibility</b>
	As AI008220 (SP)	Vinyl floor tiles (1)	Completely Sealed (0)	Good Condition (0)	Routinely disturbed (3)

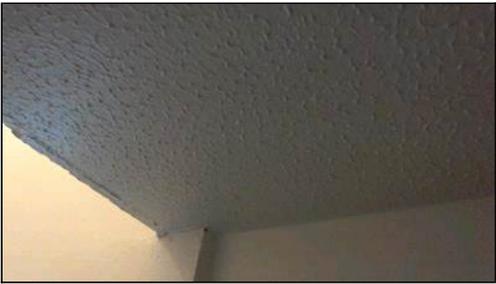
<b>Survey Date:</b>	<b>Lead Surveyor</b>	<b>Survey Type</b>	<b>Floor</b>	<b>Analysis</b>
	9 Dec 2019	Dave Milton	Management Survey	Ground	Chrysotile (1)
	<b>Building</b>	<b>Room</b>	<b>Item</b>	<b>Quantity</b>	
	Block 25-28, Flat 26	Hall G01	Textured coating to concrete and plasterboard ceiling	4m <sup>2</sup>	
	<b>Sample No (S,SP,P,As)</b>	<b>Product Type</b>	<b>Surface Treatment</b>	<b>Condition</b>	<b>Accessibility</b>
	AI008234 (S)	Textured Coating (1)	Completely Sealed (0)	Good Condition (0)	Occasionally likely to be disturbed (1)

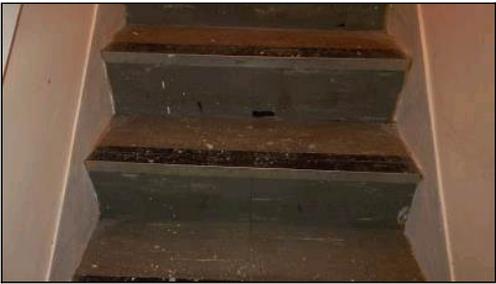
<b>Survey Date:</b>	<b>Lead Surveyor</b>	<b>Survey Type</b>	<b>Floor</b>	<b>Analysis</b>
	9 Dec 2019	Dave Milton	Management Survey	Ground	Chrysotile (1)
	<b>Building</b>	<b>Room</b>	<b>Item</b>	<b>Quantity</b>	
	Block 25-28, Flat 26	Hall G01	Green vinyl tiles and bitumen adhesive to concrete stairs	3m <sup>2</sup>	
	<b>Sample No (S,SP,P,As)</b>	<b>Product Type</b>	<b>Surface Treatment</b>	<b>Condition</b>	<b>Accessibility</b>
	AI008235 (S)	Vinyl floor tiles (1)	Completely Sealed (0)	Low Damage (1)	Routinely disturbed (3)

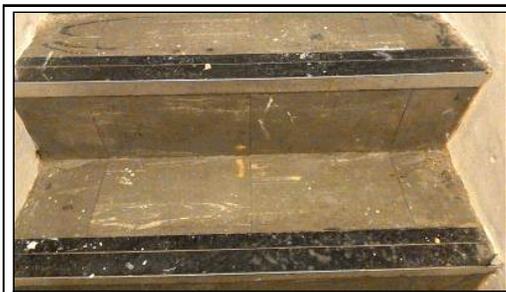
<b>Survey Date:</b>	<b>Lead Surveyor</b>	<b>Survey Type</b>	<b>Floor</b>	<b>Analysis</b>
9 Dec 2019	Dave Milton	Management Survey	Ground	Chrysotile (1)
<b>Building</b>	<b>Room</b>	<b>Item</b>	<b>Quantity</b>	
Block 25-28, Flat 26	Hall G01	Black vinyl stair nosing	12lm	
<b>Sample No (S,SP,P,As)</b>	<b>Product Type</b>	<b>Surface Treatment</b>	<b>Condition</b>	<b>Accessibility</b>
AI008236 (S)	Reinforced Composite (1)	Completely Sealed (0)	Low Damage (1)	Routinely disturbed (3)
