# **Asbestos Survey Report**

**Project Ref. No: M10538**

**3 St Peters Court**

**Full type 2 survey**

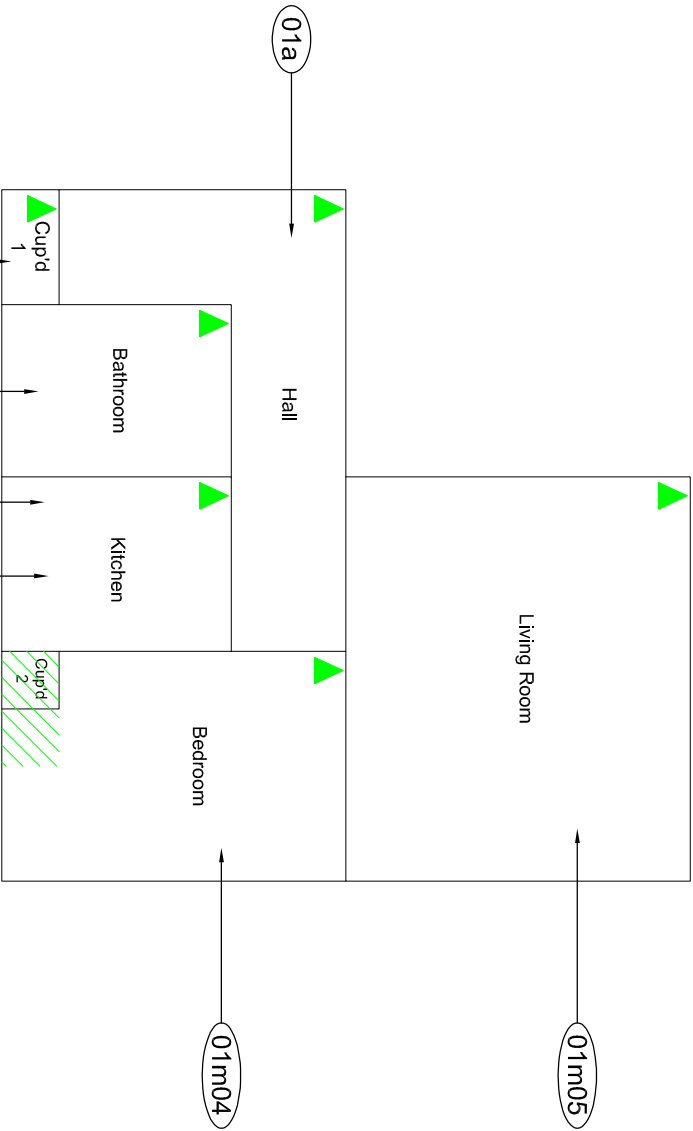
- 01a -DENOTES SAMPLES PRESUMED OR TESTED POSITIVE FOR ASBESTOS CONTENT
- 01a -DENOTES SAMPLES PRESUMED OR TESTED NEGATIVE FOR ASBESTOS CONTENT
- DENOTES NO ACCESS BENEATH FITTED FLOORING
