Management Survey

35 Constantine Court  
Constantine Street  
Williamstown  
Penygraig  
Rhondda  
CF40 1QL  
UPRN: 6393

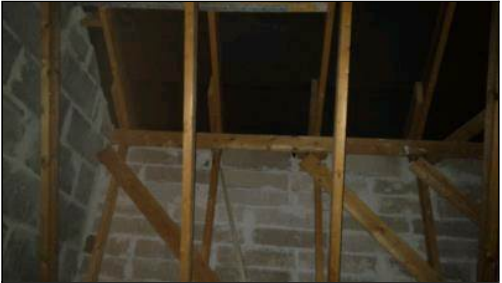
| | Survey Date: | Lead Surveyor | Survey Type | Floor | Analysis |
|---|---|---|---|---|---|
| | 6 Nov 2017 | Dave Milton | Management Survey | Roof | N/A |

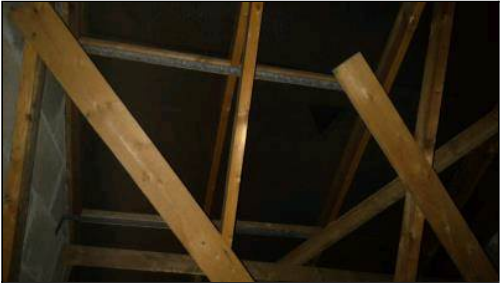
| | Survey Date: | Lead Surveyor | Survey Type | Floor | Analysis |
|---|---|---|---|---|---|
| | 6 Nov 2017 | Dave Milton | Management Survey | Roof | N/A |

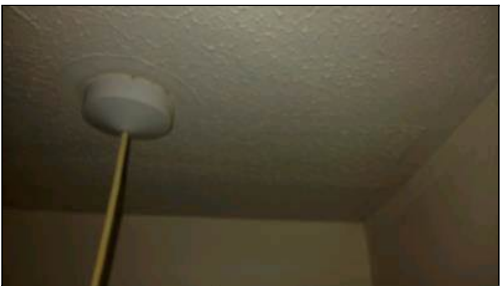
| | 6 Nov 2017 | Dave Milton | Management Survey | 2nd | No Asbestos Detected (0) |

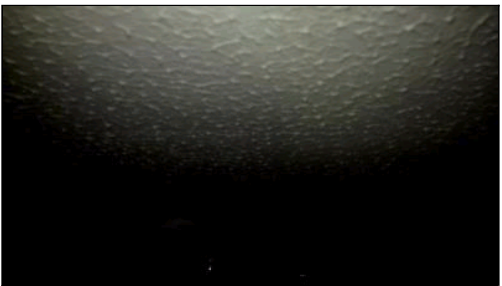
| | Survey Date: | Lead Surveyor | Survey Type | Floor | Analysis |
|---|---|---|---|---|---|
| | 6 Nov 2017 | Dave Milton | Management Survey | 2nd | No Asbestos Detected (0) |

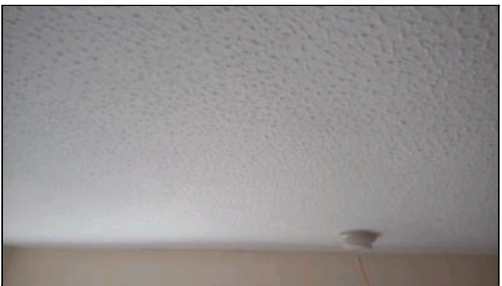
| | Survey Date: | Lead Surveyor | Survey Type | Floor | Analysis |
|---|---|---|---|---|---|
| | 6 Nov 2017 | Dave Milton | Management Survey | 2nd | No Asbestos Detected (0) |

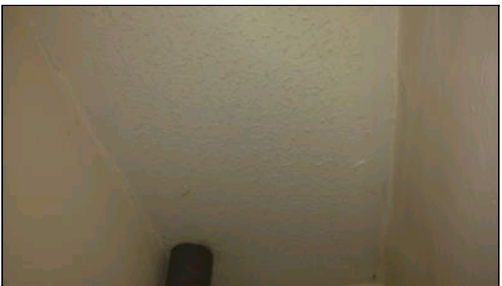
| | Survey Date: | Lead Surveyor | Survey Type | Floor | Analysis |
|---|---|---|---|---|---|
| | 6 Nov 2017 | Dave Milton | Management Survey | 2nd | No Asbestos Detected (0) |

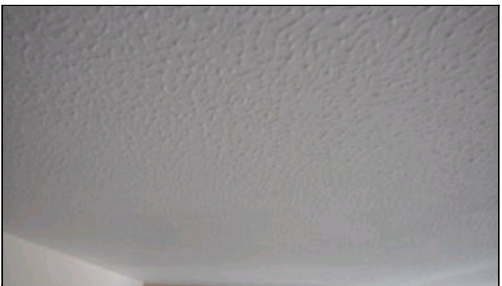
| | Survey Date: | Lead Surveyor | Survey Type | Floor | Analysis |
|---|---|---|---|---|---|
| | 6 Nov 2017 | Dave Milton | Management Survey | 2nd | No Asbestos Detected (0) |

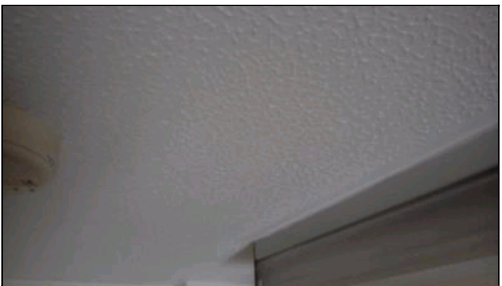
| | Survey Date: | Lead Surveyor | Survey Type | Floor | Analysis |
|---|---|---|---|---|---|
| | 6 Nov 2017 | Dave Milton | Management Survey | 2nd | No Asbestos Detected (0) |
