**WALES & WEST HOUSING  
ASSOCIATION  
3 ALEXANDRA GATE  
FFORDD PENGAM  
TREMORFA  
CARDIFF  
CF24 2UD**

**PROJECT NO:** J024782

**DATE:** AUGUST 2012

**ASBESTOS MANAGEMENT SURVEY  
OF  
LLYS BEN BOWEN THOMAS, GELLIGALED STREET, YSTRAD, CF41 7SB**

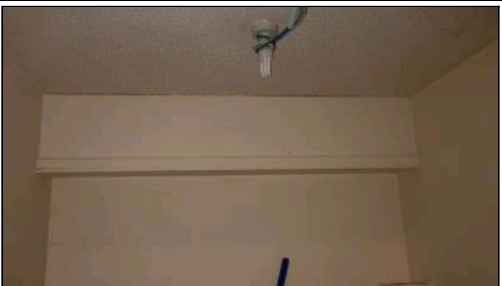
Survey Date:	Lead Surveyor	Survey Type	Floor	Analysis
	3 Oct 2017	Ben Coleman	Refurbishment Survey	Ground	No Asbestos Detected (0)
	Building	Room	Item	Quantity	
	Block 1-40	Store G01	Insulating board panels forming horizontal boxing.	1m <sup>2</sup>	
	Sample No (S,SP,P,As)	Product Type	Surface Treatment	Condition	Accessibility
	AI003646 (S)	Insulation board (2)	Surface Sealed (1)	Good Condition (0)	Occasionally likely to be disturbed (1)

Normal Occupancy	Score	Likelihood of disturbance	Score	Exposure Potential	Score	Maintenance Activity	Score
Main type of activity	N/A	Location	N/A	Number of occupants	N/A	Type of Maintenance	N/A
		Accessibility	N/A	Frequency of use	N/A	Frequency of maintenance	N/A
		Amount	N/A	Average Time	N/A		
Average Score	N/A	Average Score	N/A	Average Score	N/A	Average Score	N/A
Average of Priority	N/A						
Material Assessment Score	N/A						
Recommendation	No further action required						
Surveyor comments	Please refer to Section 6.2 of this report and project desktop study (additional inspection required if going beyond suspect material).

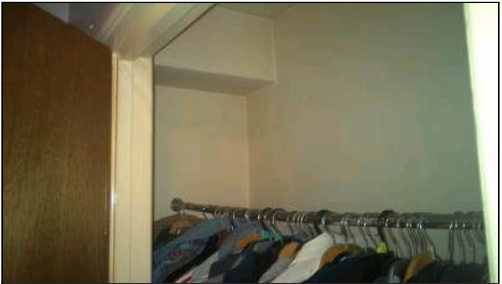
Survey Date:	Lead Surveyor	Survey Type	Floor	Analysis
	3 Oct 2017	Ben Coleman	Refurbishment Survey	Ground	N/A
	Building	Room	Item	Quantity	
	Block 1-40	Store G02	No suspect materials identified	N/A	
	Sample No (S,SP,P,As)	Product Type	Surface Treatment	Condition	Accessibility
	Visual (P)	N/A	N/A	N/A	N/A

Normal Occupancy	Score	Likelihood of disturbance	Score	Exposure Potential	Score	Maintenance Activity	Score
Main type of activity	N/A	Location	N/A	Number of occupants	N/A	Type of Maintenance	N/A
		Accessibility	N/A	Frequency of use	N/A	Frequency of maintenance	N/A
		Amount	N/A	Average Time	N/A		
Average Score	N/A	Average Score	N/A	Average Score	N/A	Average Score	N/A
Average of Priority	N/A						
Material Assessment Score	N/A						
Recommendation	No further action required						
Surveyor comments	N/A

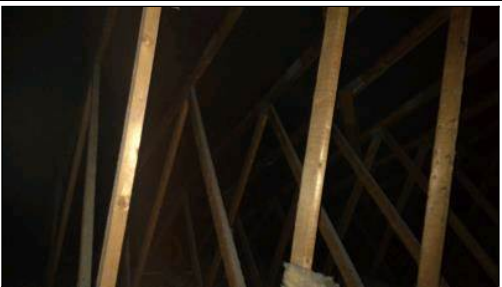
Survey Date:	Lead Surveyor	Survey Type	Floor	Analysis
	24 May 2017	Dave Milton	Refurbishment Survey	Roof	N/A
	Building	Room	Item	Quantity	
	Block 1-40 Llys Ben Bowen Thomas, Communal Areas	Loft space 1 R01	No suspect materials identified	N/A	
	Sample No (S,SP,P,As)	Product Type	Surface Treatment	Condition	Accessibility
	Visual (P)	N/A	N/A	N/A	N/A

Normal Occupancy	Score	Likelihood of disturbance	Score	Exposure Potential	Score	Maintenance Activity	Score
Main type of activity	N/A	Location	N/A	Number of occupants	N/A	Type of Maintenance	N/A
		Accessibility	N/A	Frequency of use	N/A	Frequency of maintenance	N/A
		Amount	N/A	Average Time	N/A		
Average Score	N/A	Average Score	N/A	Average Score	N/A	Average Score	N/A
Average of Priority	N/A						
Material Assessment Score	N/A						
Recommendation	No further action required						
Surveyor comments	N/A

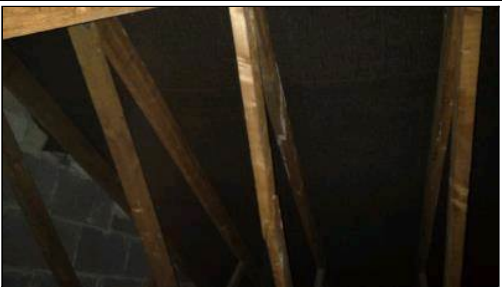
Survey Date:	Lead Surveyor	Survey Type	Floor	Analysis
	24 May 2017	Dave Milton	Refurbishment Survey	Roof	N/A
	Building	Room	Item	Quantity	
	Block 1-40 Llys Ben Bowen Thomas, Communal Areas	Loft space 2 R02	No suspect materials identified	N/A	
	Sample No (S,SP,P,As)	Product Type	Surface Treatment	Condition	Accessibility
	Visual (P)	N/A	N/A	N/A	N/A

Normal Occupancy	Score	Likelihood of disturbance	Score	Exposure Potential	Score	Maintenance Activity	Score
Main type of activity	N/A	Location	N/A	Number of occupants	N/A	Type of Maintenance	N/A
		Accessibility	N/A	Frequency of use	N/A	Frequency of maintenance	N/A
		Amount	N/A	Average Time	N/A		
Average Score	N/A	Average Score	N/A	Average Score	N/A	Average Score	N/A
Average of Priority	N/A						
Material Assessment Score	N/A						
Recommendation	No further action required						
Surveyor comments	N/A

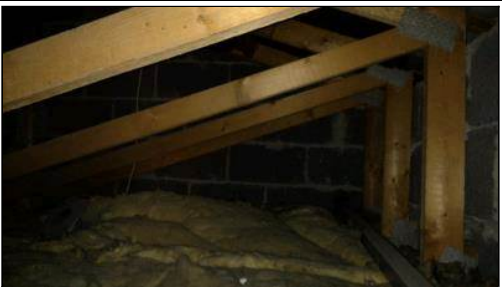
Survey Date:	Lead Surveyor	Survey Type	Floor	Analysis
	24 May 2017	Dave Milton	Refurbishment Survey	Roof	N/A
	Building	Room	Item	Quantity	
	Block 1-40 Llys Ben Bowen Thomas, Communal Areas	Loft space 3 R03	No suspect materials identified	N/A	
	Sample No (S,SP,P,As)	Product Type	Surface Treatment	Condition	Accessibility
	Visual (P)	N/A	N/A	N/A	N/A

Normal Occupancy	Score	Likelihood of disturbance	Score	Exposure Potential	Score	Maintenance Activity	Score
Main type of activity	N/A	Location	N/A	Number of occupants	N/A	Type of Maintenance	N/A
		Accessibility	N/A	Frequency of use	N/A	Frequency of maintenance	N/A
		Amount	N/A	Average Time	N/A		
Average Score	N/A	Average Score	N/A	Average Score	N/A	Average Score	N/A
Average of Priority	N/A						
Material Assessment Score	N/A						
Recommendation	No further action required						
Surveyor comments	N/A

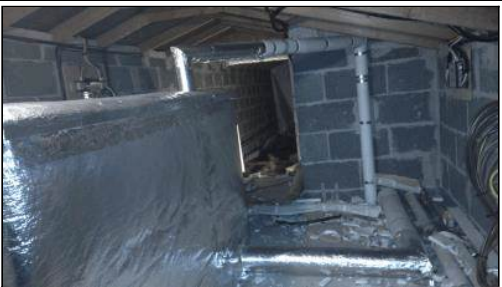
Survey Date:	Lead Surveyor	Survey Type	Floor	Analysis
	24 May 2017	Dave Milton	Refurbishment Survey	Roof	N/A
	Building	Room	Item	Quantity	
	Block 1-40 Llys Ben Bowen Thomas, Communal Areas	Loft space 4 R04	No suspect materials identified	N/A	
	Sample No (S,SP,P,As)	Product Type	Surface Treatment	Condition	Accessibility
	Visual (P)	N/A	N/A	N/A	N/A

Normal Occupancy	Score	Likelihood of disturbance	Score	Exposure Potential	Score	Maintenance Activity	Score
Main type of activity	N/A	Location	N/A	Number of occupants	N/A	Type of Maintenance	N/A
		Accessibility	N/A	Frequency of use	N/A	Frequency of maintenance	N/A
		Amount	N/A	Average Time	N/A		
Average Score	N/A	Average Score	N/A	Average Score	N/A	Average Score	N/A
Average of Priority	N/A						
Material Assessment Score	N/A						
Recommendation	No further action required						
Surveyor comments	N/A

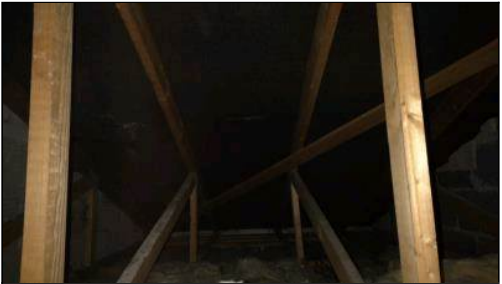
Survey Date:	Lead Surveyor	Survey Type	Floor	Analysis
	24 May 2017	Dave Milton	Refurbishment Survey	Roof	N/A
	Building	Room	Item	Quantity	
	Block 1-40 Llys Ben Bowen Thomas, Communal Areas	Loft space 5 R05	No suspect materials identified	N/A	
	Sample No (S,SP,P,As)	Product Type	Surface Treatment	Condition	Accessibility
	Visual (P)	N/A	N/A	N/A	N/A

Normal Occupancy	Score	Likelihood of disturbance	Score	Exposure Potential	Score	Maintenance Activity	Score
Main type of activity	N/A	Location	N/A	Number of occupants	N/A	Type of Maintenance	N/A
		Accessibility	N/A	Frequency of use	N/A	Frequency of maintenance	N/A
		Amount	N/A	Average Time	N/A		
Average Score	N/A	Average Score	N/A	Average Score	N/A	Average Score	N/A
Average of Priority	N/A						
Material Assessment Score	N/A						
Recommendation	No further action required						
Surveyor comments	N/A

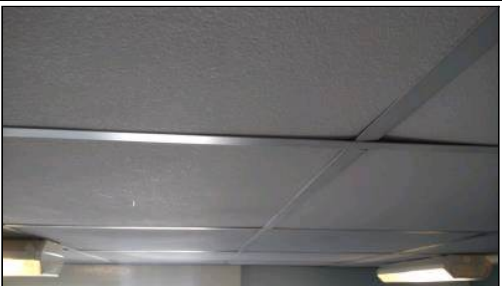
Survey Date:	Lead Surveyor	Survey Type	Floor	Analysis
	24 May 2017	Dave Milton	Refurbishment Survey	2nd	No Asbestos Detected (0)
	Building	Room	Item	Quantity	
	Block 1-40 Llys Ben Bowen Thomas, Communal Areas	Corridor 3 201	Supalux insulating board panels forming suspended ceiling.	50m <sup>2</sup>	
	Sample No (S,SP,P,As)	Product Type	Surface Treatment	Condition	Accessibility
	AE003044 (S)	Insulation board (2)	Surface Sealed (1)	Good Condition (0)	Occasionally likely to be disturbed (1)

Normal Occupancy	Score	Likelihood of disturbance	Score	Exposure Potential	Score	Maintenance Activity	Score
Main type of activity	N/A	Location	N/A	Number of occupants	N/A	Type of Maintenance	N/A
		Accessibility	N/A	Frequency of use	N/A	Frequency of maintenance	N/A
		Amount	N/A	Average Time	N/A		
Average Score	N/A	Average Score	N/A	Average Score	N/A	Average Score	N/A
Average of Priority	N/A						
Material Assessment Score	N/A						
Recommendation	No further action required						
Surveyor comments	N/A

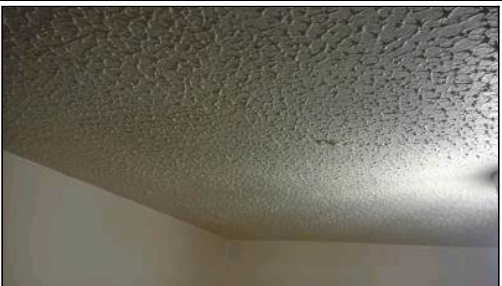
Survey Date:	Lead Surveyor	Survey Type	Floor	Analysis
	24 May 2017	Dave Milton	Refurbishment Survey	2nd	Chrysotile (1)
	Building	Room	Item	Quantity	
	Block 1-40 Llys Ben Bowen Thomas, Communal Areas	Store 202	Textured coating to plasterboard ceiling with non-suspect void above (viewed from corridor).	4m <sup>2</sup>	
	Sample No (S,SP,P,As)	Product Type	Surface Treatment	Condition	Accessibility
	AE003045 (S)	Textured Coating (1)	Completely Sealed (0)	Good Condition (0)	Occasionally likely to be disturbed (1)

Normal Occupancy	Score	Likelihood of disturbance	Score	Exposure Potential	Score	Maintenance Activity	Score
Main type of activity	1	Location	2	Number of occupants	1	Type of Maintenance	1
		Accessibility	1	Frequency of use	3	Frequency of maintenance	1
		Amount	1	Average Time	0		
Average Score	1	Average Score	2	Average Score	2	Average Score	1
Average of Priority	6						
Material Assessment Score	2						
Recommendation	Manage in-situ or remove if affected by works						
Surveyor comments	N/A

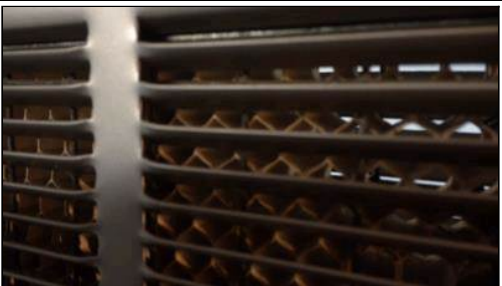
Survey Date:	Lead Surveyor	Survey Type	Floor	Analysis
	24 May 2017	Dave Milton	Refurbishment Survey	2nd	No Asbestos Detected (0)
	Building	Room	Item	Quantity	
	Block 1-40 Llys Ben Bowen Thomas, Communal Areas	Store 202	Paper filter within timber door.	0.25m <sup>2</sup>	
	Sample No (S,SP,P,As)	Product Type	Surface Treatment	Condition	Accessibility
	AE003047 (S)	Textiles/Paper (0)	Surface Sealed (1)	Good Condition (0)	Occasionally likely to be disturbed (1)

Normal Occupancy	Score	Likelihood of disturbance	Score	Exposure Potential	Score	Maintenance Activity	Score
Main type of activity	N/A	Location	N/A	Number of occupants	N/A	Type of Maintenance	N/A
		Accessibility	N/A	Frequency of use	N/A	Frequency of maintenance	N/A
		Amount	N/A	Average Time	N/A		
Average Score	N/A	Average Score	N/A	Average Score	N/A	Average Score	N/A
Average of Priority	N/A						
Material Assessment Score	N/A						
Recommendation	No further action required						
Surveyor comments	N/A

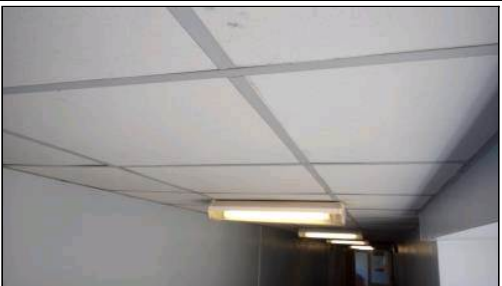
Survey Date:	Lead Surveyor	Survey Type	Floor	Analysis
	24 May 2017	Dave Milton	Refurbishment Survey	2nd	No Asbestos Detected (0)
	Building	Room	Item	Quantity	
	Block 1-40 Llys Ben Bowen Thomas, Communal Areas	Corridor 2 203	Supalux insulating board panels forming suspended ceiling.	30m <sup>2</sup>	
	Sample No (S,SP,P,As)	Product Type	Surface Treatment	Condition	Accessibility
	AE003046 (S)	Insulation board (2)	Surface Sealed (1)	Good Condition (0)	Occasionally likely to be disturbed (1)

Normal Occupancy	Score	Likelihood of disturbance	Score	Exposure Potential	Score	Maintenance Activity	Score
Main type of activity	N/A	Location	N/A	Number of occupants	N/A	Type of Maintenance	N/A
		Accessibility	N/A	Frequency of use	N/A	Frequency of maintenance	N/A
		Amount	N/A	Average Time	N/A		
Average Score	N/A	Average Score	N/A	Average Score	N/A	Average Score	N/A
Average of Priority	N/A						
Material Assessment Score	N/A						
Recommendation	No further action required						
Surveyor comments	N/A

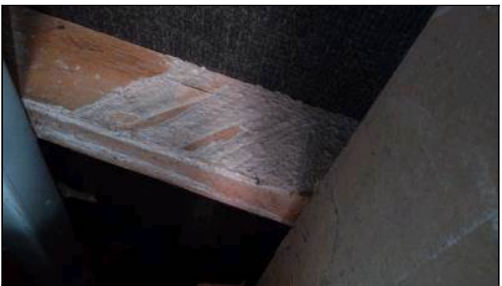
Survey Date:	Lead Surveyor	Survey Type	Floor	Analysis
	24 May 2017	Dave Milton	Refurbishment Survey	2nd	No Asbestos Detected (0)
	Building	Room	Item	Quantity	
	Block 1-40 Llys Ben Bowen Thomas, Communal Areas	Corridor 2 203	Textured coating to timber beam beyond suspended ceiling tiles above window.	1lm	
	Sample No (S,SP,P,As)	Product Type	Surface Treatment	Condition	Accessibility
	AE003052 (S)	Textured Coating (1)	Completely Sealed (0)	Medium Damage (2)	Usually inaccessible or unlikely to be disturbed (0)

Normal Occupancy	Score	Likelihood of disturbance	Score	Exposure Potential	Score	Maintenance Activity	Score
Main type of activity	N/A	Location	N/A	Number of occupants	N/A	Type of Maintenance	N/A
		Accessibility	N/A	Frequency of use	N/A	Frequency of maintenance	N/A
		Amount	N/A	Average Time	N/A		
Average Score	N/A	Average Score	N/A	Average Score	N/A	Average Score	N/A
Average of Priority	N/A						
Material Assessment Score	N/A						
Recommendation	No further action required						
Surveyor comments	N/A

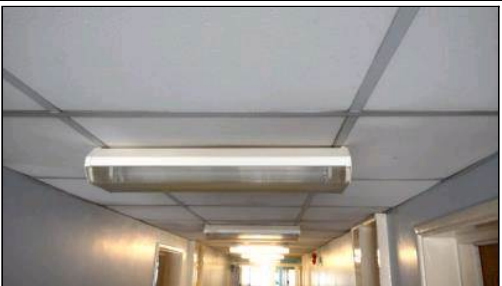
Survey Date:	Lead Surveyor	Survey Type	Floor	Analysis
	24 May 2017	Dave Milton	Refurbishment Survey	2nd	No Asbestos Detected (0)
	Building	Room	Item	Quantity	
	Block 1-40 Llys Ben Bowen Thomas, Communal Areas	Corridor 1 204	Supalux insulating board panels forming suspended ceiling.	30m <sup>2</sup>	
	Sample No (S,SP,P,As)	Product Type	Surface Treatment	Condition	Accessibility
	AE003048 (S)	Insulation board (2)	Surface Sealed (1)	Good Condition (0)	Occasionally likely to be disturbed (1)

Normal Occupancy	Score	Likelihood of disturbance	Score	Exposure Potential	Score	Maintenance Activity	Score
Main type of activity	N/A	Location	N/A	Number of occupants	N/A	Type of Maintenance	N/A
		Accessibility	N/A	Frequency of use	N/A	Frequency of maintenance	N/A
		Amount	N/A	Average Time	N/A		
Average Score	N/A	Average Score	N/A	Average Score	N/A	Average Score	N/A
Average of Priority	N/A						
Material Assessment Score	N/A						
Recommendation	No further action required						
Surveyor comments	N/A

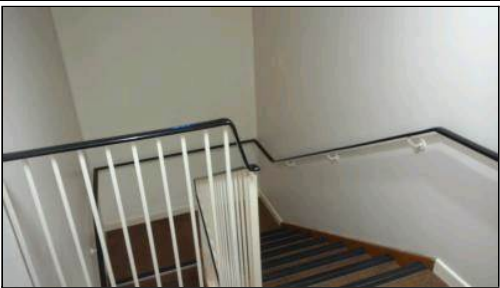
Survey Date:	Lead Surveyor	Survey Type	Floor	Analysis
	24 May 2017	Dave Milton	Refurbishment Survey	2nd	N/A
	Building	Room	Item	Quantity	
	Block 1-40 Llys Ben Bowen Thomas, Communal Areas	Stairwell 3 205	No suspect materials identified	N/A	
	Sample No (S,SP,P,As)	Product Type	Surface Treatment	Condition	Accessibility
	Visual (P)	N/A	N/A	N/A	N/A

Normal Occupancy	Score	Likelihood of disturbance	Score	Exposure Potential	Score	Maintenance Activity	Score
Main type of activity	N/A	Location	N/A	Number of occupants	N/A	Type of Maintenance	N/A
		Accessibility	N/A	Frequency of use	N/A	Frequency of maintenance	N/A
		Amount	N/A	Average Time	N/A		
Average Score	N/A	Average Score	N/A	Average Score	N/A	Average Score	N/A
Average of Priority	N/A						
Material Assessment Score	N/A						
Recommendation	No further action required						
Surveyor comments	N/A

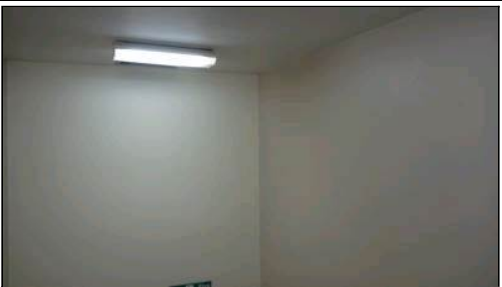
Survey Date:	Lead Surveyor	Survey Type	Floor	Analysis
	24 May 2017	Dave Milton	Refurbishment Survey	2nd	N/A
	Building	Room	Item	Quantity	
	Block 1-40 Llys Ben Bowen Thomas, Communal Areas	Stairwell 2 206	No suspect materials identified	N/A	
	Sample No (S,SP,P,As)	Product Type	Surface Treatment	Condition	Accessibility
	Visual (P)	N/A	N/A	N/A	N/A

Normal Occupancy	Score	Likelihood of disturbance	Score	Exposure Potential	Score	Maintenance Activity	Score
Main type of activity	N/A	Location	N/A	Number of occupants	N/A	Type of Maintenance	N/A
		Accessibility	N/A	Frequency of use	N/A	Frequency of maintenance	N/A
		Amount	N/A	Average Time	N/A		
Average Score	N/A	Average Score	N/A	Average Score	N/A	Average Score	N/A
Average of Priority	N/A						
Material Assessment Score	N/A						
Recommendation	No further action required						
Surveyor comments	N/A

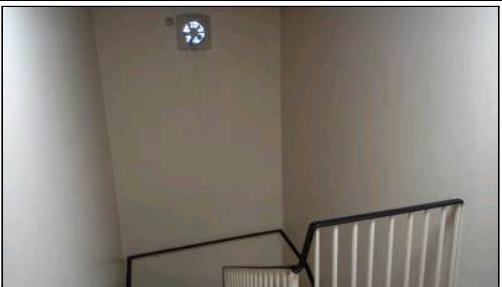
Survey Date:	Lead Surveyor	Survey Type	Floor	Analysis
	24 May 2017	Dave Milton	Refurbishment Survey	2nd	N/A
	Building	Room	Item	Quantity	
	Block 1-40 Llys Ben Bowen Thomas, Communal Areas	Stairwell 1 207	No suspect materials identified	N/A	
	Sample No (S,SP,P,As)	Product Type	Surface Treatment	Condition	Accessibility
	Visual (P)	N/A	N/A	N/A	N/A

Normal Occupancy	Score	Likelihood of disturbance	Score	Exposure Potential	Score	Maintenance Activity	Score
Main type of activity	N/A	Location	N/A	Number of occupants	N/A	Type of Maintenance	N/A
		Accessibility	N/A	Frequency of use	N/A	Frequency of maintenance	N/A
		Amount	N/A	Average Time	N/A		
Average Score	N/A	Average Score	N/A	Average Score	N/A	Average Score	N/A
Average of Priority	N/A						
Material Assessment Score	N/A						
Recommendation	No further action required						
Surveyor comments	N/A

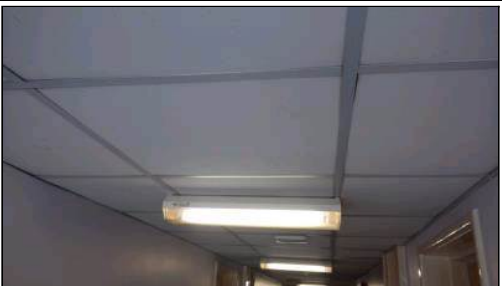
Survey Date:	Lead Surveyor	Survey Type	Floor	Analysis
	24 May 2017	Dave Milton	Refurbishment Survey	1st	No Asbestos Detected (0)
	Building	Room	Item	Quantity	
	Block 1-40 Llys Ben Bowen Thomas, Communal Areas	Corridor 1 101	Supalux insulating board tiles forming suspended ceiling.	50m <sup>2</sup>	
	Sample No (S,SP,P,As)	Product Type	Surface Treatment	Condition	Accessibility
	AE003027 (S)	Insulation board (2)	Surface Sealed (1)	Good Condition (0)	Occasionally likely to be disturbed (1)

Normal Occupancy	Score	Likelihood of disturbance	Score	Exposure Potential	Score	Maintenance Activity	Score
Main type of activity	N/A	Location	N/A	Number of occupants	N/A	Type of Maintenance	N/A
		Accessibility	N/A	Frequency of use	N/A	Frequency of maintenance	N/A
		Amount	N/A	Average Time	N/A		
Average Score	N/A	Average Score	N/A	Average Score	N/A	Average Score	N/A
Average of Priority	N/A						
Material Assessment Score	N/A						
Recommendation	No further action required						
Surveyor comments	N/A

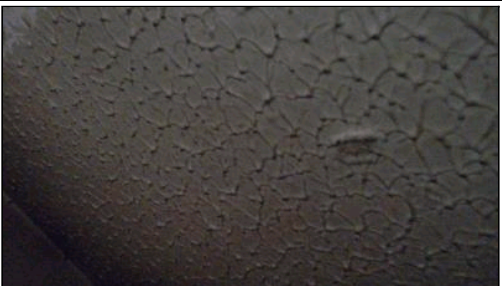
Survey Date:	Lead Surveyor	Survey Type	Floor	Analysis
	24 May 2017	Dave Milton	Refurbishment Survey	1st	Chrysotile (1)
	Building	Room	Item	Quantity	
	Block 1-40 Llys Ben Bowen Thomas, Communal Areas	Store cupboard 102	Textured coating to plasterboard ceiling.	1m <sup>2</sup>	
	Sample No (S,SP,P,As)	Product Type	Surface Treatment	Condition	Accessibility
	AE003028 (S)	Textured Coating (1)	Completely Sealed (0)	Good Condition (0)	Occasionally likely to be disturbed (1)

Normal Occupancy	Score	Likelihood of disturbance	Score	Exposure Potential	Score	Maintenance Activity	Score
Main type of activity	1	Location	2	Number of occupants	1	Type of Maintenance	1
		Accessibility	1	Frequency of use	3	Frequency of maintenance	1
		Amount	1	Average Time	0		
Average Score	1	Average Score	2	Average Score	2	Average Score	1
Average of Priority	6						
Material Assessment Score	2						
Recommendation	Manage in-situ or remove if affected by works						
Surveyor comments	Please refer to Section 6.2 of this report and project desktop study (additional inspection required if going beyond suspect material).

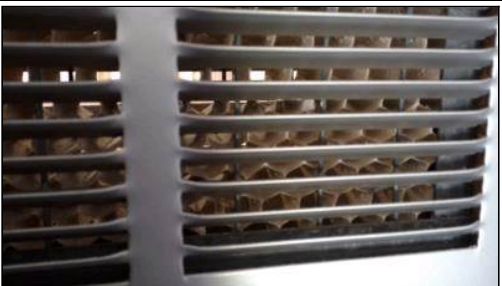
Survey Date:	Lead Surveyor	Survey Type	Floor	Analysis
	24 May 2017	Dave Milton	Refurbishment Survey	1st	No Asbestos Detected (0)
	Building	Room	Item	Quantity	
	Block 1-40 Llys Ben Bowen Thomas, Communal Areas	Store cupboard 102	Paper filter within timber door.	0.25m <sup>2</sup>	
	Sample No (S,SP,P,As)	Product Type	Surface Treatment	Condition	Accessibility
	AE003029 (S)	Textiles/Paper (0)	Surface Sealed (1)	Good Condition (0)	Occasionally likely to be disturbed (1)

Normal Occupancy	Score	Likelihood of disturbance	Score	Exposure Potential	Score	Maintenance Activity	Score
Main type of activity	N/A	Location	N/A	Number of occupants	N/A	Type of Maintenance	N/A
		Accessibility	N/A	Frequency of use	N/A	Frequency of maintenance	N/A
		Amount	N/A	Average Time	N/A		
Average Score	N/A	Average Score	N/A	Average Score	N/A	Average Score	N/A
Average of Priority	N/A						
Material Assessment Score	N/A						
Recommendation	No further action required						
Surveyor comments	N/A

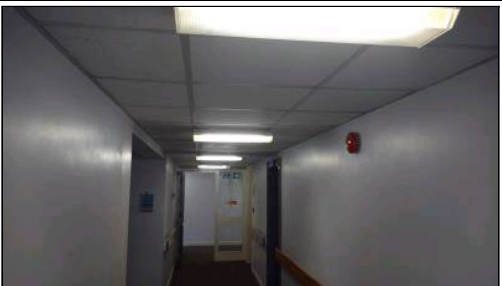
Survey Date:	Lead Surveyor	Survey Type	Floor	Analysis
	24 May 2017	Dave Milton	Refurbishment Survey	1st	No Asbestos Detected (0)
	Building	Room	Item	Quantity	
	Block 1-40 Llys Ben Bowen Thomas, Communal Areas	Corridor 2 103	Supalux insulating board tiles forming suspended ceiling.	20m <sup>2</sup>	
	Sample No (S,SP,P,As)	Product Type	Surface Treatment	Condition	Accessibility
	AE003030 (S)	Insulating Board (0)	Surface Sealed (1)	Good Condition (0)	Occasionally likely to be disturbed (1)

Normal Occupancy	Score	Likelihood of disturbance	Score	Exposure Potential	Score	Maintenance Activity	Score
Main type of activity	N/A	Location	N/A	Number of occupants	N/A	Type of Maintenance	N/A
		Accessibility	N/A	Frequency of use	N/A	Frequency of maintenance	N/A
		Amount	N/A	Average Time	N/A		
Average Score	N/A	Average Score	N/A	Average Score	N/A	Average Score	N/A
Average of Priority	N/A						
Material Assessment Score	N/A						
Recommendation	No further action required						
Surveyor comments	N/A

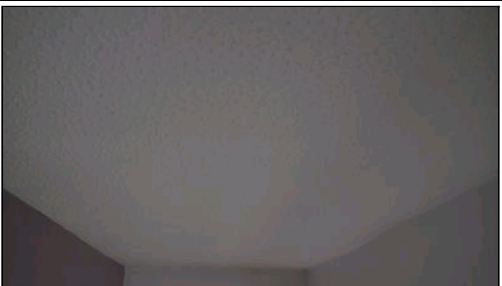
Survey Date:	Lead Surveyor	Survey Type	Floor	Analysis
	24 May 2017	Dave Milton	Refurbishment Survey	1st	Chrysotile (1)
	Building	Room	Item	Quantity	
	Block 1-40 Llys Ben Bowen Thomas, Communal Areas	Corridor 2 103	Textured coating to plasterboard ceiling above doors to toilets and guest shower room.	4m <sup>2</sup>	
	Sample No (S,SP,P,As)	Product Type	Surface Treatment	Condition	Accessibility
	AE003031 (S)	Textured Coating (1)	Completely Sealed (0)	Good Condition (0)	Occasionally likely to be disturbed (1)

Normal Occupancy	Score	Likelihood of disturbance	Score	Exposure Potential	Score	Maintenance Activity	Score
Main type of activity	1	Location	2	Number of occupants	3	Type of Maintenance	1
		Accessibility	1	Frequency of use	3	Frequency of maintenance	1
		Amount	1	Average Time	0		
Average Score	1	Average Score	2	Average Score	2	Average Score	1
Average of Priority	6						
Material Assessment Score	2						
Recommendation	Manage in-situ or remove if affected by works						
Surveyor comments	Please refer to Section 6.2 of this report and project desktop study (additional inspection required if going beyond suspect material).

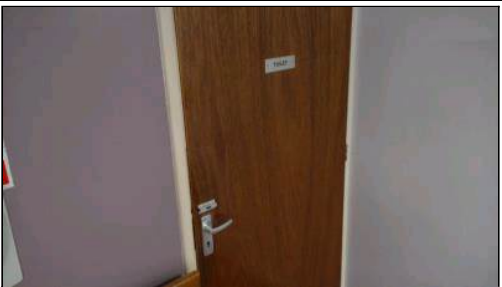
Survey Date:	Lead Surveyor	Survey Type	Floor	Analysis
	24 May 2017	Dave Milton	Refurbishment Survey	1st	N/A
	Building	Room	Item	Quantity	
	Block 1-40 Llys Ben Bowen Thomas, Communal Areas	WC 104	Inaccessible	N/A	
	Sample No (S,SP,P,As)	Product Type	Surface Treatment	Condition	Accessibility
	Visual (P)	N/A	N/A	N/A	N/A

Normal Occupancy	Score	Likelihood of disturbance	Score	Exposure Potential	Score	Maintenance Activity	Score
Main type of activity	N/A	Location	N/A	Number of occupants	N/A	Type of Maintenance	N/A
		Accessibility	N/A	Frequency of use	N/A	Frequency of maintenance	N/A
		Amount	N/A	Average Time	N/A		
Average Score	N/A	Average Score	N/A	Average Score	N/A	Average Score	N/A
Average of Priority	N/A						
Material Assessment Score	N/A						
Recommendation	Inspection Required						
Surveyor comments	Presumed to contain asbestos - inaccessible due to locked door. No key available.

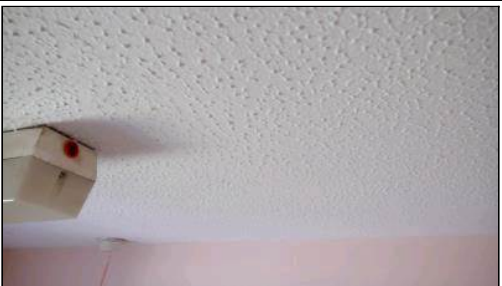
Survey Date:	Lead Surveyor	Survey Type	Floor	Analysis
	24 May 2017	Dave Milton	Refurbishment Survey	1st	Chrysotile (1)
	Building	Room	Item	Quantity	
	Block 1-40 Llys Ben Bowen Thomas, Communal Areas	Disabled WC 105	Textured coating to plasterboard ceiling.	4m <sup>2</sup>	
	Sample No (S,SP,P,As)	Product Type	Surface Treatment	Condition	Accessibility
	AE003032 (S)	Textured Coating (1)	Completely Sealed (0)	Good Condition (0)	Occasionally likely to be disturbed (1)

Normal Occupancy	Score	Likelihood of disturbance	Score	Exposure Potential	Score	Maintenance Activity	Score
Main type of activity	1	Location	2	Number of occupants	1	Type of Maintenance	1
		Accessibility	1	Frequency of use	3	Frequency of maintenance	1
		Amount	1	Average Time	0		
Average Score	1	Average Score	2	Average Score	2	Average Score	1
Average of Priority	6						
Material Assessment Score	2						
Recommendation	Manage in-situ or remove if affected by works						
Surveyor comments	Please refer to Section 6.2 of this report and project desktop study (additional inspection required if going beyond suspect material).

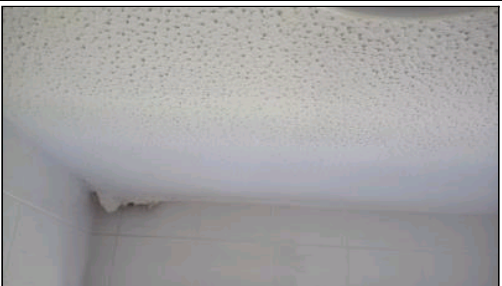
Survey Date:	Lead Surveyor	Survey Type	Floor	Analysis
	24 May 2017	Dave Milton	Refurbishment Survey	1st	Chrysotile (1)
	Building	Room	Item	Quantity	
	Block 1-40 Llys Ben Bowen Thomas, Communal Areas	Guest shower room 106	Textured coating to plasterboard ceiling.	6m <sup>2</sup>	
	Sample No (S,SP,P,As)	Product Type	Surface Treatment	Condition	Accessibility
	AE003033 (S)	Textured Coating (1)	Completely Sealed (0)	Low Damage (1)	Occasionally likely to be disturbed (1)

Normal Occupancy	Score	Likelihood of disturbance	Score	Exposure Potential	Score	Maintenance Activity	Score
Main type of activity	1	Location	2	Number of occupants	0	Type of Maintenance	1
		Accessibility	1	Frequency of use	3	Frequency of maintenance	1
		Amount	1	Average Time	0		
Average Score	1	Average Score	2	Average Score	1	Average Score	1
Average of Priority	5						
Material Assessment Score	3						
Recommendation	Manage in-situ or remove if affected by works						
Surveyor comments	Please refer to Section 6.2 of this report and project desktop study (additional inspection required if going beyond suspect material).

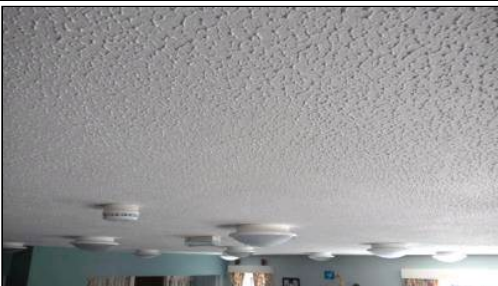
Survey Date:	Lead Surveyor	Survey Type	Floor	Analysis
	24 May 2017	Dave Milton	Refurbishment Survey	1st	Chrysotile (1)
	Building	Room	Item	Quantity	
	Block 1-40 Llys Ben Bowen Thomas, Communal Areas	Communal room 107	Textured coating to plasterboard ceiling.	56m <sup>2</sup>	
	Sample No (S,SP,P,As)	Product Type	Surface Treatment	Condition	Accessibility
	AE003034 (S)	Textured Coating (1)	Completely Sealed (0)	Good Condition (0)	Occasionally likely to be disturbed (1)

Normal Occupancy	Score	Likelihood of disturbance	Score	Exposure Potential	Score	Maintenance Activity	Score
Main type of activity	1	Location	2	Number of occupants	3	Type of Maintenance	1
		Accessibility	1	Frequency of use	3	Frequency of maintenance	1
		Amount	3	Average Time	2		
Average Score	1	Average Score	2	Average Score	3	Average Score	1
Average of Priority	7						
Material Assessment Score	2						
Recommendation	Manage in-situ or remove if affected by works						
Surveyor comments	Please refer to Section 6.2 of this report and project desktop study (additional inspection required if going beyond suspect material).

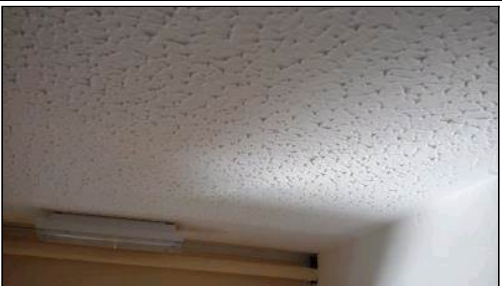
Survey Date:	Lead Surveyor	Survey Type	Floor	Analysis
	24 May 2017	Dave Milton	Refurbishment Survey	1st	Chrysotile (1)
	Building	Room	Item	Quantity	
	Block 1-40 Llys Ben Bowen Thomas, Communal Areas	Kitchen 108	Textured coating to plasterboard ceiling.	16m <sup>2</sup>	
	Sample No (S,SP,P,As)	Product Type	Surface Treatment	Condition	Accessibility
	AE003035 (S)	Textured Coating (1)	Completely Sealed (0)	Good Condition (0)	Occasionally likely to be disturbed (1)

Normal Occupancy	Score	Likelihood of disturbance	Score	Exposure Potential	Score	Maintenance Activity	Score
Main type of activity	1	Location	2	Number of occupants	1	Type of Maintenance	1
		Accessibility	1	Frequency of use	3	Frequency of maintenance	1
		Amount	2	Average Time	1		
Average Score	1	Average Score	2	Average Score	2	Average Score	1
Average of Priority	6						
Material Assessment Score	2						
Recommendation	Manage in-situ or remove if affected by works						
Surveyor comments	Please refer to Section 6.2 of this report and project desktop study (additional inspection required if going beyond suspect material).

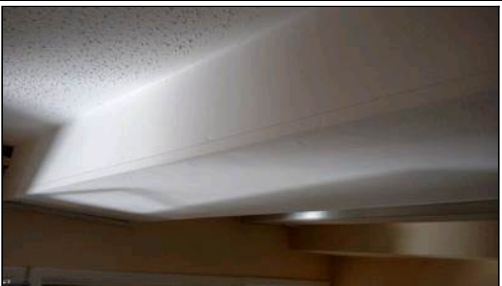
Survey Date:	Lead Surveyor	Survey Type	Floor	Analysis
	24 May 2017	Dave Milton	Refurbishment Survey	1st	No Asbestos Detected (0)
	Building	Room	Item	Quantity	
	Block 1-40 Llys Ben Bowen Thomas, Communal Areas	Kitchen 108	Supalux insulating board panels forming boxing.	4m <sup>2</sup>	
	Sample No (S,SP,P,As)	Product Type	Surface Treatment	Condition	Accessibility
	AE003036 (S)	Insulation board (2)	Surface Sealed (1)	Good Condition (0)	Occasionally likely to be disturbed (1)

Normal Occupancy	Score	Likelihood of disturbance	Score	Exposure Potential	Score	Maintenance Activity	Score
Main type of activity	N/A	Location	N/A	Number of occupants	N/A	Type of Maintenance	N/A
		Accessibility	N/A	Frequency of use	N/A	Frequency of maintenance	N/A
		Amount	N/A	Average Time	N/A		
Average Score	N/A	Average Score	N/A	Average Score	N/A	Average Score	N/A
Average of Priority	N/A						
Material Assessment Score	N/A						
Recommendation	No further action required						
Surveyor comments	Please refer to Section 6.2 of this report and project desktop study (additional inspection required if going beyond suspect material).'

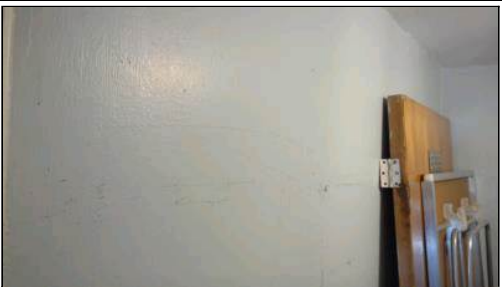
Survey Date:	Lead Surveyor	Survey Type	Floor	Analysis
	24 May 2017	Dave Milton	Refurbishment Survey	1st	No Asbestos Detected (0)
	Building	Room	Item	Quantity	
	Block 1-40 Llys Ben Bowen Thomas, Communal Areas	Store 109	Supalux insulating board panels to wall to back of lift shaft.	4m <sup>2</sup>	
	Sample No (S,SP,P,As)	Product Type	Surface Treatment	Condition	Accessibility
	AE003037 (S)	Insulation board (2)	Surface Sealed (1)	Good Condition (0)	Easily disturbed (2)

Normal Occupancy	Score	Likelihood of disturbance	Score	Exposure Potential	Score	Maintenance Activity	Score
Main type of activity	N/A	Location	N/A	Number of occupants	N/A	Type of Maintenance	N/A
		Accessibility	N/A	Frequency of use	N/A	Frequency of maintenance	N/A
		Amount	N/A	Average Time	N/A		
Average Score	N/A	Average Score	N/A	Average Score	N/A	Average Score	N/A
Average of Priority	N/A						
Material Assessment Score	N/A						
Recommendation	No further action required						
Surveyor comments	Please refer to Section 6.2 of this report and project desktop study (additional inspection required if going beyond suspect material).

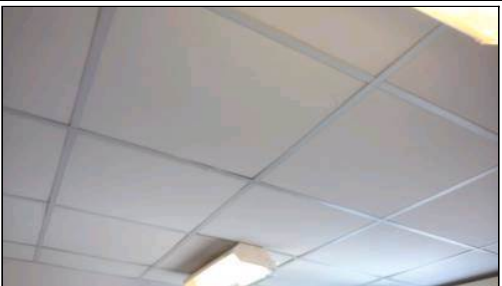
Survey Date:	Lead Surveyor	Survey Type	Floor	Analysis
	24 May 2017	Dave Milton	Refurbishment Survey	1st	No Asbestos Detected (0)
	Building	Room	Item	Quantity	
	Block 1-40 Llys Ben Bowen Thomas, Communal Areas	Corridor 3 110	Supalux insulating board tiles forming suspended ceiling.	60m <sup>2</sup>	
	Sample No (S,SP,P,As)	Product Type	Surface Treatment	Condition	Accessibility
	AE003038 (S)	Insulation board (2)	Surface Sealed (1)	Good Condition (0)	Occasionally likely to be disturbed (1)

Normal Occupancy	Score	Likelihood of disturbance	Score	Exposure Potential	Score	Maintenance Activity	Score
Main type of activity	N/A	Location	N/A	Number of occupants	N/A	Type of Maintenance	N/A
		Accessibility	N/A	Frequency of use	N/A	Frequency of maintenance	N/A
		Amount	N/A	Average Time	N/A		
Average Score	N/A	Average Score	N/A	Average Score	N/A	Average Score	N/A
Average of Priority	N/A						
Material Assessment Score	N/A						
Recommendation	No further action required						
Surveyor comments	N/A

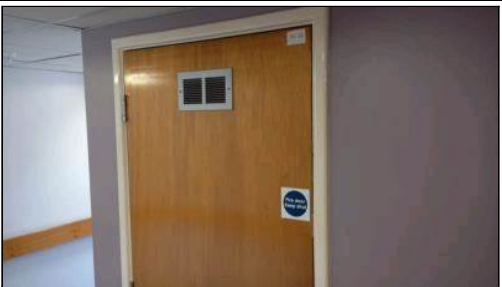
Survey Date:	Lead Surveyor	Survey Type	Floor	Analysis
	24 May 2017	Dave Milton	Refurbishment Survey	1st	N/A
	Building	Room	Item	Quantity	
	Block 1-40 Llys Ben Bowen Thomas, Communal Areas	Cupboard 111	Inaccessible	N/A	
	Sample No (S,SP,P,As)	Product Type	Surface Treatment	Condition	Accessibility
	Visual (P)	N/A	N/A	N/A	N/A

Normal Occupancy	Score	Likelihood of disturbance	Score	Exposure Potential	Score	Maintenance Activity	Score
Main type of activity	N/A	Location	N/A	Number of occupants	N/A	Type of Maintenance	N/A
		Accessibility	N/A	Frequency of use	N/A	Frequency of maintenance	N/A
		Amount	N/A	Average Time	N/A		
Average Score	N/A	Average Score	N/A	Average Score	N/A	Average Score	N/A
Average of Priority	N/A						
Material Assessment Score	N/A						
Recommendation	Inspection Required						
Surveyor comments	Presumed to contain asbestos - inaccessible due to locked door. No key available.

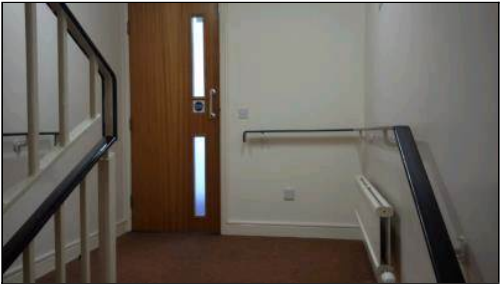
Survey Date:	Lead Surveyor	Survey Type	Floor	Analysis
	24 May 2017	Dave Milton	Refurbishment Survey	1st	N/A
	Building	Room	Item	Quantity	
	Block 1-40 Llys Ben Bowen Thomas, Communal Areas	Stairwell 1 112	No suspect materials identified	N/A	
	Sample No (S,SP,P,As)	Product Type	Surface Treatment	Condition	Accessibility
	Visual (P)	N/A	N/A	N/A	N/A

Normal Occupancy	Score	Likelihood of disturbance	Score	Exposure Potential	Score	Maintenance Activity	Score
Main type of activity	N/A	Location	N/A	Number of occupants	N/A	Type of Maintenance	N/A
		Accessibility	N/A	Frequency of use	N/A	Frequency of maintenance	N/A
		Amount	N/A	Average Time	N/A		
Average Score	N/A	Average Score	N/A	Average Score	N/A	Average Score	N/A
Average of Priority	N/A						
Material Assessment Score	N/A						
Recommendation	No further action required						
Surveyor comments	N/A

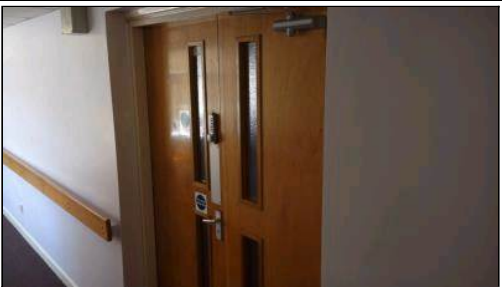
Survey Date:	Lead Surveyor	Survey Type	Floor	Analysis
	24 May 2017	Dave Milton	Refurbishment Survey	1st	N/A
	Building	Room	Item	Quantity	
	Block 1-40 Llys Ben Bowen Thomas, Communal Areas	Computer room 113	Inaccessible	N/A	
	Sample No (S,SP,P,As)	Product Type	Surface Treatment	Condition	Accessibility
	Visual (P)	N/A	N/A	N/A	N/A

Normal Occupancy	Score	Likelihood of disturbance	Score	Exposure Potential	Score	Maintenance Activity	Score
Main type of activity	N/A	Location	N/A	Number of occupants	N/A	Type of Maintenance	N/A
		Accessibility	N/A	Frequency of use	N/A	Frequency of maintenance	N/A
		Amount	N/A	Average Time	N/A		
Average Score	N/A	Average Score	N/A	Average Score	N/A	Average Score	N/A
Average of Priority	N/A						
Material Assessment Score	N/A						
Recommendation	Inspection Required						
Surveyor comments	Presumed to contain asbestos - inaccessible due to locked door. No key available.

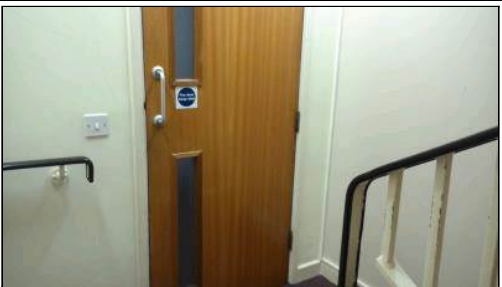
Survey Date:	Lead Surveyor	Survey Type	Floor	Analysis
	24 May 2017	Dave Milton	Refurbishment Survey	1st	N/A
	Building	Room	Item	Quantity	
	Block 1-40 Llys Ben Bowen Thomas, Communal Areas	Stairwell 2 114	No suspect materials identified	N/A	
	Sample No (S,SP,P,As)	Product Type	Surface Treatment	Condition	Accessibility
	Visual (P)	N/A	N/A	N/A	N/A

Normal Occupancy	Score	Likelihood of disturbance	Score	Exposure Potential	Score	Maintenance Activity	Score
Main type of activity	N/A	Location	N/A	Number of occupants	N/A	Type of Maintenance	N/A
		Accessibility	N/A	Frequency of use	N/A	Frequency of maintenance	N/A
		Amount	N/A	Average Time	N/A		
Average Score	N/A	Average Score	N/A	Average Score	N/A	Average Score	N/A
Average of Priority	N/A						
Material Assessment Score	N/A						
Recommendation	No further action required						
Surveyor comments	N/A

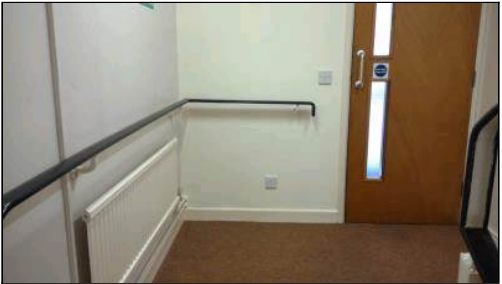
Survey Date:	Lead Surveyor	Survey Type	Floor	Analysis
	24 May 2017	Dave Milton	Refurbishment Survey	1st	N/A
	Building	Room	Item	Quantity	
	Block 1-40 Llys Ben Bowen Thomas, Communal Areas	Stairwell 3 115	No suspect materials identified	N/A	
	Sample No (S,SP,P,As)	Product Type	Surface Treatment	Condition	Accessibility
	Visual (P)	N/A	N/A	N/A	N/A

Normal Occupancy	Score	Likelihood of disturbance	Score	Exposure Potential	Score	Maintenance Activity	Score
Main type of activity	N/A	Location	N/A	Number of occupants	N/A	Type of Maintenance	N/A
		Accessibility	N/A	Frequency of use	N/A	Frequency of maintenance	N/A
		Amount	N/A	Average Time	N/A		
Average Score	N/A	Average Score	N/A	Average Score	N/A	Average Score	N/A
Average of Priority	N/A						
Material Assessment Score	N/A						
Recommendation	No further action required						
Surveyor comments	N/A

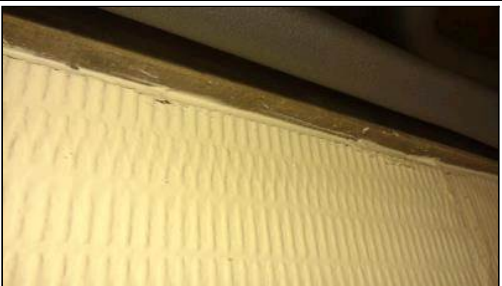
Survey Date:	Lead Surveyor	Survey Type	Floor	Analysis
	24 May 2017	Dave Milton	Refurbishment Survey	Ground	Chrysotile (1)
	Building	Room	Item	Quantity	
	Block 1-40 Llys Ben Bowen Thomas, Communal Areas	Boiler room G02	Cement panels above doors.	3lm	
	Sample No (S,SP,P,As)	Product Type	Surface Treatment	Condition	Accessibility
	AE003039 (S)	Asbestos Cement (1)	Surface Sealed (1)	Good Condition (0)	Occasionally likely to be disturbed (1)

Normal Occupancy	Score	Likelihood of disturbance	Score	Exposure Potential	Score	Maintenance Activity	Score
Main type of activity	0	Location	2	Number of occupants	1	Type of Maintenance	1
		Accessibility	1	Frequency of use	2	Frequency of maintenance	1
		Amount	1	Average Time	0		
Average Score	0	Average Score	2	Average Score	1	Average Score	1
Average of Priority	4						
Material Assessment Score	3						
Recommendation	Manage in-situ or remove if affected by works						
Surveyor comments	N/A

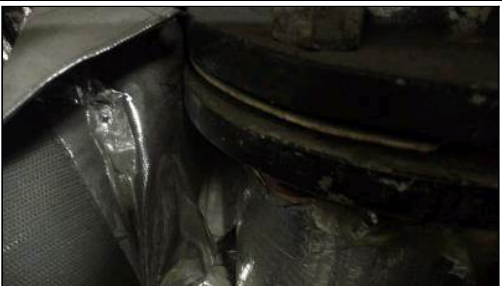
Survey Date:	Lead Surveyor	Survey Type	Floor	Analysis
	24 May 2017	Dave Milton	Refurbishment Survey	Ground	No Asbestos Detected (0)
	Building	Room	Item	Quantity	
	Block 1-40 Llys Ben Bowen Thomas, Communal Areas	Boiler room G02	Gasket to metal pipework.	<12no.	
	Sample No (S,SP,P,As)	Product Type	Surface Treatment	Condition	Accessibility
	AE003040 (S)	Gasket (2)	Surface Sealed (1)	Good Condition (0)	Usually inaccessible or unlikely to be disturbed (0)

Normal Occupancy	Score	Likelihood of disturbance	Score	Exposure Potential	Score	Maintenance Activity	Score
Main type of activity	N/A	Location	N/A	Number of occupants	N/A	Type of Maintenance	N/A
		Accessibility	N/A	Frequency of use	N/A	Frequency of maintenance	N/A
		Amount	N/A	Average Time	N/A		
Average Score	N/A	Average Score	N/A	Average Score	N/A	Average Score	N/A
Average of Priority	N/A						
Material Assessment Score	N/A						
Recommendation	No further action required						
Surveyor comments	N/A

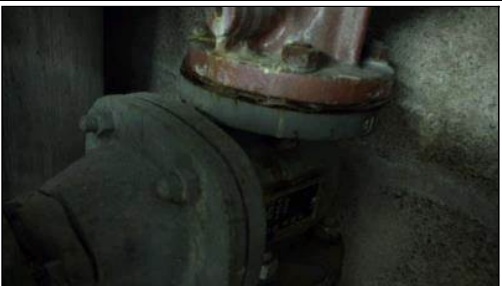
Survey Date:	Lead Surveyor	Survey Type	Floor	Analysis
	24 May 2017	Dave Milton	Refurbishment Survey	Ground	Chrysotile (1)
	Building	Room	Item	Quantity	
	Block 1-40 Llys Ben Bowen Thomas, Communal Areas	Boiler room G02	Gasket to metal pipework.	2no.	
	Sample No (S,SP,P,As)	Product Type	Surface Treatment	Condition	Accessibility
	AE003041 (S)	Gasket (2)	Surface Sealed (1)	Low Damage (1)	Usually inaccessible or unlikely to be disturbed (0)

Normal Occupancy	Score	Likelihood of disturbance	Score	Exposure Potential	Score	Maintenance Activity	Score
Main type of activity	0	Location	2	Number of occupants	1	Type of Maintenance	0
		Accessibility	0	Frequency of use	2	Frequency of maintenance	0
		Amount	0	Average Time	0		
Average Score	0	Average Score	1	Average Score	1	Average Score	0
Average of Priority	2						
Material Assessment Score	5						
Recommendation	Manage in-situ or remove if affected by works						
Surveyor comments	N/A

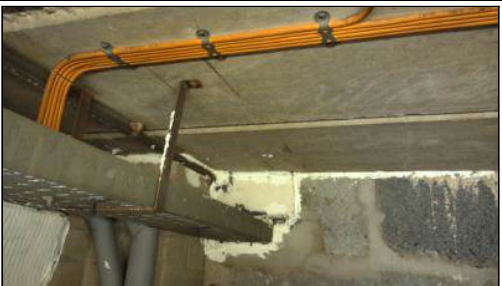
Survey Date:	Lead Surveyor	Survey Type	Floor	Analysis
	24 May 2017	Dave Milton	Refurbishment Survey	Ground	No Asbestos Detected (0)
	Building	Room	Item	Quantity	
	Block 1-40 Llys Ben Bowen Thomas, Communal Areas	Boiler room G02	Supalux insulating board panels to side and back walls where cable trays enter.	2no.	
	Sample No (S,SP,P,As)	Product Type	Surface Treatment	Condition	Accessibility
	AE003042 (S)	Insulation board (2)	Surface Sealed (1)	Low Damage (1)	Occasionally likely to be disturbed (1)

Normal Occupancy	Score	Likelihood of disturbance	Score	Exposure Potential	Score	Maintenance Activity	Score
Main type of activity	N/A	Location	N/A	Number of occupants	N/A	Type of Maintenance	N/A
		Accessibility	N/A	Frequency of use	N/A	Frequency of maintenance	N/A
		Amount	N/A	Average Time	N/A		
Average Score	N/A	Average Score	N/A	Average Score	N/A	Average Score	N/A
Average of Priority	N/A						
Material Assessment Score	N/A						
Recommendation	No further action required						
Surveyor comments	N/A

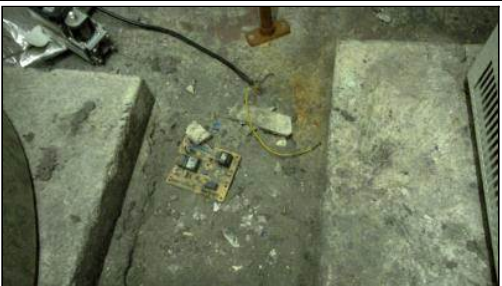
Survey Date:	Lead Surveyor	Survey Type	Floor	Analysis
	24 May 2017	Dave Milton	Refurbishment Survey	Ground	No Asbestos Detected (0)
	Building	Room	Item	Quantity	
	Block 1-40 Llys Ben Bowen Thomas, Communal Areas	Boiler room G02	Supalux insulating board debris on the ground to the side of each of the boiler units.	1m <sup>2</sup>	
	Sample No (S,SP,P,As)	Product Type	Surface Treatment	Condition	Accessibility
	AE003043 (S)	Insulation board (2)	Unsealed (2)	High Damage (3)	Routinely disturbed (3)

Normal Occupancy	Score	Likelihood of disturbance	Score	Exposure Potential	Score	Maintenance Activity	Score
Main type of activity	N/A	Location	N/A	Number of occupants	N/A	Type of Maintenance	N/A
		Accessibility	N/A	Frequency of use	N/A	Frequency of maintenance	N/A
		Amount	N/A	Average Time	N/A		
Average Score	N/A	Average Score	N/A	Average Score	N/A	Average Score	N/A
Average of Priority	N/A						
Material Assessment Score	N/A						
Recommendation	No further action required						
Surveyor comments	N/A

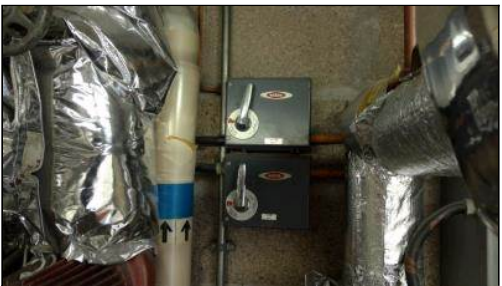
Survey Date:	Lead Surveyor	Survey Type	Floor	Analysis
	24 May 2017	Dave Milton	Refurbishment Survey	Ground	Chrysotile (1)
	Building	Room	Item	Quantity	
	Block 1-40 Llys Ben Bowen Thomas, Communal Areas	Boiler room G02	Strongly presumed textile flash guards within electrical switch gear.	2no.	
	Sample No (S,SP,P,As)	Product Type	Surface Treatment	Condition	Accessibility
	Visual (SP)	Asbestos Textiles/Paper (2)	Surface Sealed (1)	Good Condition (0)	Usually inaccessible or unlikely to be disturbed (0)

Normal Occupancy	Score	Likelihood of disturbance	Score	Exposure Potential	Score	Maintenance Activity	Score
Main type of activity	0	Location	2	Number of occupants	1	Type of Maintenance	1
		Accessibility	0	Frequency of use	2	Frequency of maintenance	1
		Amount	1	Average Time	0		
Average Score	0	Average Score	1	Average Score	1	Average Score	1
Average of Priority	3						
Material Assessment Score	4						
Recommendation	Inspection required						
Surveyor comments	Unable to safely inspect at time of survey due to live electrics.

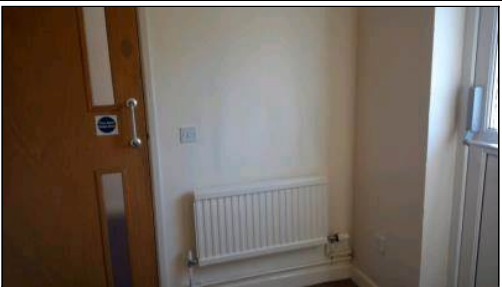
Survey Date:	Lead Surveyor	Survey Type	Floor	Analysis
	24 May 2017	Dave Milton	Refurbishment Survey	Ground	N/A
	Building	Room	Item	Quantity	
	Block 1-40 Llys Ben Bowen Thomas, Communal Areas	Stairwell 1 G03	No suspect materials identified	N/A	
	Sample No (S,SP,P,As)	Product Type	Surface Treatment	Condition	Accessibility
	Visual (P)	N/A	N/A	N/A	N/A

Normal Occupancy	Score	Likelihood of disturbance	Score	Exposure Potential	Score	Maintenance Activity	Score
Main type of activity	N/A	Location	N/A	Number of occupants	N/A	Type of Maintenance	N/A
		Accessibility	N/A	Frequency of use	N/A	Frequency of maintenance	N/A
		Amount	N/A	Average Time	N/A		
Average Score	N/A	Average Score	N/A	Average Score	N/A	Average Score	N/A
Average of Priority	N/A						
Material Assessment Score	N/A						
Recommendation	No further action required						
Surveyor comments	N/A

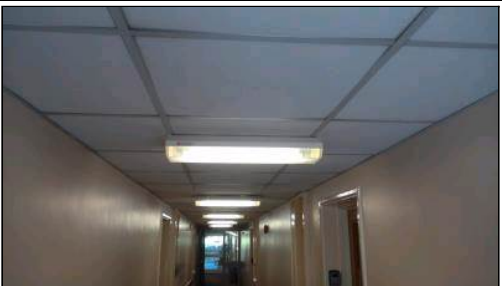
Survey Date:	Lead Surveyor	Survey Type	Floor	Analysis
	24 May 2017	Dave Milton	Refurbishment Survey	Ground	No Asbestos Detected (0)
	Building	Room	Item	Quantity	
	Block 1-40 Llys Ben Bowen Thomas, Communal Areas	Corridor 1 G04	Supalux insulating board panels forming suspended ceiling.	30m <sup>2</sup>	
	Sample No (S,SP,P,As)	Product Type	Surface Treatment	Condition	Accessibility
	AE003049 (S)	Insulation board (2)	Surface Sealed (1)	Good Condition (0)	Occasionally likely to be disturbed (1)

Normal Occupancy	Score	Likelihood of disturbance	Score	Exposure Potential	Score	Maintenance Activity	Score
Main type of activity	N/A	Location	N/A	Number of occupants	N/A	Type of Maintenance	N/A
		Accessibility	N/A	Frequency of use	N/A	Frequency of maintenance	N/A
		Amount	N/A	Average Time	N/A		
Average Score	N/A	Average Score	N/A	Average Score	N/A	Average Score	N/A
Average of Priority	N/A						
Material Assessment Score	N/A						
Recommendation	No further action required						
Surveyor comments	N/A

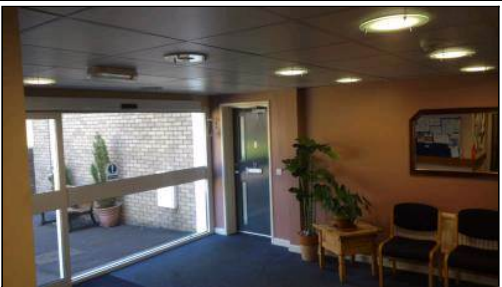
Survey Date:	Lead Surveyor	Survey Type	Floor	Analysis
	24 May 2017	Dave Milton	Refurbishment Survey	Ground	N/A
	Building	Room	Item	Quantity	
	Block 1-40 Llys Ben Bowen Thomas, Communal Areas	Lobby G05	No suspect materials identified	N/A	
	Sample No (S,SP,P,As)	Product Type	Surface Treatment	Condition	Accessibility
	Visual (P)	N/A	N/A	N/A	N/A

Normal Occupancy	Score	Likelihood of disturbance	Score	Exposure Potential	Score	Maintenance Activity	Score
Main type of activity	N/A	Location	N/A	Number of occupants	N/A	Type of Maintenance	N/A
		Accessibility	N/A	Frequency of use	N/A	Frequency of maintenance	N/A
		Amount	N/A	Average Time	N/A		
Average Score	N/A	Average Score	N/A	Average Score	N/A	Average Score	N/A
Average of Priority	N/A						
Material Assessment Score	N/A						
Recommendation	No further action required						
Surveyor comments	N/A

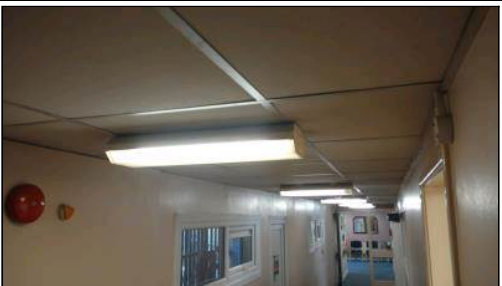
Survey Date:	Lead Surveyor	Survey Type	Floor	Analysis
	24 May 2017	Dave Milton	Refurbishment Survey	Ground	No Asbestos Detected (0)
	Building	Room	Item	Quantity	
	Block 1-40 Llys Ben Bowen Thomas, Communal Areas	Corridor 2 G06	Supalux insulating board panels forming suspended ceiling.	20m <sup>2</sup>	
	Sample No (S,SP,P,As)	Product Type	Surface Treatment	Condition	Accessibility
	AE003050 (S)	Insulation board (2)	Surface Sealed (1)	Good Condition (0)	Occasionally likely to be disturbed (1)

Normal Occupancy	Score	Likelihood of disturbance	Score	Exposure Potential	Score	Maintenance Activity	Score
Main type of activity	N/A	Location	N/A	Number of occupants	N/A	Type of Maintenance	N/A
		Accessibility	N/A	Frequency of use	N/A	Frequency of maintenance	N/A
		Amount	N/A	Average Time	N/A		
Average Score	N/A	Average Score	N/A	Average Score	N/A	Average Score	N/A
Average of Priority	N/A						
Material Assessment Score	N/A						
Recommendation	No further action required						
Surveyor comments	N/A

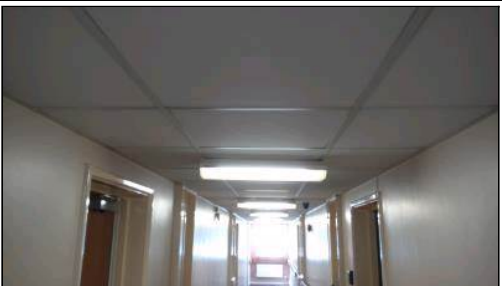
Survey Date:	Lead Surveyor	Survey Type	Floor	Analysis
	24 May 2017	Dave Milton	Refurbishment Survey	Ground	No Asbestos Detected (0)
	Building	Room	Item	Quantity	
	Block 1-40 Llys Ben Bowen Thomas, Communal Areas	Corridor 3 G07	Supalux insulating board panels forming suspended ceiling.	50m <sup>2</sup>	
	Sample No (S,SP,P,As)	Product Type	Surface Treatment	Condition	Accessibility
	AE003051 (S)	Insulation board (2)	Surface Sealed (1)	Good Condition (0)	Occasionally likely to be disturbed (1)

Normal Occupancy	Score	Likelihood of disturbance	Score	Exposure Potential	Score	Maintenance Activity	Score
Main type of activity	N/A	Location	N/A	Number of occupants	N/A	Type of Maintenance	N/A
		Accessibility	N/A	Frequency of use	N/A	Frequency of maintenance	N/A
		Amount	N/A	Average Time	N/A		
Average Score	N/A	Average Score	N/A	Average Score	N/A	Average Score	N/A
Average of Priority	N/A						
Material Assessment Score	N/A						
Recommendation	No further action required						
Surveyor comments	N/A

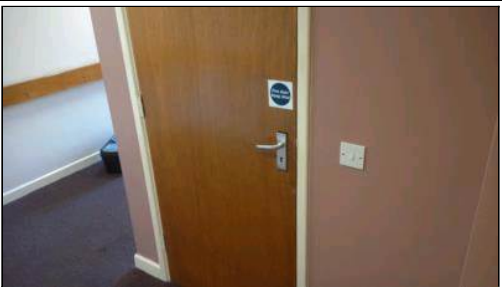
Survey Date:	Lead Surveyor	Survey Type	Floor	Analysis
	24 May 2017	Dave Milton	Refurbishment Survey	Ground	N/A
	Building	Room	Item	Quantity	
	Block 1-40 Llys Ben Bowen Thomas, Communal Areas	Store G08	Inaccessible	N/A	
	Sample No (S,SP,P,As)	Product Type	Surface Treatment	Condition	Accessibility
	Visual (P)	N/A	N/A	N/A	N/A

Normal Occupancy	Score	Likelihood of disturbance	Score	Exposure Potential	Score	Maintenance Activity	Score
Main type of activity	N/A	Location	N/A	Number of occupants	N/A	Type of Maintenance	N/A
		Accessibility	N/A	Frequency of use	N/A	Frequency of maintenance	N/A
		Amount	N/A	Average Time	N/A		
Average Score	N/A	Average Score	N/A	Average Score	N/A	Average Score	N/A
Average of Priority	N/A						
Material Assessment Score	N/A						
Recommendation	Inspection Required						
Surveyor comments	Presumed to contain asbestos - inaccessible due to locked door. No key available.

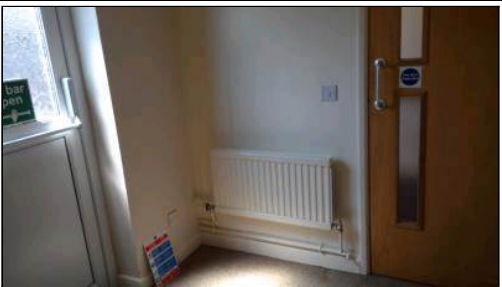
Survey Date:	Lead Surveyor	Survey Type	Floor	Analysis
	24 May 2017	Dave Milton	Refurbishment Survey	Ground	N/A
	Building	Room	Item	Quantity	
	Block 1-40 Llys Ben Bowen Thomas, Communal Areas	Stairwell 3 G09	No suspect materials identified	N/A	
	Sample No (S,SP,P,As)	Product Type	Surface Treatment	Condition	Accessibility
	Visual (P)	N/A	N/A	N/A	N/A

Normal Occupancy	Score	Likelihood of disturbance	Score	Exposure Potential	Score	Maintenance Activity	Score
Main type of activity	N/A	Location	N/A	Number of occupants	N/A	Type of Maintenance	N/A
		Accessibility	N/A	Frequency of use	N/A	Frequency of maintenance	N/A
		Amount	N/A	Average Time	N/A		
Average Score	N/A	Average Score	N/A	Average Score	N/A	Average Score	N/A
Average of Priority	N/A						
Material Assessment Score	N/A						
Recommendation	No further action required						
Surveyor comments	N/A

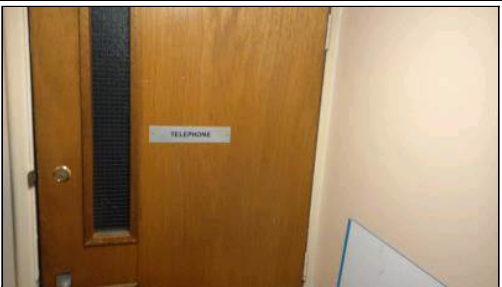
Survey Date:	Lead Surveyor	Survey Type	Floor	Analysis
	24 May 2017	Dave Milton	Refurbishment Survey	Ground	N/A
	Building	Room	Item	Quantity	
	Block 1-40 Llys Ben Bowen Thomas, Communal Areas	Telephone room G10	Inaccessible	N/A	
	Sample No (S,SP,P,As)	Product Type	Surface Treatment	Condition	Accessibility
	Visual (P)	N/A	N/A	N/A	N/A

Normal Occupancy	Score	Likelihood of disturbance	Score	Exposure Potential	Score	Maintenance Activity	Score
Main type of activity	N/A	Location	N/A	Number of occupants	N/A	Type of Maintenance	N/A
		Accessibility	N/A	Frequency of use	N/A	Frequency of maintenance	N/A
		Amount	N/A	Average Time	N/A		
Average Score	N/A	Average Score	N/A	Average Score	N/A	Average Score	N/A
Average of Priority	N/A						
Material Assessment Score	N/A						
Recommendation	Inspection Required						
Surveyor comments	Presumed to contain asbestos - inaccessible due to locked door. No key available.

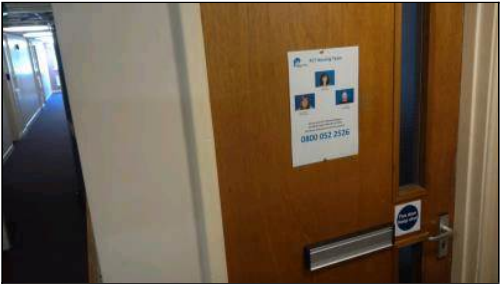
Survey Date:	Lead Surveyor	Survey Type	Floor	Analysis
	24 May 2017	Dave Milton	Refurbishment Survey	Ground	N/A
	Building	Room	Item	Quantity	
	Block 1-40 Llys Ben Bowen Thomas, Communal Areas	Office G11	Inaccessible	N/A	
	Sample No (S,SP,P,As)	Product Type	Surface Treatment	Condition	Accessibility
	Visual (P)	N/A	N/A	N/A	N/A

Normal Occupancy	Score	Likelihood of disturbance	Score	Exposure Potential	Score	Maintenance Activity	Score
Main type of activity	N/A	Location	N/A	Number of occupants	N/A	Type of Maintenance	N/A
		Accessibility	N/A	Frequency of use	N/A	Frequency of maintenance	N/A
		Amount	N/A	Average Time	N/A		
Average Score	N/A	Average Score	N/A	Average Score	N/A	Average Score	N/A
Average of Priority	N/A						
Material Assessment Score	N/A						
Recommendation	Inspection Required						
Surveyor comments	Presumed to contain asbestos - inaccessible due to locked door. No key available.

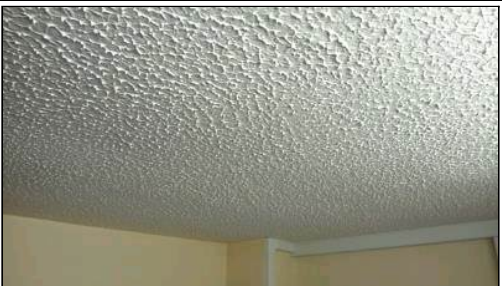
Survey Date:	Lead Surveyor	Survey Type	Floor	Analysis
	24 May 2017	Dave Milton	Refurbishment Survey	Ground	Chrysotile (1)
	Building	Room	Item	Quantity	
	Block 1-40 Llys Ben Bowen Thomas, Communal Areas	Office 2 G12	Textured coating to plasterboard ceiling.	9m <sup>2</sup>	
	Sample No (S,SP,P,As)	Product Type	Surface Treatment	Condition	Accessibility
	AE003070 (S)	Textured Coating (1)	Completely Sealed (0)	Good Condition (0)	Occasionally likely to be disturbed (1)

Normal Occupancy	Score	Likelihood of disturbance	Score	Exposure Potential	Score	Maintenance Activity	Score
Main type of activity	1	Location	2	Number of occupants	1	Type of Maintenance	1
		Accessibility	1	Frequency of use	3	Frequency of maintenance	1
		Amount	1	Average Time	1		
Average Score	1	Average Score	2	Average Score	2	Average Score	1
Average of Priority	6						
Material Assessment Score	2						
Recommendation	Manage in-situ or remove if affected by works						
Surveyor comments	Please refer to Section 6.2 of this report and project desktop study (additional inspection required if going beyond suspect material).

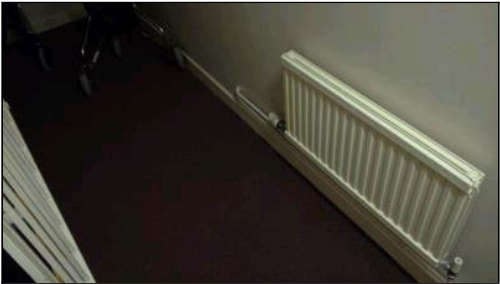
Survey Date:	Lead Surveyor	Survey Type	Floor	Analysis
	24 May 2017	Dave Milton	Refurbishment Survey	Ground	N/A
	Building	Room	Item	Quantity	
	Block 1-40 Llys Ben Bowen Thomas, Communal Areas	Stairwell 2 G13	No suspect materials identified	N/A	
	Sample No (S,SP,P,As)	Product Type	Surface Treatment	Condition	Accessibility
	Visual (P)	N/A	N/A	N/A	N/A

Normal Occupancy	Score	Likelihood of disturbance	Score	Exposure Potential	Score	Maintenance Activity	Score
Main type of activity	N/A	Location	N/A	Number of occupants	N/A	Type of Maintenance	N/A
		Accessibility	N/A	Frequency of use	N/A	Frequency of maintenance	N/A
		Amount	N/A	Average Time	N/A		
Average Score	N/A	Average Score	N/A	Average Score	N/A	Average Score	N/A
Average of Priority	N/A						
Material Assessment Score	N/A						
Recommendation	No further action required						
Surveyor comments	N/A

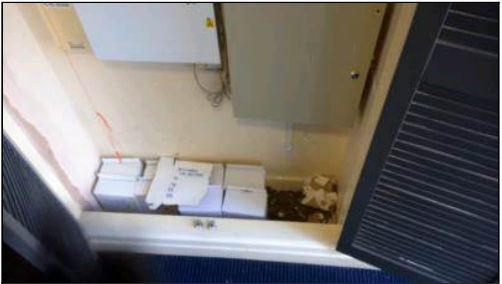
Survey Date:	Lead Surveyor	Survey Type	Floor	Analysis
	24 May 2017	Dave Milton	Refurbishment Survey	Ground	N/A
	Building	Room	Item	Quantity	
	Block 1-40 Llys Ben Bowen Thomas, Communal Areas	Lobby cupboard G14	No suspect materials identified	N/A	
	Sample No (S,SP,P,As)	Product Type	Surface Treatment	Condition	Accessibility
	Visual (P)	N/A	N/A	N/A	N/A

Normal Occupancy	Score	Likelihood of disturbance	Score	Exposure Potential	Score	Maintenance Activity	Score
Main type of activity	N/A	Location	N/A	Number of occupants	N/A	Type of Maintenance	N/A
		Accessibility	N/A	Frequency of use	N/A	Frequency of maintenance	N/A
		Amount	N/A	Average Time	N/A		
Average Score	N/A	Average Score	N/A	Average Score	N/A	Average Score	N/A
Average of Priority	N/A						
Material Assessment Score	N/A						
Recommendation	No further action required						
Surveyor comments	N/A
