**WALES & WEST HOUSING  
ASSOCIATION  
3 ALEXANDRA GATE  
FFORDD PENGAM  
TREMORFA  
CARDIFF  
CF24 2UD**

**PROJECT NO:** J024782

**DATE:** AUGUST 2012

**ASBESTOS MANAGEMENT SURVEY  
OF  
LLYS BEN BOWEN THOMAS, GELLIGALED STREET, YSTRAD, CF41 7SB**

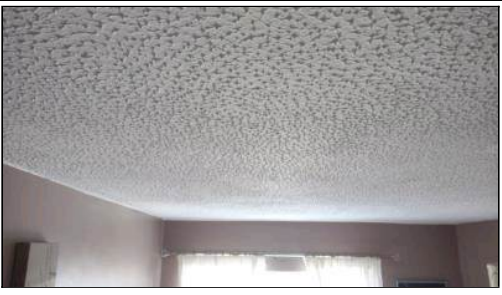
Survey Date:	Lead Surveyor	Survey Type	Floor	Analysis
	24 May 2017	Dave Milton	Refurbishment Survey	1st	Chrysotile (1)
	Building	Room	Item	Quantity	
	Block 1-40 Llys Ben Bowen Thomas, Flat 25	Bedroom 101	Textured coating to plasterboard ceiling.	12m <sup>2</sup>	
	Sample No (S,SP,P,As)	Product Type	Surface Treatment	Condition	Accessibility
	AE003061 (S)	Textured Coating (1)	Completely Sealed (0)	Good Condition (0)	Occasionally likely to be disturbed (1)

Normal Occupancy	Score	Likelihood of disturbance	Score	Exposure Potential	Score	Maintenance Activity	Score
Main type of activity	1	Location	2	Number of occupants	1	Type of Maintenance	1
		Accessibility	1	Frequency of use	3	Frequency of maintenance	1
		Amount	2	Average Time	3		
Average Score	1	Average Score	2	Average Score	3	Average Score	1
Average of Priority	7						
Material Assessment Score	2						
Recommendation	Manage in-situ or remove if affected by works						
Surveyor comments	Please refer to Section 6.2 of this report and project desktop study (additional inspection required if going beyond suspect material).

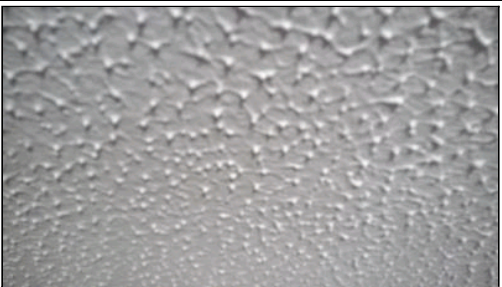
Survey Date:	Lead Surveyor	Survey Type	Floor	Analysis
	24 May 2017	Dave Milton	Refurbishment Survey	1st	Chrysotile (1)
	Building	Room	Item	Quantity	
	Block 1-40 Llys Ben Bowen Thomas, Flat 25	Bedroom cupboard 102	Textured coating to plasterboard ceiling.	1m <sup>2</sup>	
	Sample No (S,SP,P,As)	Product Type	Surface Treatment	Condition	Accessibility
	AE003064 (S)	Textured Coating (1)	Completely Sealed (0)	Good Condition (0)	Occasionally likely to be disturbed (1)

Normal Occupancy	Score	Likelihood of disturbance	Score	Exposure Potential	Score	Maintenance Activity	Score
Main type of activity	1	Location	2	Number of occupants	1	Type of Maintenance	1
		Accessibility	1	Frequency of use	3	Frequency of maintenance	1
		Amount	1	Average Time	0		
Average Score	1	Average Score	2	Average Score	2	Average Score	1
Average of Priority	6						
Material Assessment Score	2						
Recommendation	Manage in-situ or remove if affected by works						
Surveyor comments	Please refer to Section 6.2 of this report and project desktop study (additional inspection required if going beyond suspect material).

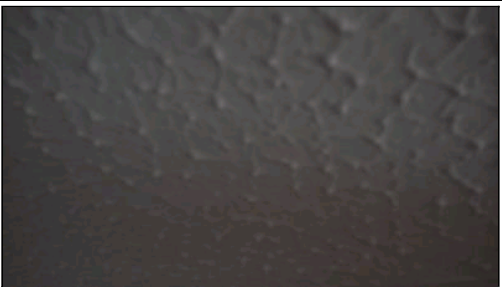
Survey Date:	Lead Surveyor	Survey Type	Floor	Analysis
	24 May 2017	Dave Milton	Refurbishment Survey	1st	Chrysotile (1)
	Building	Room	Item	Quantity	
	Block 1-40 Llys Ben Bowen Thomas, Flat 25	Airing cupboard 103	Textured coating to plasterboard ceiling.	1m <sup>2</sup>	
	Sample No (S,SP,P,As)	Product Type	Surface Treatment	Condition	Accessibility
	AE003065 (S)	Textured Coating (1)	Completely Sealed (0)	Good Condition (0)	Occasionally likely to be disturbed (1)

Normal Occupancy	Score	Likelihood of disturbance	Score	Exposure Potential	Score	Maintenance Activity	Score
Main type of activity	1	Location	2	Number of occupants	1	Type of Maintenance	1
		Accessibility	1	Frequency of use	3	Frequency of maintenance	1
		Amount	1	Average Time	0		
Average Score	1	Average Score	2	Average Score	2	Average Score	1
Average of Priority	6						
Material Assessment Score	2						
Recommendation	Manage in-situ or remove if affected by works						
Surveyor comments	Please refer to Section 6.2 of this report and project desktop study (additional inspection required if going beyond suspect material).

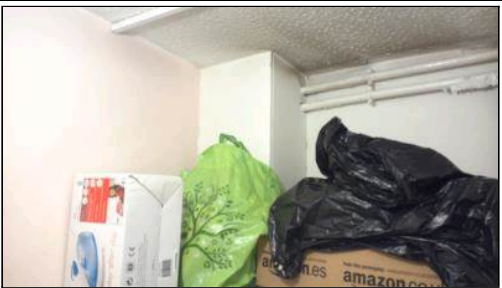
Survey Date:	Lead Surveyor	Survey Type	Floor	Analysis
	24 May 2017	Dave Milton	Refurbishment Survey	1st	No Asbestos Detected (0)
	Building	Room	Item	Quantity	
	Block 1-40 Llys Ben Bowen Thomas, Flat 25	Cupboard 105	Insulating board panels forming boxing.	2m²	
	Sample No (S,SP,P,As)	Product Type	Surface Treatment	Condition	Accessibility
	AE003062 (S)	Insulation board (2)	Surface Sealed (1)	Good Condition (0)	Easily disturbed (2)

Normal Occupancy	Score	Likelihood of disturbance	Score	Exposure Potential	Score	Maintenance Activity	Score
Main type of activity	N/A	Location	N/A	Number of occupants	N/A	Type of Maintenance	N/A
		Accessibility	N/A	Frequency of use	N/A	Frequency of maintenance	N/A
		Amount	N/A	Average Time	N/A		
Average Score	N/A	Average Score	N/A	Average Score	N/A	Average Score	N/A
Average of Priority	N/A						
Material Assessment Score	N/A						
Recommendation	No further action required						
Surveyor comments	Please refer to Section 6.2 of this report and project desktop study (additional inspection required if going beyond suspect material).

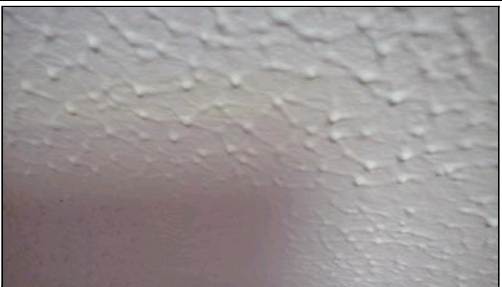
Survey Date:	Lead Surveyor	Survey Type	Floor	Analysis
	24 May 2017	Dave Milton	Refurbishment Survey	1st	Chrysotile (1)
	Building	Room	Item	Quantity	
	Block 1-40 Llys Ben Bowen Thomas, Flat 25	Cupboard 105	Textured coating to plasterboard ceiling.	2m <sup>2</sup>	
	Sample No (S,SP,P,As)	Product Type	Surface Treatment	Condition	Accessibility
	AE003067 (S)	Textured Coating (1)	Completely Sealed (0)	Good Condition (0)	Occasionally likely to be disturbed (1)

Normal Occupancy	Score	Likelihood of disturbance	Score	Exposure Potential	Score	Maintenance Activity	Score
Main type of activity	1	Location	2	Number of occupants	1	Type of Maintenance	1
		Accessibility	1	Frequency of use	3	Frequency of maintenance	1
		Amount	1	Average Time	0		
Average Score	1	Average Score	2	Average Score	2	Average Score	1
Average of Priority	6						
Material Assessment Score	2						
Recommendation	Manage in-situ or remove if affected by works						
Surveyor comments	Please refer to Section 6.2 of this report and project desktop study (additional inspection required if going beyond suspect material).

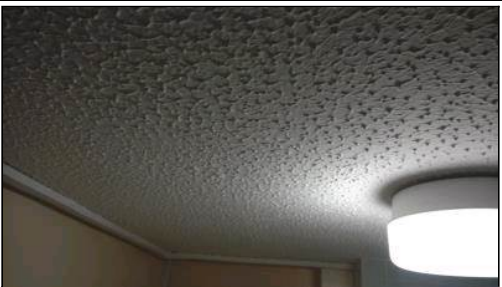
Survey Date:	Lead Surveyor	Survey Type	Floor	Analysis
	24 May 2017	Dave Milton	Refurbishment Survey	1st	Chrysotile (1)
	Building	Room	Item	Quantity	
	Block 1-40 Llys Ben Bowen Thomas, Flat 25	Shower room 106	Textured coating to plasterboard ceiling.	4m <sup>2</sup>	
	Sample No (S,SP,P,As)	Product Type	Surface Treatment	Condition	Accessibility
	AE003063 (S)	Textured Coating (1)	Completely Sealed (0)	Good Condition (0)	Occasionally likely to be disturbed (1)

Normal Occupancy	Score	Likelihood of disturbance	Score	Exposure Potential	Score	Maintenance Activity	Score
Main type of activity	1	Location	2	Number of occupants	1	Type of Maintenance	1
		Accessibility	1	Frequency of use	3	Frequency of maintenance	1
		Amount	1	Average Time	0		
Average Score	1	Average Score	2	Average Score	2	Average Score	1
Average of Priority	6						
Material Assessment Score	2						
Recommendation	Manage in-situ or remove if affected by works						
Surveyor comments	Please refer to Section 6.2 of this report and project desktop study (additional inspection required if going beyond suspect material).

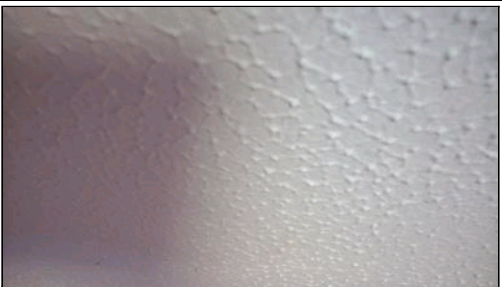
Survey Date:	Lead Surveyor	Survey Type	Floor	Analysis
	24 May 2017	Dave Milton	Refurbishment Survey	1st	Chrysotile (1)
	Building	Room	Item	Quantity	
	Block 1-40 Llys Ben Bowen Thomas, Flat 25	Kitchen 107	Textured coating to plasterboard ceiling.	4m <sup>2</sup>	
	Sample No (S,SP,P,As)	Product Type	Surface Treatment	Condition	Accessibility
	AE003068 (S)	Textured Coating (1)	Completely Sealed (0)	Good Condition (0)	Occasionally likely to be disturbed (1)

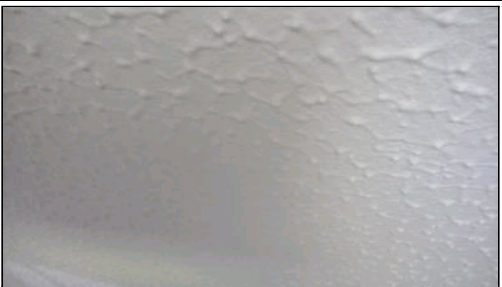
Survey Date:	Lead Surveyor	Survey Type	Floor	Analysis
	24 May 2017	Dave Milton	Refurbishment Survey	1st	Chrysotile (1)
	Building	Room	Item	Quantity	
	Block 1-40 Llys Ben Bowen Thomas, Flat 25	Lounge 108	Textured coating to plasterboard ceiling.	12m <sup>2</sup>	
	Sample No (S,SP,P,As)	Product Type	Surface Treatment	Condition	Accessibility
	AE003069 (S)	Textured Coating (1)	Completely Sealed (0)	Good Condition (0)	Occasionally likely to be disturbed (1)

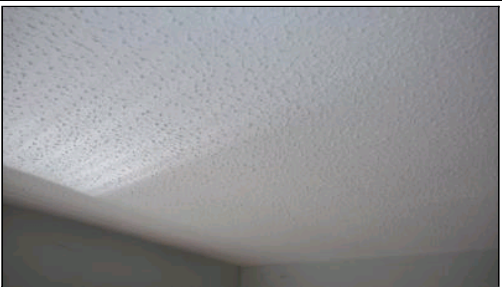
Survey Date:	Lead Surveyor	Survey Type	Floor	Analysis
	24 May 2017	Dave Milton	Refurbishment Survey	2nd	Chrysotile (1)
	Building	Room	Item	Quantity	
	Block 1-40 Llys Ben Bowen Thomas, Flat 30	Kitchen 201	Textured coating to plasterboard ceiling.	4m <sup>2</sup>	
	Sample No (S,SP,P,As)	Product Type	Surface Treatment	Condition	Accessibility
	AE003053 (S)	Textured Coating (1)	Completely Sealed (0)	Good Condition (0)	Occasionally likely to be disturbed (1)

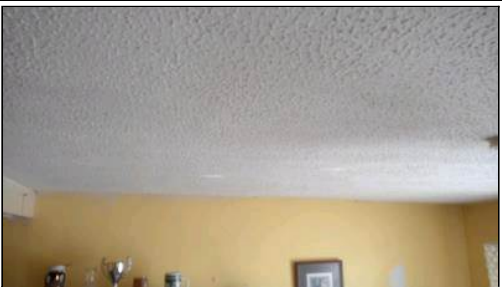
Survey Date:	Lead Surveyor	Survey Type	Floor	Analysis
	24 May 2017	Dave Milton	Refurbishment Survey	2nd	Chrysotile (1)
	Building	Room	Item	Quantity	
	Block 1-40 Llys Ben Bowen Thomas, Flat 30	Lounge/bedroom 202	Textured coating to plasterboard ceiling.	16m <sup>2</sup>	
	Sample No (S,SP,P,As)	Product Type	Surface Treatment	Condition	Accessibility
	AE003054 (S)	Textured Coating (1)	Completely Sealed (0)	Good Condition (0)	Occasionally likely to be disturbed (1)

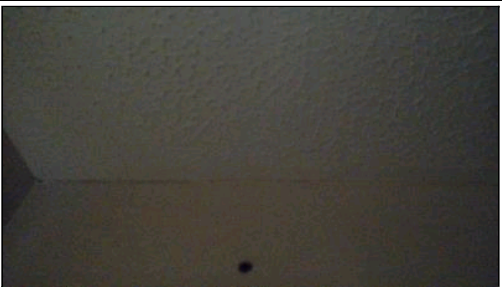
Survey Date:	Lead Surveyor	Survey Type	Floor	Analysis
	24 May 2017	Dave Milton	Refurbishment Survey	2nd	Chrysotile (1)
	Building	Room	Item	Quantity	
	Block 1-40 Llys Ben Bowen Thomas, Flat 30	Airing Cupboard 203	Textured coating to plasterboard ceiling.	1m <sup>2</sup>	
	Sample No (S,SP,P,As)	Product Type	Surface Treatment	Condition	Accessibility
	AE003055 (S)	Textured Coating (1)	Completely Sealed (0)	Good Condition (0)	Occasionally likely to be disturbed (1)

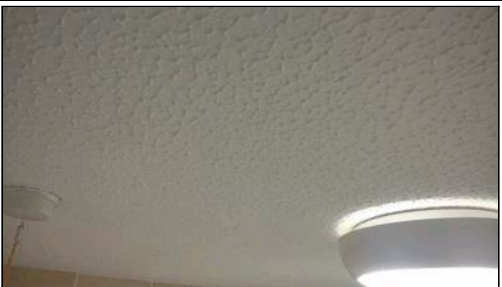
Survey Date:	Lead Surveyor	Survey Type	Floor	Analysis
	24 May 2017	Dave Milton	Refurbishment Survey	2nd	Chrysotile (1)
	Building	Room	Item	Quantity	
	Block 1-40 Llys Ben Bowen Thomas, Flat 30	Shower room 204	Textured coating to plasterboard ceiling.	4m <sup>2</sup>	
	Sample No (S,SP,P,As)	Product Type	Surface Treatment	Condition	Accessibility
	AE003056 (S)	Textured Coating (1)	Completely Sealed (0)	Good Condition (0)	Occasionally likely to be disturbed (1)

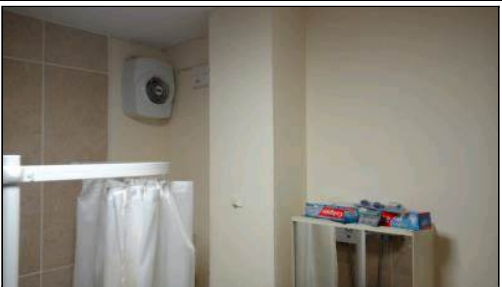
Survey Date:	Lead Surveyor	Survey Type	Floor	Analysis	
	24 May 2017	Dave Milton	Refurbishment Survey	2nd	No Asbestos Detected (0)	
	Building	Room	Item	Quantity		
	Block 1-40 Llys Ben Bowen Thomas, Flat 30	Shower room 204	Insulating board forming boxing.	2m²		
	Sample No (S,SP,P,As)	Product Type	Surface Treatment	Condition	Accessibility	
	AE003057 (S)	Insulation board (2)	Surface Sealed (1)	Good Condition (0)	Easily disturbed (2)

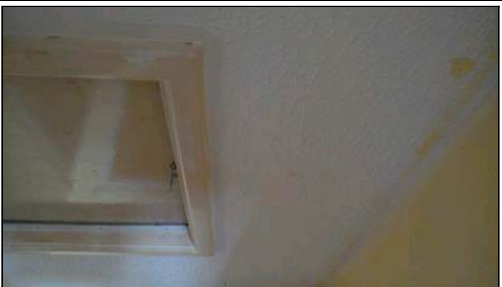
Survey Date:	Lead Surveyor	Survey Type	Floor	Analysis
	24 May 2017	Dave Milton	Refurbishment Survey	2nd	Chrysotile (1)
	Building	Room	Item	Quantity	
	Block 1-40 Llys Ben Bowen Thomas, Flat 30	Hall 205	Textured coating to plasterboard ceiling.	2m <sup>2</sup>	
	Sample No (S,SP,P,As)	Product Type	Surface Treatment	Condition	Accessibility
	AE003058 (S)	Textured Coating (1)	Completely Sealed (0)	Good Condition (0)	Occasionally likely to be disturbed (1)

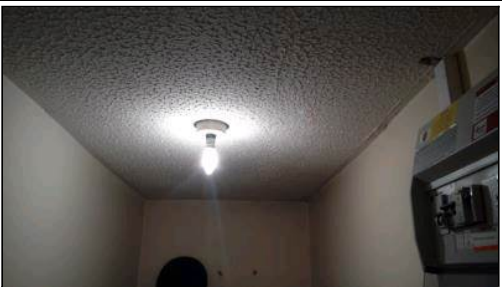
Survey Date:	Lead Surveyor	Survey Type	Floor	Analysis
	24 May 2017	Dave Milton	Refurbishment Survey	2nd	Chrysotile (1)
	Building	Room	Item	Quantity	
	Block 1-40 Llys Ben Bowen Thomas, Flat 30	Electric cupboard 206	Textured coating to plasterboard ceiling.	2m <sup>2</sup>	
	Sample No (S,SP,P,As)	Product Type	Surface Treatment	Condition	Accessibility
	AE003059 (S)	Textured Coating (1)	Completely Sealed (0)	Good Condition (0)	Occasionally likely to be disturbed (1)

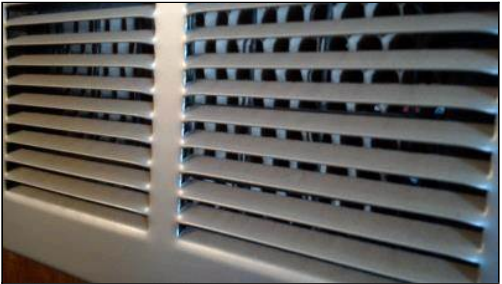
Survey Date:	Lead Surveyor	Survey Type	Floor	Analysis
	24 May 2017	Dave Milton	Refurbishment Survey	2nd	No Asbestos Detected (0)
	Building	Room	Item	Quantity	
	Block 1-40 Llys Ben Bowen Thomas, Flat 30	Electric cupboard 206	Paper filter within timber door.	0.25m <sup>2</sup>	
	Sample No (S,SP,P,As)	Product Type	Surface Treatment	Condition	Accessibility
	AE003060 (S)	Textiles/Paper (0)	Surface Sealed (1)	Good Condition (0)	Occasionally likely to be disturbed (1)

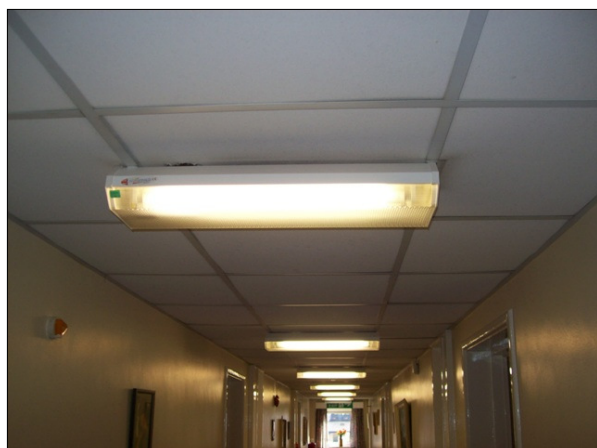
<b>Condition:</b>	Good	<b>Accessibility:</b>	Medium
<b>Friability:</b>	Low	<b>Exposure:</b>	Public
<b>Surface:</b>	Fully sealed	<b>Amount:</b>	20 m <sup>2</sup>
<b>Position:</b>	Internal	<b>RISK:</b>	<b>NONE</b>

N.A.D.I.S insulating board ceiling tiles.

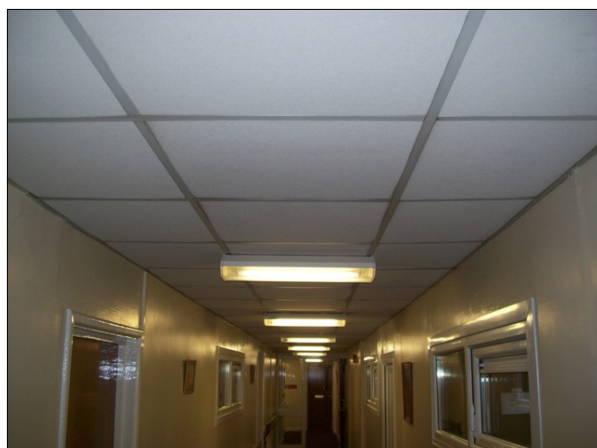
<b>Condition:</b>	Good	<b>Accessibility:</b>	Medium
<b>Friability:</b>	Medium	<b>Exposure:</b>	Public
<b>Surface:</b>	Fully sealed	<b>Amount:</b>	20 m <sup>2</sup>
<b>Position:</b>	Internal	<b>RISK:</b>	<b>NONE</b>

N.A.D.I.S insulating board ceiling tiles.

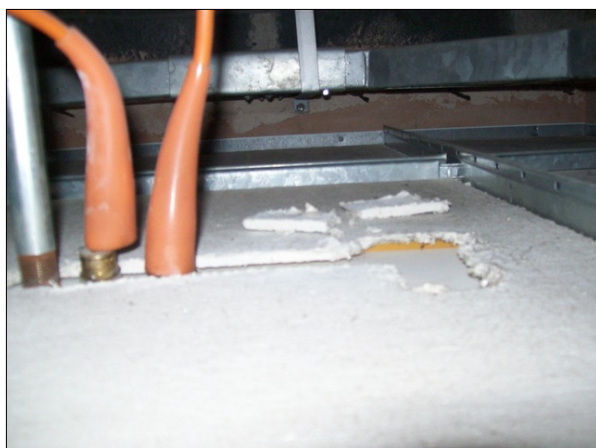
<b>Condition:</b>	Debris	<b>Accessibility:</b>	High
<b>Friability:</b>	High	<b>Exposure:</b>	Public
<b>Surface:</b>	None	<b>Amount:</b>	<1 m <sup>2</sup>
<b>Position:</b>	Internal	<b>RISK:</b>	<b>NONE</b>

N.A.D.I.S insulating board ceiling tiles debris.

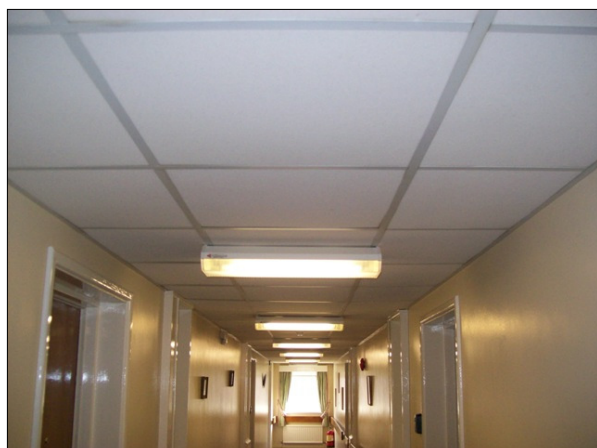
<b>Condition:</b>	Good	<b>Accessibility:</b>	Medium
<b>Friability:</b>	Low	<b>Exposure:</b>	Public
<b>Surface:</b>	Fully sealed	<b>Amount:</b>	12 m <sup>2</sup>
<b>Position:</b>	Internal	<b>RISK:</b>	<b>NONE</b>

N.A.D.I.S insulating board ceiling tiles.

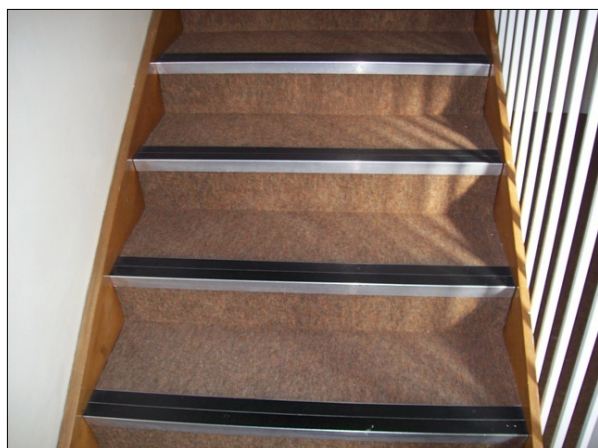
<b>Condition:</b>	Good	<b>Accessibility:</b>	High
<b>Friability:</b>	Low	<b>Exposure:</b>	Public
<b>Surface:</b>	None	<b>Amount:</b>	22 Lm
<b>Position:</b>	Internal	<b>RISK:</b>	<b>NONE</b>

N.A.D.I.S thermoplastic stair nosing to steps.

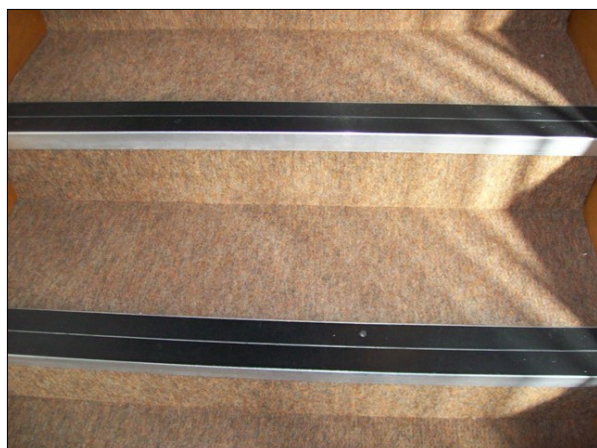
<b>Condition:</b>	Good	<b>Accessibility:</b>	High
<b>Friability:</b>	Low	<b>Exposure:</b>	Public
<b>Surface:</b>	None	<b>Amount:</b>	22 Lm
<b>Position:</b>	Internal	<b>RISK:</b>	<b>NONE</b>

N.A.D.I.S thermoplastic stair nosing to steps.

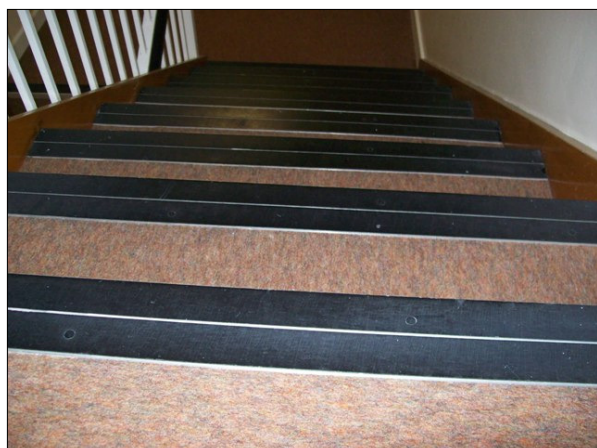
<b>Condition:</b>	Good	<b>Accessibility:</b>	High
<b>Friability:</b>	Low	<b>Exposure:</b>	Public
<b>Surface:</b>	None	<b>Amount:</b>	22 Lm
<b>Position:</b>	Internal	<b>RISK:</b>	<b>NONE</b>

N.A.D.I.S thermoplastic stair nosing to steps.

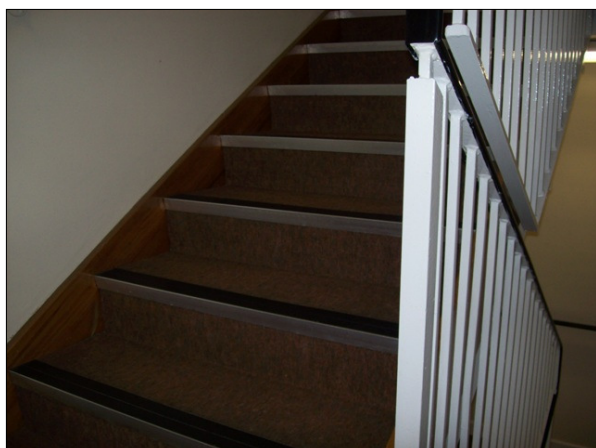
<b>Condition:</b>	Good	<b>Accessibility:</b>	High
<b>Friability:</b>	Low	<b>Exposure:</b>	Public
<b>Surface:</b>	None	<b>Amount:</b>	22 Lm
<b>Position:</b>	Internal	<b>RISK:</b>	<b>NONE</b>

N.A.D.I.S thermoplastic stair nosing to steps.

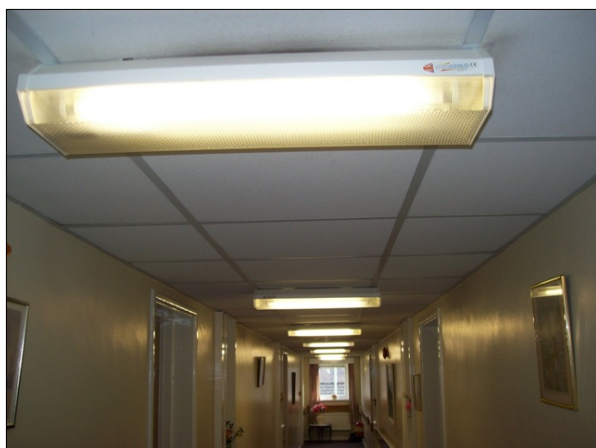
<b>Condition:</b>	Good	<b>Accessibility:</b>	Medium
<b>Friability:</b>	Low	<b>Exposure:</b>	Public
<b>Surface:</b>	Fully sealed	<b>Amount:</b>	12 m <sup>2</sup>
<b>Position:</b>	Internal	<b>RISK:</b>	<b>NONE</b>

N.A.D.I.S insulating board ceiling tiles.

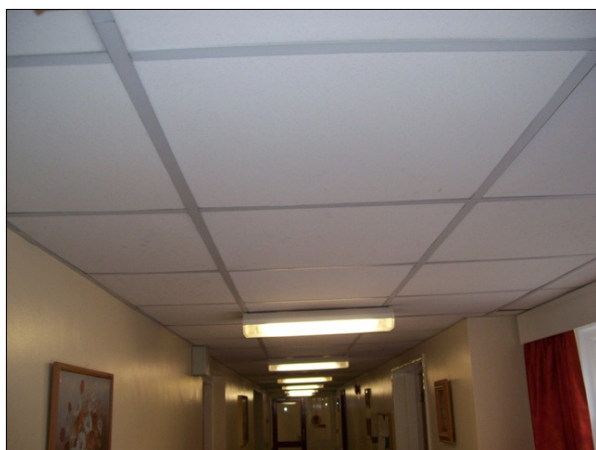
<b>Condition:</b>	Good	<b>Accessibility:</b>	Medium
<b>Friability:</b>	Low	<b>Exposure:</b>	Public
<b>Surface:</b>	Fully sealed	<b>Amount:</b>	20 m <sup>2</sup>
<b>Position:</b>	Internal	<b>RISK:</b>	<b>NONE</b>

N.A.D.I.S insulating board ceiling tiles.

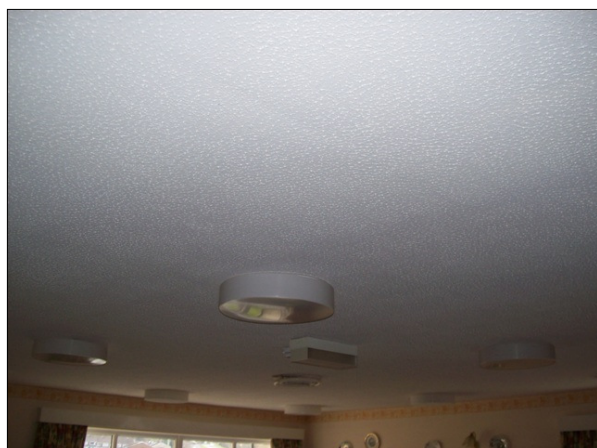
Condition:	Good	Accessibility:	Medium
Friability:	Low	Exposure:	Public
Surface:	Fully sealed	Amount:	8 m <sup>2</sup>
Position:	Internal	RISK:	<b>MINOR (6)</b>

Asbestos textured coating to plasterboard ceiling.

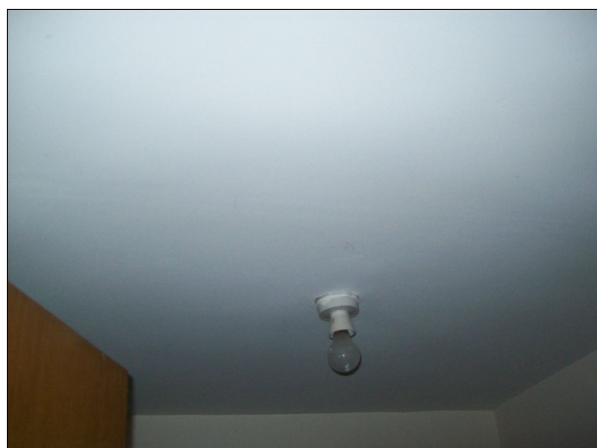
<b>Condition:</b>	Good	<b>Accessibility:</b>	Medium
<b>Friability:</b>	Low	<b>Exposure:</b>	Public
<b>Surface:</b>	Fully sealed	<b>Amount:</b>	2 m <sup>2</sup>
<b>Position:</b>	Internal	<b>RISK:</b>	<b>MINOR (6)</b>

Strongly presumed asbestos textured coating to plasterboard ceiling.

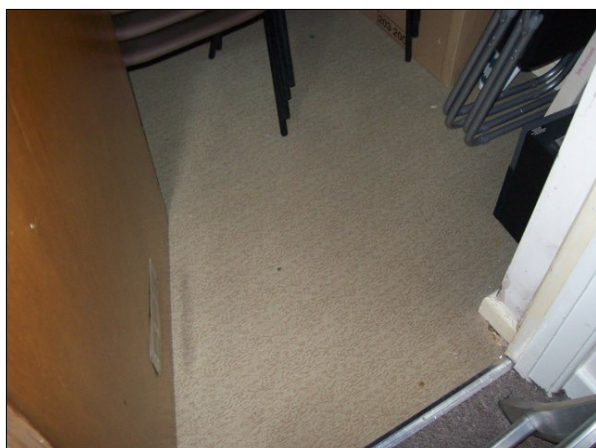
<b>Condition:</b>	Good	<b>Accessibility:</b>	High
<b>Friability:</b>	Low	<b>Exposure:</b>	Public
<b>Surface:</b>	None	<b>Amount:</b>	2 m <sup>2</sup>
<b>Position:</b>	Internal	<b>RISK:</b>	<b>NONE</b>

N.A.D.I.S beige floor vinyl.

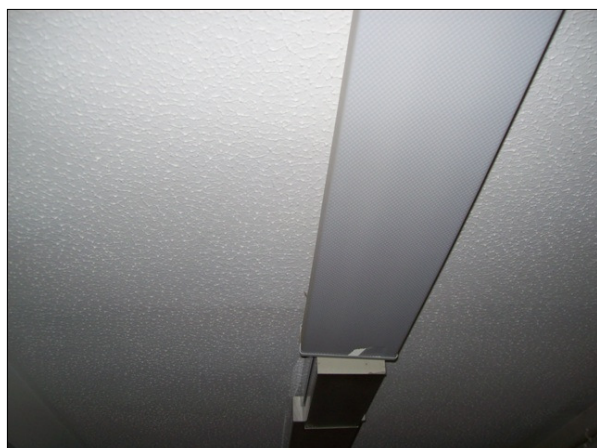
<b>Condition:</b>	Good	<b>Accessibility:</b>	Medium
<b>Friability:</b>	Low	<b>Exposure:</b>	Public
<b>Surface:</b>	Fully sealed	<b>Amount:</b>	6 m <sup>2</sup>
<b>Position:</b>	Internal	<b>RISK:</b>	<b>MINOR (6)</b>

Strongly presumed asbestos textured coating to plasterboard ceiling.

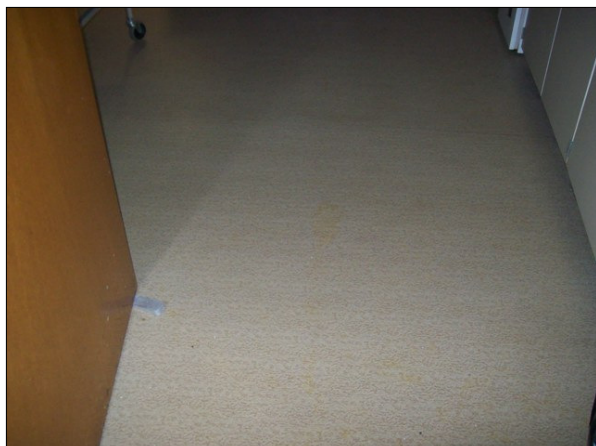
<b>Condition:</b>	Good	<b>Accessibility:</b>	High
<b>Friability:</b>	Low	<b>Exposure:</b>	Public
<b>Surface:</b>	None	<b>Amount:</b>	6 m <sup>2</sup>
<b>Position:</b>	Internal	<b>RISK:</b>	<b>NONE</b>

N.A.D.I.S beige floor vinyl.

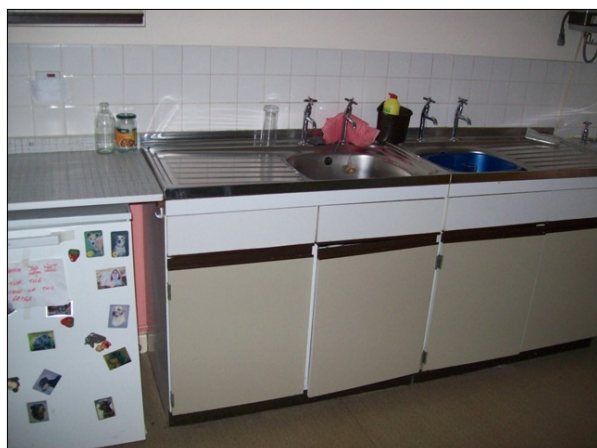
<b>Condition:</b>	Good	<b>Accessibility:</b>	Low
<b>Friability:</b>	Low	<b>Exposure:</b>	Public
<b>Surface:</b>	None	<b>Amount:</b>	<1 m <sup>2</sup>
<b>Position:</b>	Internal	<b>RISK:</b>	<b>NONE</b>

N.A.D.I.S bitumastic sink pad under sink unit.

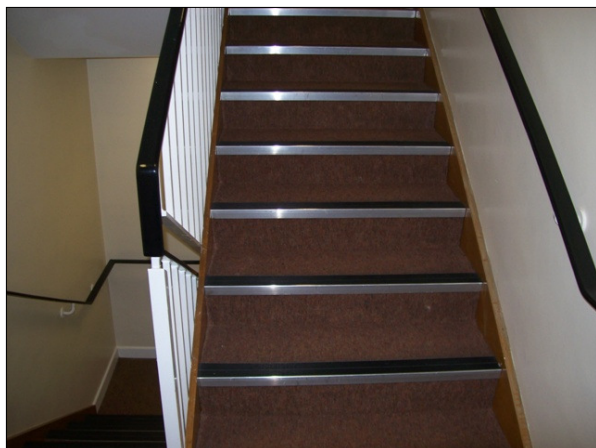
<b>Condition:</b>	Good	<b>Accessibility:</b>	High
<b>Friability:</b>	Low	<b>Exposure:</b>	Public
<b>Surface:</b>	None	<b>Amount:</b>	22 Lm
<b>Position:</b>	Internal	<b>RISK:</b>	<b>NONE</b>

N.A.D.I.S thermoplastic stair nosing to steps.

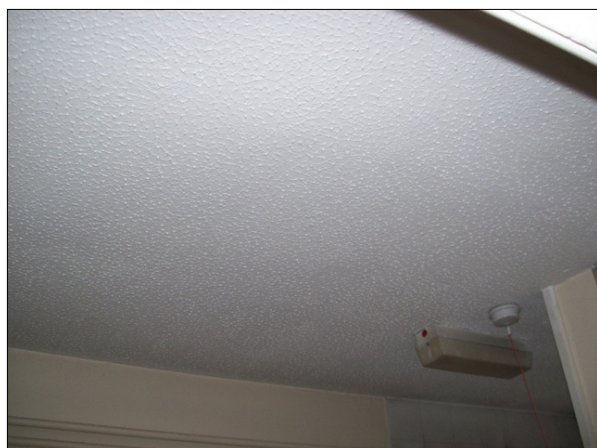
<b>Condition:</b>	Good	<b>Accessibility:</b>	Medium
<b>Friability:</b>	Low	<b>Exposure:</b>	Public
<b>Surface:</b>	Fully sealed	<b>Amount:</b>	2 m <sup>2</sup>
<b>Position:</b>	Internal	<b>RISK:</b>	<b>MINOR (6)</b>

Strongly presumed asbestos textured coating to plasterboard ceiling.

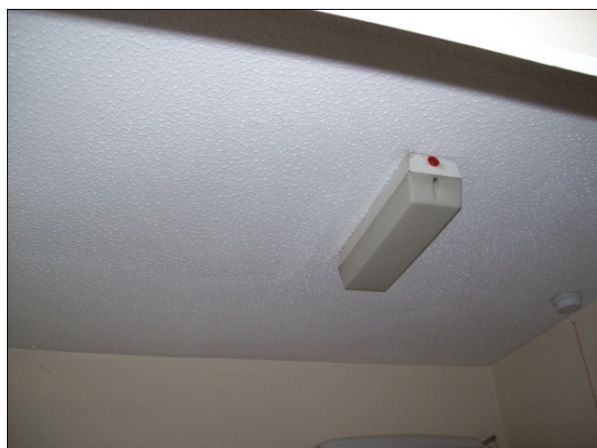
<b>Condition:</b>	Good	<b>Accessibility:</b>	Medium
<b>Friability:</b>	Low	<b>Exposure:</b>	Public
<b>Surface:</b>	Fully sealed	<b>Amount:</b>	2 m <sup>2</sup>
<b>Position:</b>	Internal	<b>RISK:</b>	<b>MINOR (6)</b>

Strongly presumed asbestos textured coating to plasterboard ceiling.

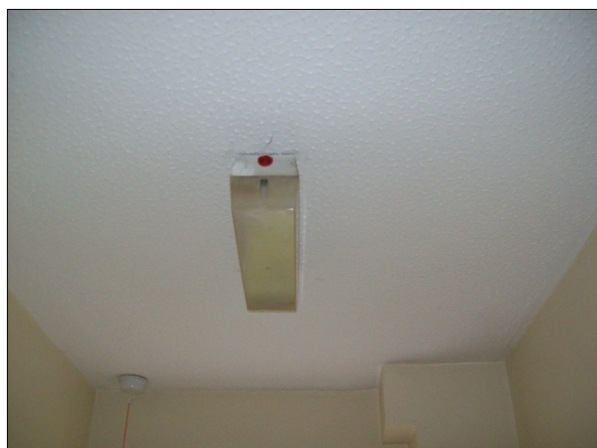
<b>Condition:</b>	Good	<b>Accessibility:</b>	Medium
<b>Friability:</b>	Low	<b>Exposure:</b>	Public
<b>Surface:</b>	Fully sealed	<b>Amount:</b>	2 m <sup>2</sup>
<b>Position:</b>	Internal	<b>RISK:</b>	<b>MINOR (6)</b>

Strongly presumed asbestos textured coating to plasterboard ceiling.

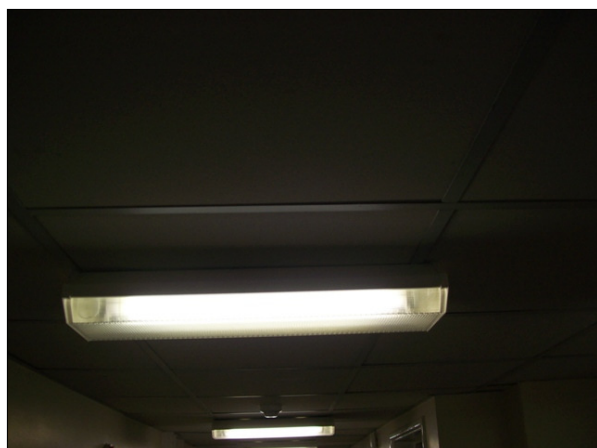
<b>Condition:</b>	Good	<b>Accessibility:</b>	Medium
<b>Friability:</b>	Medium	<b>Exposure:</b>	Public
<b>Surface:</b>	None	<b>Amount:</b>	15 m <sup>2</sup>
<b>Position:</b>	Internal	<b>RISK:</b>	<b>NONE</b>

N.A.D.I.S insulating board ceiling tiles.

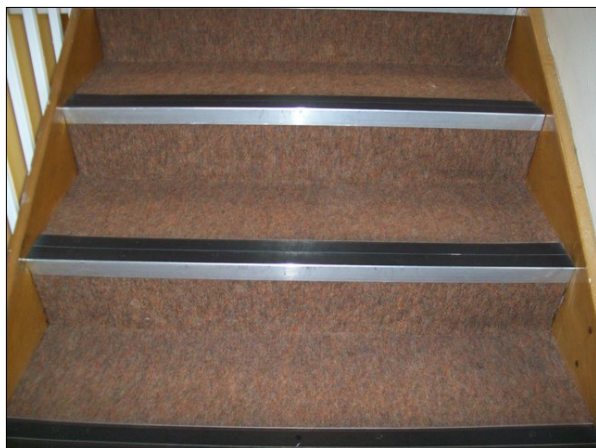
<b>Condition:</b>	Good	<b>Accessibility:</b>	High
<b>Friability:</b>	Low	<b>Exposure:</b>	Public
<b>Surface:</b>	None	<b>Amount:</b>	22 Lm
<b>Position:</b>	Internal	<b>RISK:</b>	<b>NONE</b>

N.A.D.I.S thermoplastic stair nosing to steps.

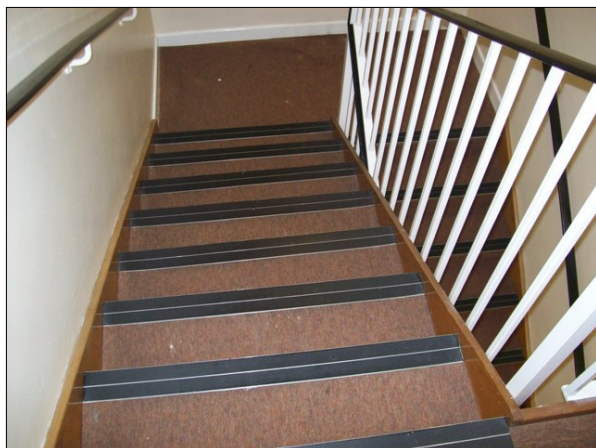
<b>Condition:</b>	Good	<b>Accessibility:</b>	High
<b>Friability:</b>	Low	<b>Exposure:</b>	Public
<b>Surface:</b>	None	<b>Amount:</b>	10 m <sup>2</sup>
<b>Position:</b>	Internal	<b>RISK:</b>	<b>NONE</b>

N.A.D.I.S thermoplastic stair nosing to steps.

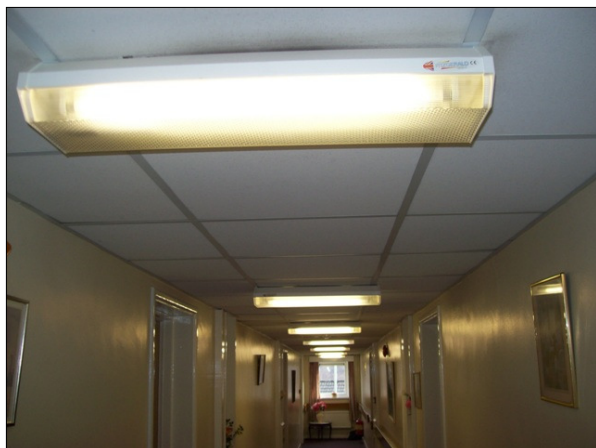
<b>Condition:</b>	Good	<b>Accessibility:</b>	Medium
<b>Friability:</b>	Low	<b>Exposure:</b>	Public
<b>Surface:</b>	Fully sealed	<b>Amount:</b>	15 m <sup>2</sup>
<b>Position:</b>	Internal	<b>RISK:</b>	<b>NONE</b>

N.A.D.I.S insulating board ceiling tiles.

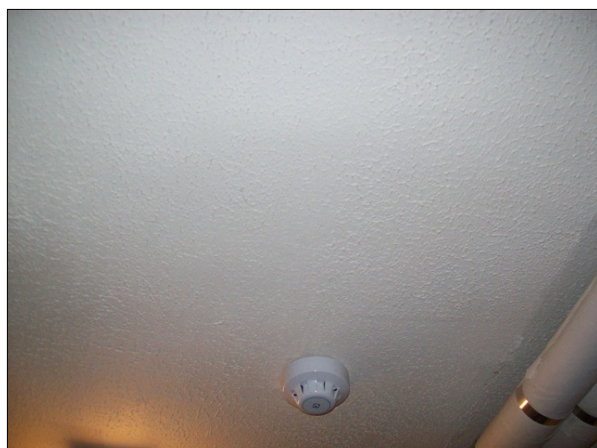
<b>Condition:</b>	Good	<b>Accessibility:</b>	Medium
<b>Friability:</b>	Low	<b>Exposure:</b>	Public
<b>Surface:</b>	Fully sealed	<b>Amount:</b>	2 m <sup>2</sup>
<b>Position:</b>	Internal	<b>RISK:</b>	<b>MINOR (6)</b>

Asbestos textured coating to plasterboard ceiling.

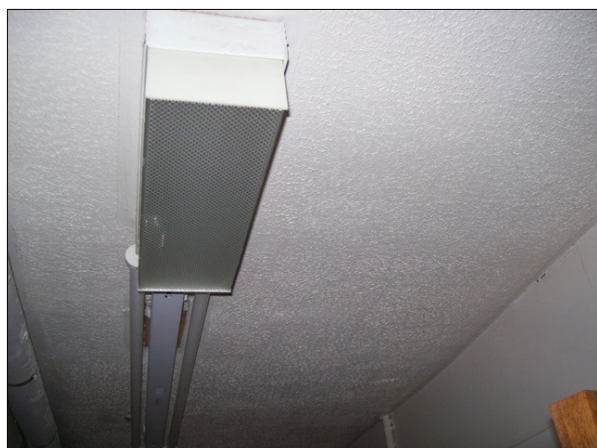
<b>Condition:</b>	Poor	<b>Accessibility:</b>	Medium
<b>Friability:</b>	High	<b>Exposure:</b>	Public
<b>Surface:</b>	Fully sealed	<b>Amount:</b>	2 m <sup>2</sup>
<b>Position:</b>	Internal	<b>RISK:</b>	<b>LOW (10)</b>

Strongly presumed asbestos textured coating to plasterboard ceiling which is falling down.

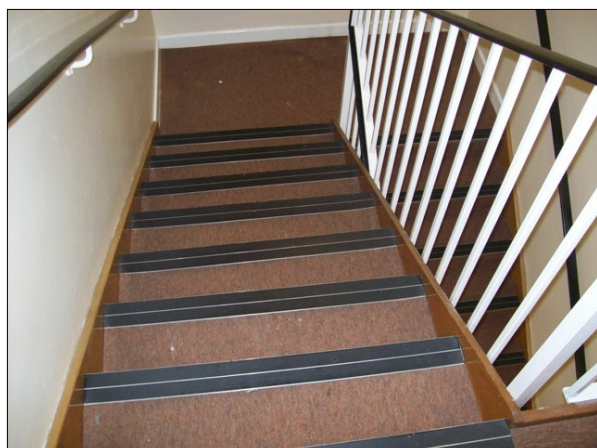
<b>Condition:</b>	Good	<b>Accessibility:</b>	High
<b>Friability:</b>	Low	<b>Exposure:</b>	Public
<b>Surface:</b>	None	<b>Amount:</b>	10 Lm
<b>Position:</b>	Internal	<b>RISK:</b>	<b>NONE</b>

N.A.D.I.S thermoplastic stair nosing to steps.

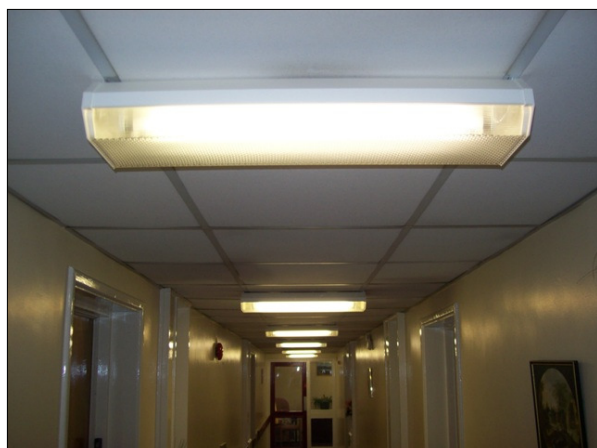
<b>Condition:</b>	Good	<b>Accessibility:</b>	Medium
<b>Friability:</b>	Low	<b>Exposure:</b>	Public
<b>Surface:</b>	Fully sealed	<b>Amount:</b>	24 m <sup>2</sup>
<b>Position:</b>	Internal	<b>RISK:</b>	<b>NONE</b>

N.A.D.I.S insulating board ceiling tiles.

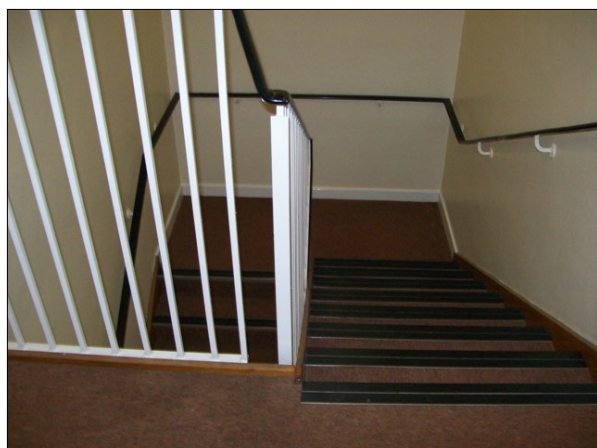
<b>Condition:</b>	Good	<b>Accessibility:</b>	High
<b>Friability:</b>	Low	<b>Exposure:</b>	Public
<b>Surface:</b>	None	<b>Amount:</b>	10 m <sup>2</sup>
<b>Position:</b>	Internal	<b>RISK:</b>	<b>NONE</b>

N.A.D.I.S thermoplastic stair nosing.

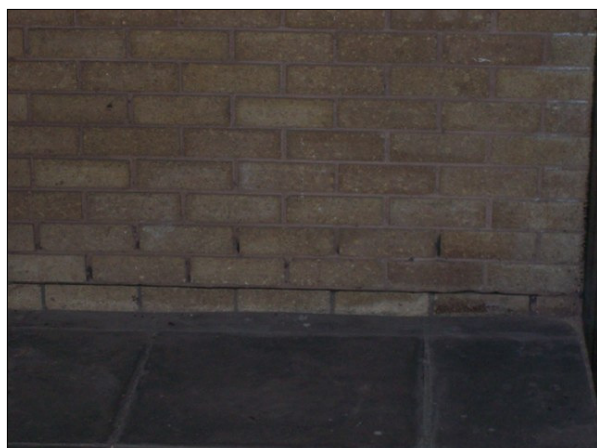
<b>Condition:</b>	Good	<b>Accessibility:</b>	High
<b>Friability:</b>	Low	<b>Exposure:</b>	Public
<b>Surface:</b>	None	<b>Amount:</b>	80 Lm
<b>Position:</b>	External	<b>RISK:</b>	<b>NONE</b>

N.A.D.I.S bitumastic damp proof course to external walls.

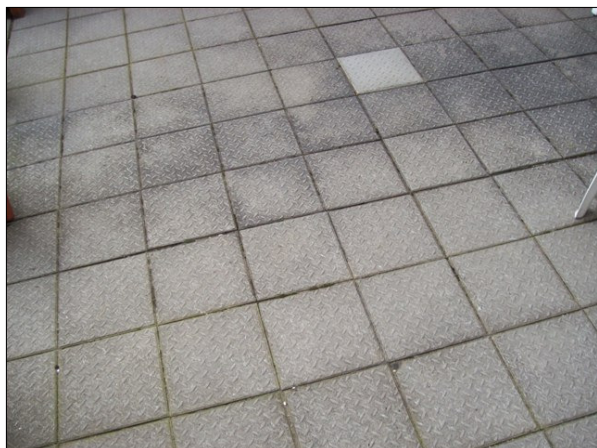
<b>Condition:</b>	Good	<b>Accessibility:</b>	High
<b>Friability:</b>	Low	<b>Exposure:</b>	Public
<b>Surface:</b>	None	<b>Amount:</b>	4 m <sup>2</sup>
<b>Position:</b>	External	<b>RISK:</b>	<b>NONE</b>

N.A.D.I.S cement promenade tiles.

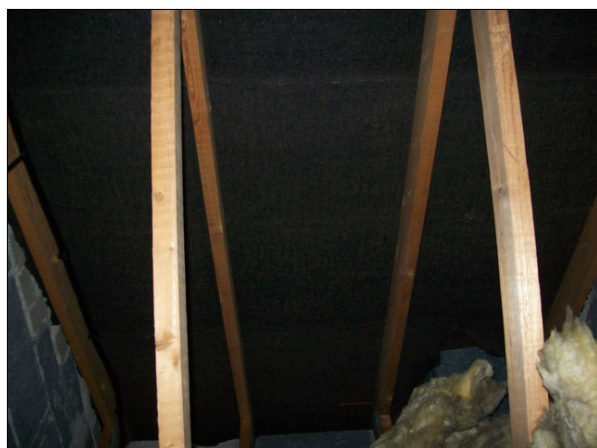
Condition:	Good	Accessibility:	Low
Friability:	Low	Exposure:	Maintenance
Surface:	None	Amount:	180 m <sup>2</sup>
Position:	Internal	RISK:	<b>MINOR (7)</b>

Presumed asbestos bitumastic roof felt.

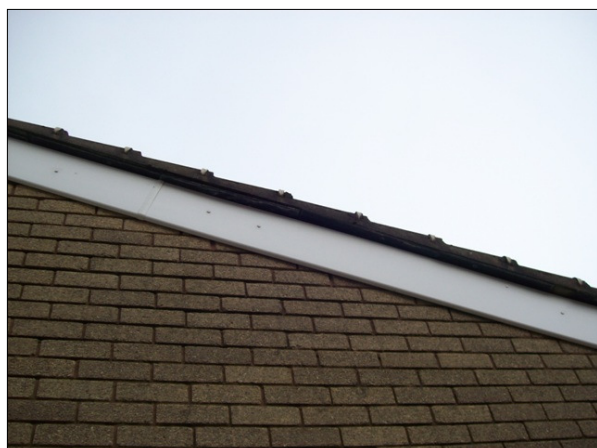
<b>Condition:</b>	Good	<b>Accessibility:</b>	Low
<b>Friability:</b>	Low	<b>Exposure:</b>	Maintenance
<b>Surface:</b>	None	<b>Amount:</b>	20 Lm
<b>Position:</b>	External	<b>RISK:</b>	<b>MINOR (7)</b>

Presumed asbestos cement undercloaking.

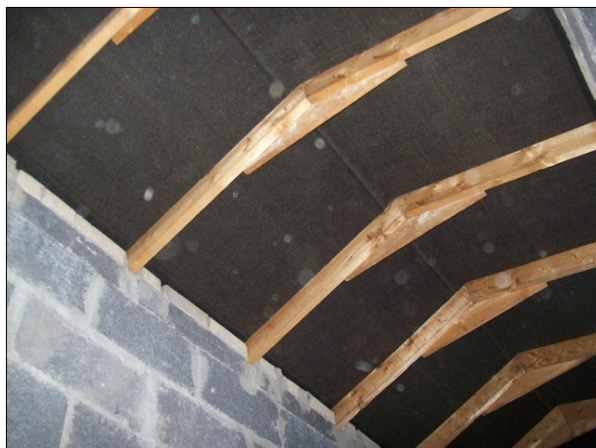
Condition:	Good	Accessibility:	Low
Friability:	Low	Exposure:	Maintenance
Surface:	None	Amount:	180 m <sup>2</sup>
Position:	Internal	RISK:	<b>MINOR (7)</b>

Presumed asbestos bitumastic roof felt.
