- 1.1. Following discussions with Mr Les Adams of Pectel (Wales) Limited, Unit 6, Stadium Close, Cardiff, CF11 8TS, Manestream Ltd, Unit 7 Olympic Business Centre, Paycocke Road, Basildon, Essex, SS14 3EX were requested to undertake a Type II inspection of asbestos containing materials in:

**No 11
Llys Glanrhondda
High Street
Treorchy
CF42 6NY**

- 1.5. Accreditation Details – see APPENDIX 4.
- 1.6. This survey was carried out by Byron Phillips on 11th July 2005 in accordance with Guidance Note **MDHS 100** *Surveying, sampling and assessment of asbestos-containing materials*

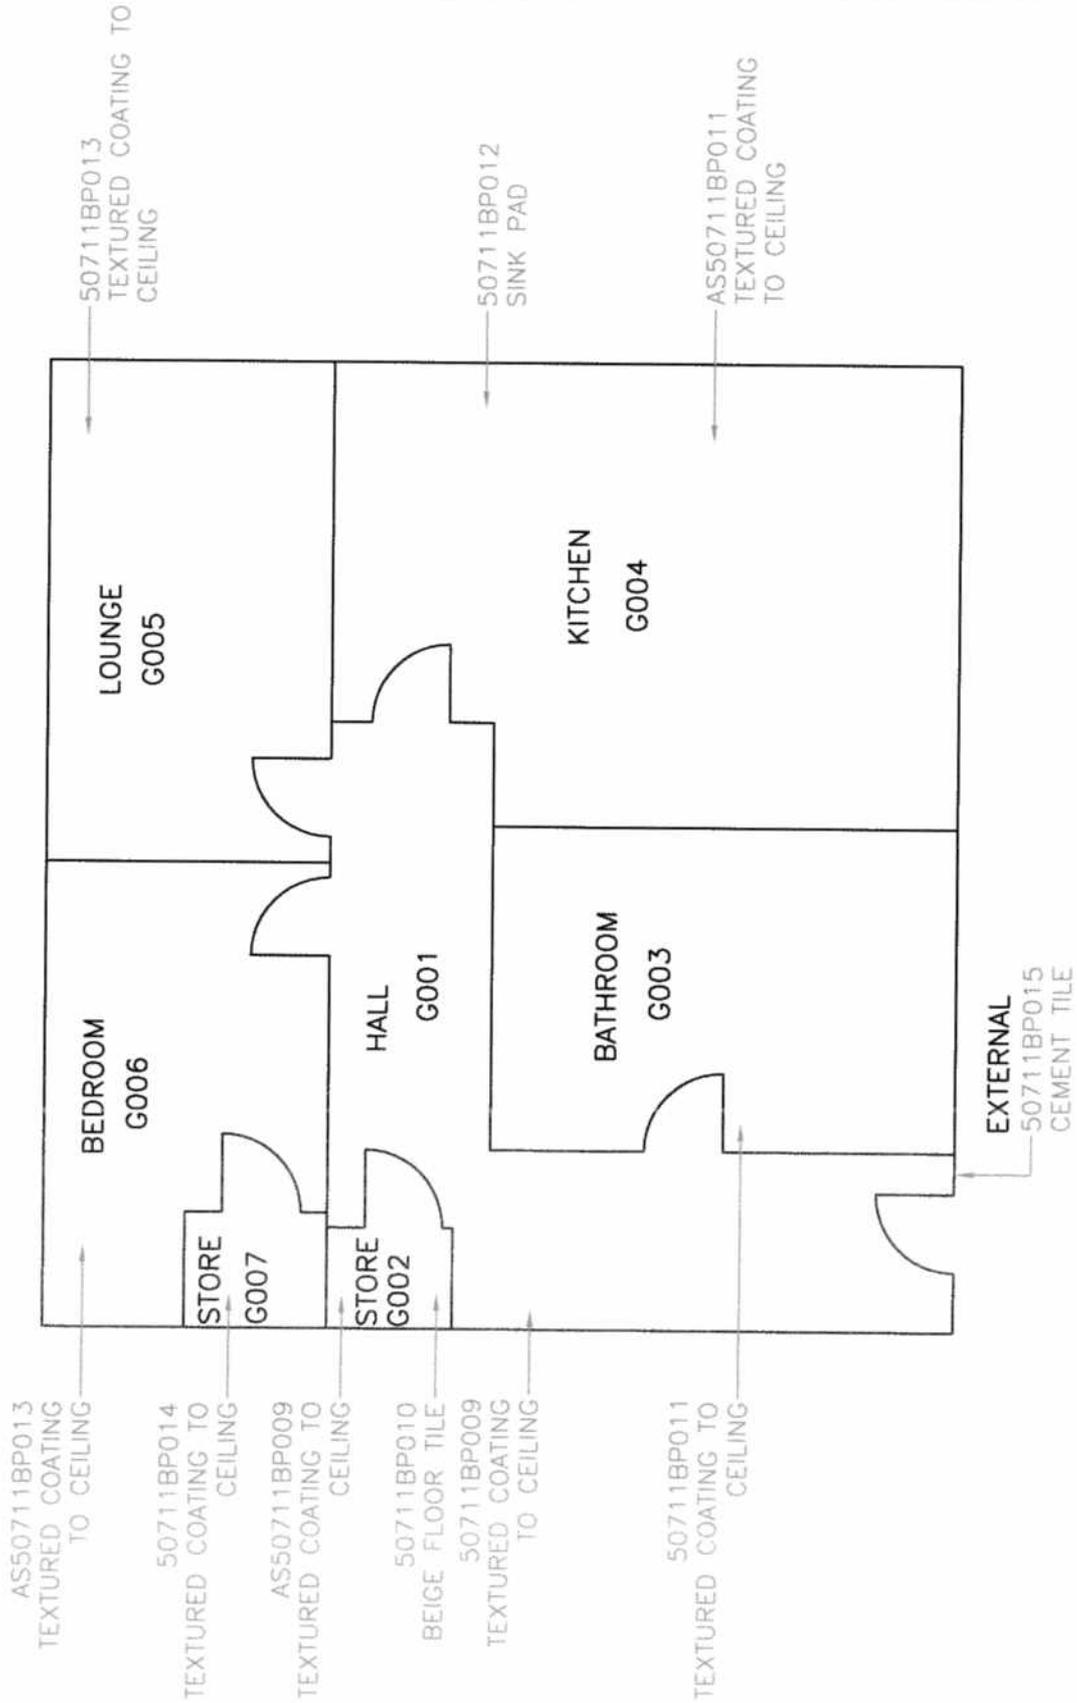
GROUND FLOOR

- 5.1. No asbestos containing materials were found whilst carrying out this survey. Therefore, no discussions/ recommendations are required.
