**WALES & WEST HOUSING  
ASSOCIATION  
3 ALEXANDRA GATE  
FFORDD PENGAM  
TREMORFA  
CARDIFF  
CF24 2UD**

**PROJECT NO: J096753**

**DATE: JUNE 2013**

**ASBESTOS MANAGEMENT SURVEY WITH REFURBISHMENT SURVEY TO  
SPECIFIED AREAS OF  
2 LLYS GLANRHONDDA, HIGH STREET, TREORCHY, RHONDDA, CF42 6NZ**

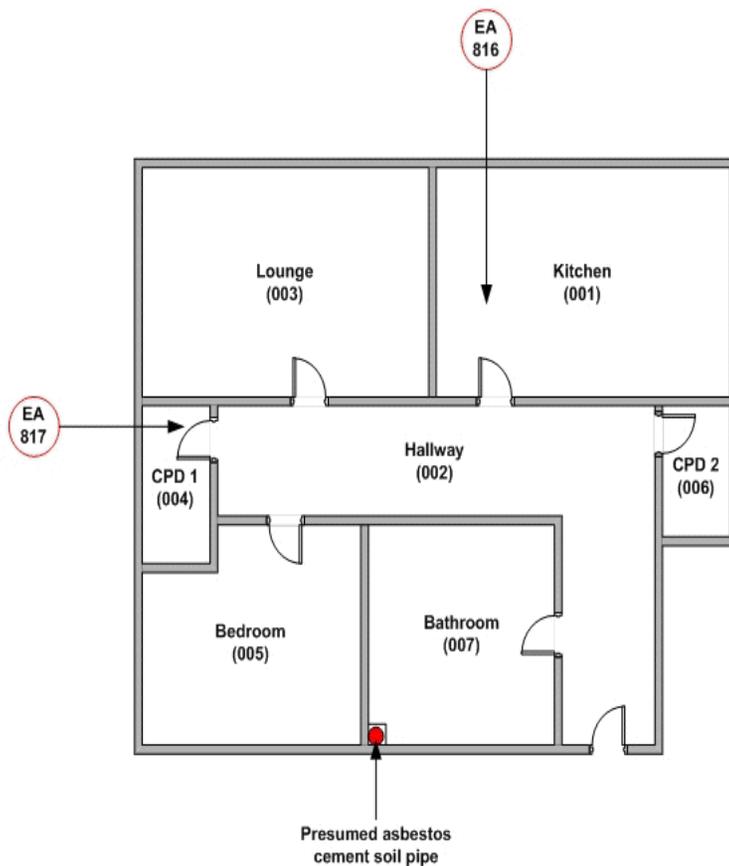
J096753  
Ground Floor

<b>Location</b>	<b>Description</b>	<b>Priority/Risk</b>	<b>Recommendation</b>
Bathroom (007) / Ground Floor	Presumed asbestos cement soil pipe within fixed timber riser boxing - unable to inspect the area due to tenant refusal		Conduct further investigation prior to relevant maintenance / refurbishment works
