MANAGEMENT SURVEY

**Client: Wales & West Housing
Site ID: PF /13 LH628**

**3 Llys Hebron
Pentre Rhondda
CF417AD**

Information based upon D.M.W. Survey **D-50559** Survey Date **17 Dec 2013**.

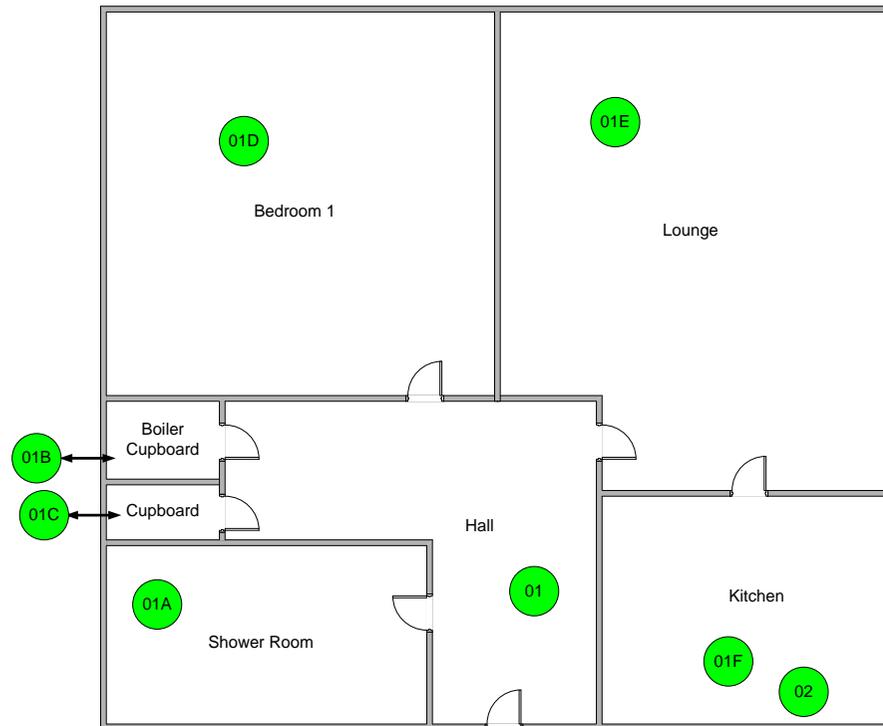
See Sample 01F, 02

No access under modern sealed lino
No access into plasterboard boxing
No access behind live wall fan
