Management Survey

10 Llys Nazareth
Llewellyn Street
Pentre
Rhondda
CF41 7BS
UPRN: 5464

Report issue date:	28 Sep 2015

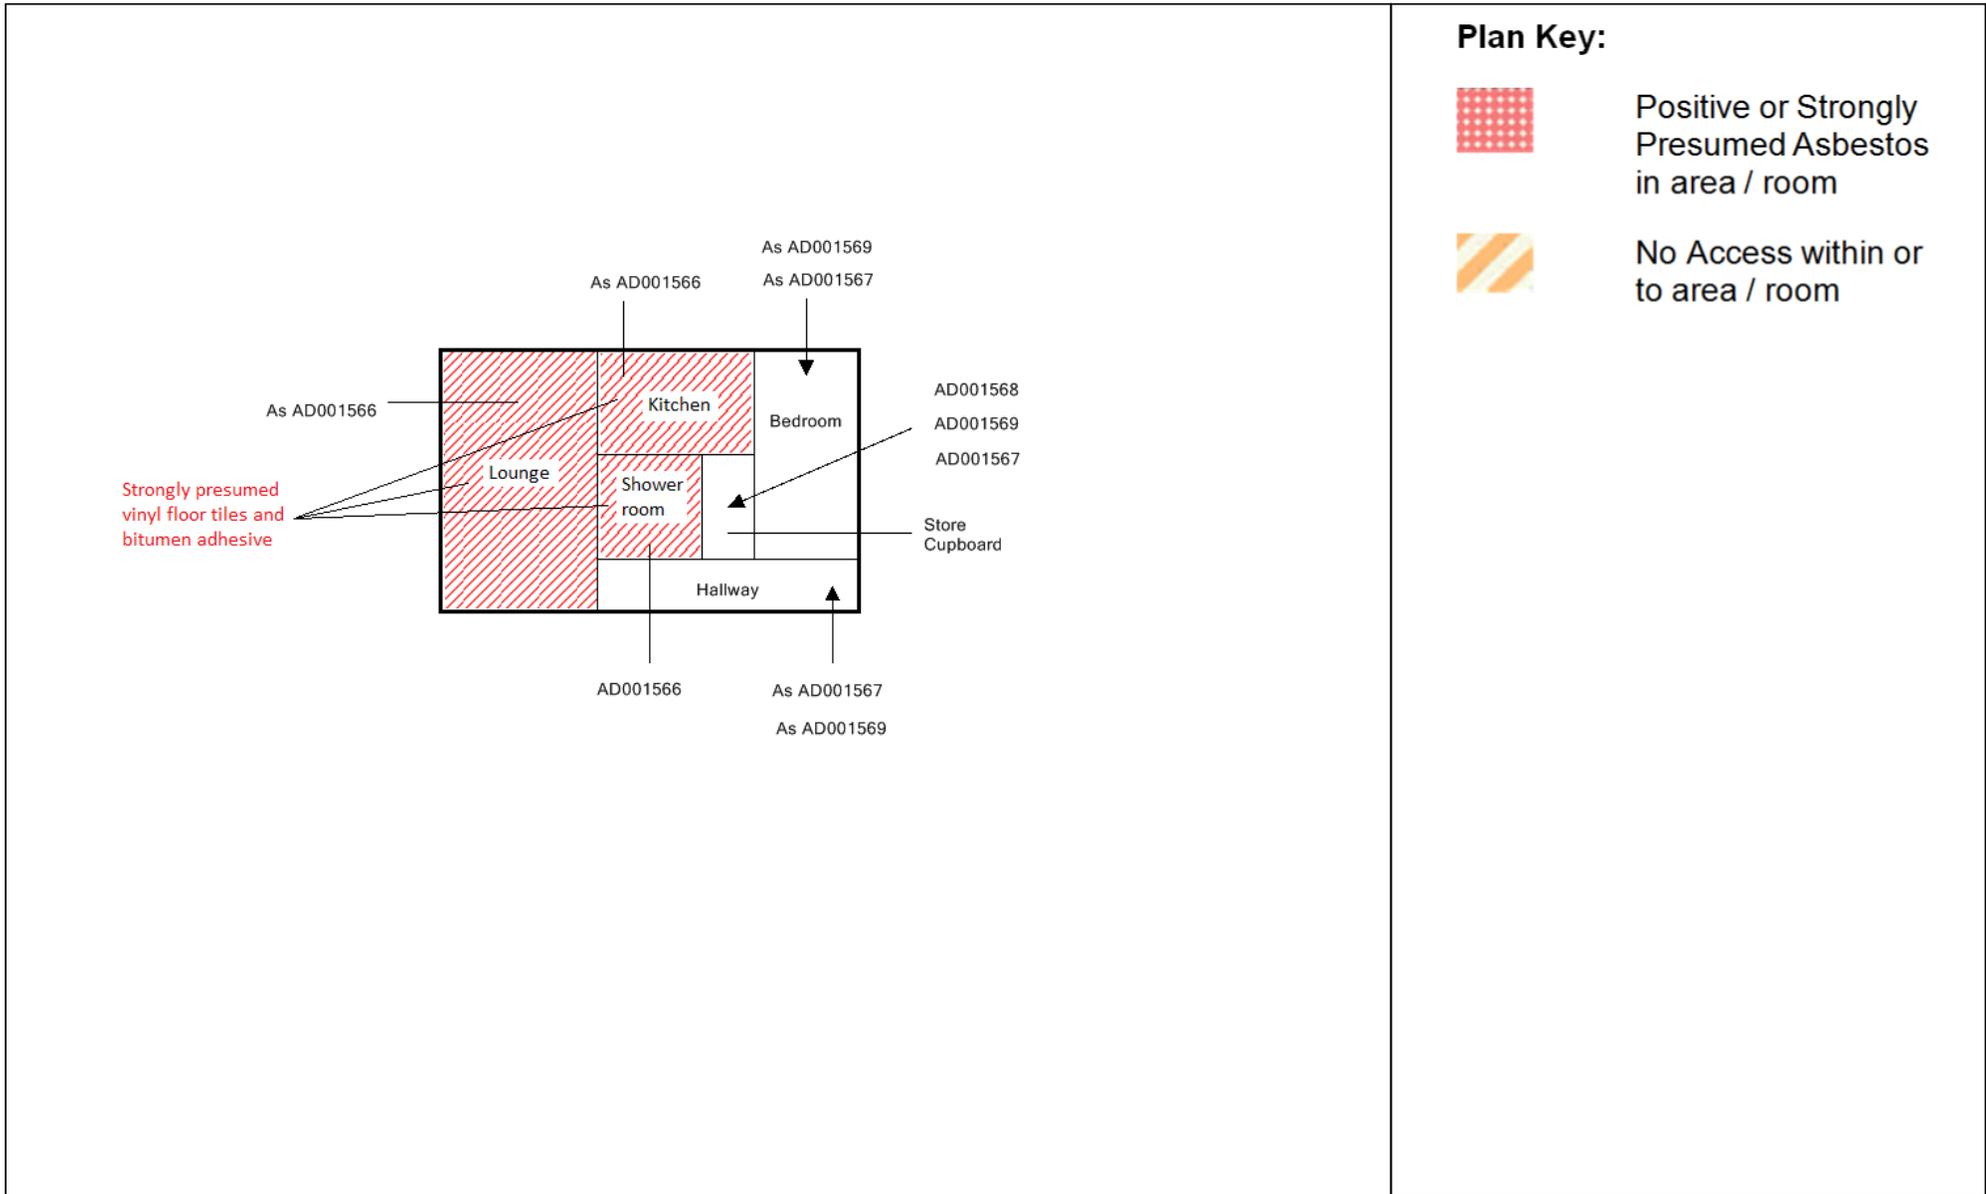
Appendix 5 – Plans

Client: Wales & West Housing
Site: 10 Llys Nazareth Building: Main Flat.
Floor: 1st Floor
UPRN No: 5464
