**WALES & WEST HOUSING  
ASSOCIATION  
3 ALEXANDRA GATE  
FFORDD PENGAM  
TREMORFA  
CARDIFF  
CF24 2UD**

**PROJECT NO: J172418**

**DATE: APRIL 2014**

**ASBESTOS MANAGEMENT SURVEY  
OF  
23 LLYS YR ONNEN, MISKIN ROAD, MOUNTAIN ASH, CF45 3TS**

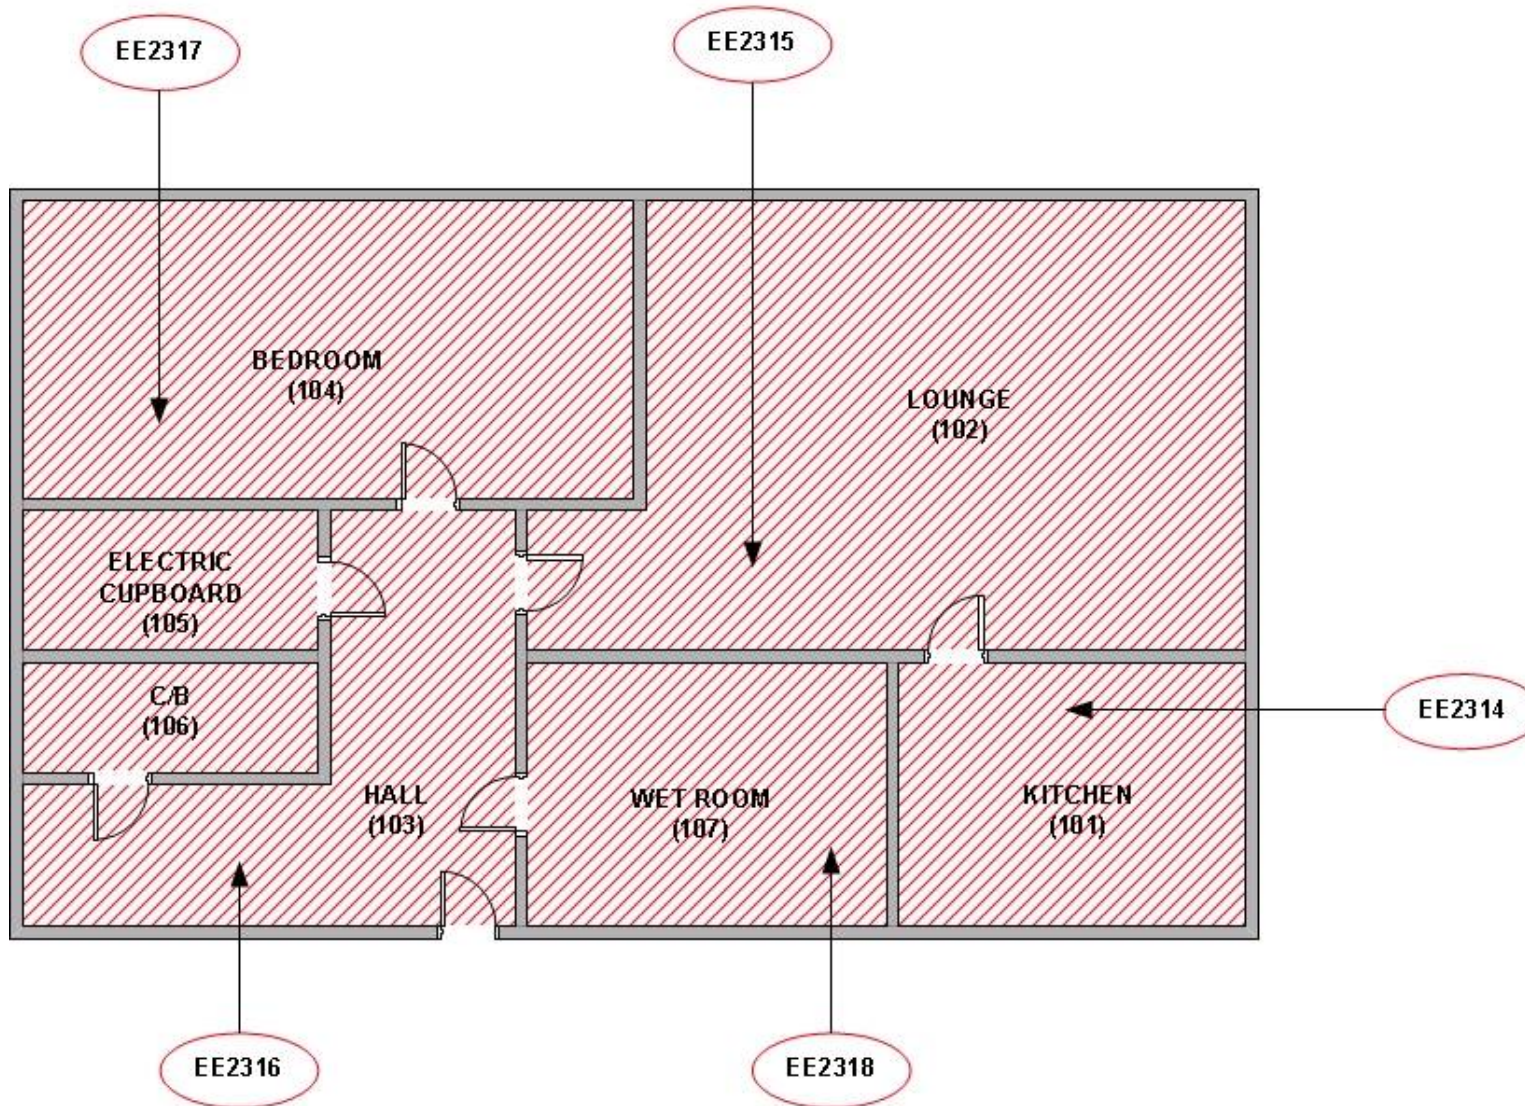
Floor: 1st Floor

| Location | Description | Priority/Risk | Recommendation |
|---|---|---|---|
| Bedroom (104) / 1st Floor | Textured coating to ceiling | Very Low | Manage, label, monitor and inform maintenance personnel prior to relevant works |

| <b>RECOMMENDATIONS:</b> | Manage, label, monitor and inform maintenance personnel prior to relevant works | |
