**An Asbestos Management Survey (MA & PA) at
Block 1 - 31
Maes Trisant
CF72 8RQ**

Survey Conducted:	1 August 2023	
Date of approval:	4 Aug 2023	
Our Reference:	J329567	
Surveyed By:	Fiona Williamson	
UPRN:	3674	
Scope of Works:	Management survey to all accessible communal areas of the property.

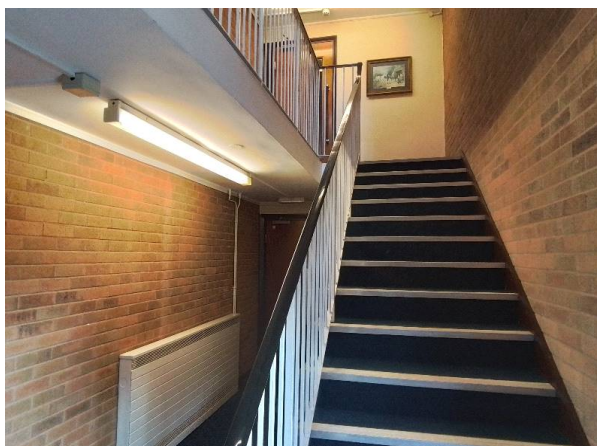
Building:	1 - 31 Maes Trisant	Floor Level:	Basement 1	Item Ref:	J329567-3
Room Name:	(003) Stairs				
Sample Ref:					
Component:	No asbestos containing materials found				
Extent:

Conclusions and Actions	
Recommendation:	No further action required
Further Information:	None
General Notes: Concrete ceiling. Plaster to brick and brick walls. Modern stone tiles to concrete floor under stairs. Carpet to concrete floor and stairs to rest of room. Modern white vinyl stair treads. uPVC door to street. Wooden beading to glass panel in wooden door to corridor. Modern wiring running in plastic conduit along walls and ceiling. Modern radiator.

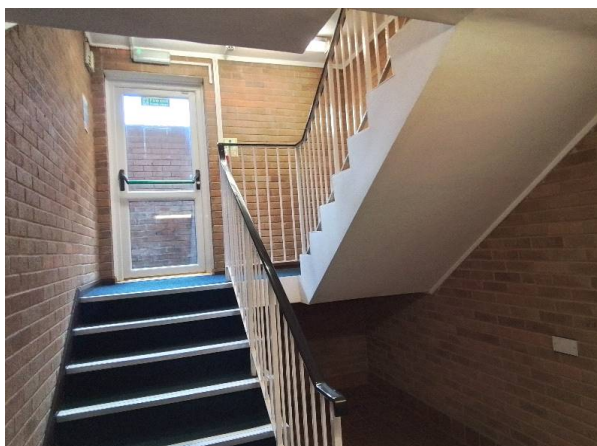
Building:	1 - 31 Maes Trisant	Floor Level:	Basement 1	Item Ref:	J329567-5
Room Name:	(007) Stairs				
Sample Ref:					
Component:	No asbestos containing materials found				
Extent:

Conclusions and Actions	
Recommendation:	No further action required
Further Information:	None
General Notes: Concrete ceiling. Brick walls. Modern stone tiles to concrete floor under stairs. Carpet to concrete floor and stairs to rest of room. Modern white vinyl stair treads. uPVC door to street. Wooden beading to fire glass panel in wooden door to corridor. Modern wiring running in plastic conduit along walls and ceiling. Modern radiator.

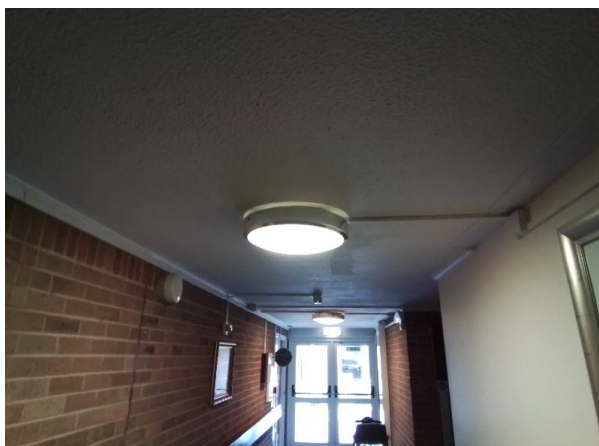
Building:	1 - 31 Maes Trisant	Floor Level:	Basement 1	Item Ref:	J329567-6
Room Name:	(008) Lobby				
Sample Ref:	JZ001101				
Component:	Textured coating to plasterboard ceiling				
Extent:	24m ²

Material Assessment		
Product Type	Extent of damage	Surface Treatment Score
Asbestos Type	Material Assessment Score (MA)	
No Asbestos Detected

Conclusions and Actions	
Recommendation:	No further action required
Further Information:	None
General Notes: Textured coating to plasterboard ceiling. Plaster to brick and brick walls. Carpet to concrete floor. Wooden beading to fire glass panels in wooden fire doors to corridor. Plaster to brick header panel above doors to corridor. uPVC door to street. Wooden doors to flats. Wooden panelling to left hand side of doors to flats (housing letter boxes). Modern wiring running in plastic conduit along walls and ceiling. Modern mastic in gaps between sections of brick work. Modern radiators. Wooden panels to rear of electric meters in glass fibre meter cupboards in walls.

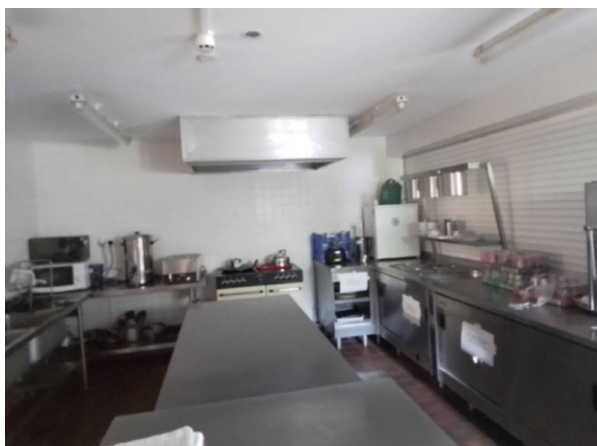
Building:	1 - 31 Maes Trisant	Floor Level:	Ground	Item Ref:	J329567-8
Room Name:	(010) Kitchen				
Sample Ref:					
Component:	No asbestos containing materials found				
Extent:

Conclusions and Actions	
Recommendation:	No further action required
Further Information:	None
General Notes: Concrete ceiling. Ceramic tiled plaster to brick walls. Modern stone tiles to concrete floor. Laminated wooden boxing adjacent to door to lounge and above window - no access within boxing (excessive damage). No sink pads. Fire glass panels in wooden fire doors to lounge and lobby. Wooden fire door to electrical cupboard. uPVC window and ceramic tile sill. Metal servery hatch in wall to communal lounge.

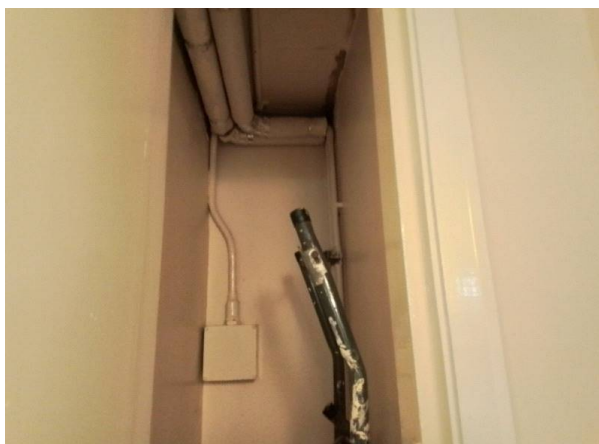
Building:	1 - 31 Maes Trisant	Floor Level:	Ground	Item Ref:	J329567-11
Room Name:	(013) Cupboard				
Sample Ref:					
Component:	No asbestos containing materials found				
Extent:

Material Assessment		
Product Type	Extent of damage	Surface Treatment Score
Asbestos Type	Material Assessment Score (MA)	
No suspect materials

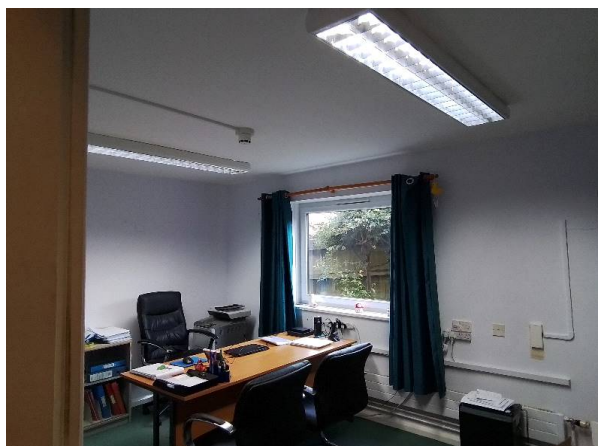
Building:	1 - 31 Maes Trisant	Floor Level:	Ground	Item Ref:	J329567-13
Room Name:	(015) Office				
Sample Ref:					
Component:	No asbestos containing materials found				
Extent:

Material Assessment		
Product Type	Extent of damage	Surface Treatment Score
Asbestos Type	Material Assessment Score (MA)	
No suspect materials

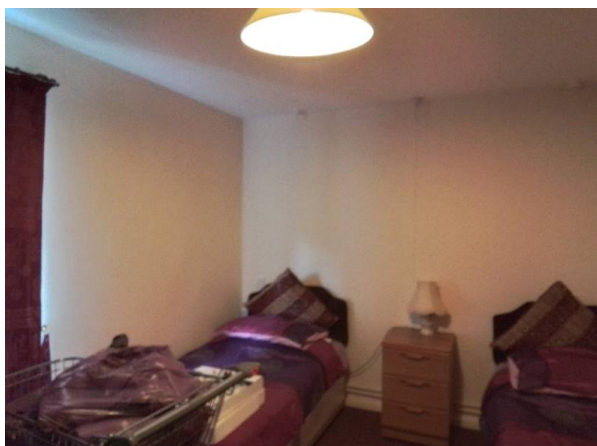
Building:	1 - 31 Maes Trisant	Floor Level:	Ground	Item Ref:	J329567-53
Room Name:	(016) Guest Room				
Sample Ref:					
Component:	No asbestos containing materials found				
Extent:

Material Assessment		
Product Type	Extent of damage	Surface Treatment Score
Asbestos Type	Material Assessment Score (MA)	
No suspect materials

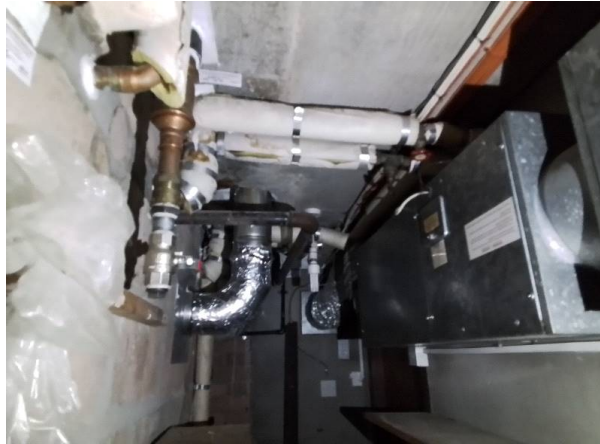
Building:	1 - 31 Maes Trisant	Floor Level:	Ground	Item Ref:	J329567-52
Room Name:	(021) Riser				
Sample Ref:					
Component:	No asbestos containing materials found				
Extent:

Material Assessment		
Product Type	Extent of damage	Surface Treatment Score
Asbestos Type	Material Assessment Score (MA)	
No suspect materials

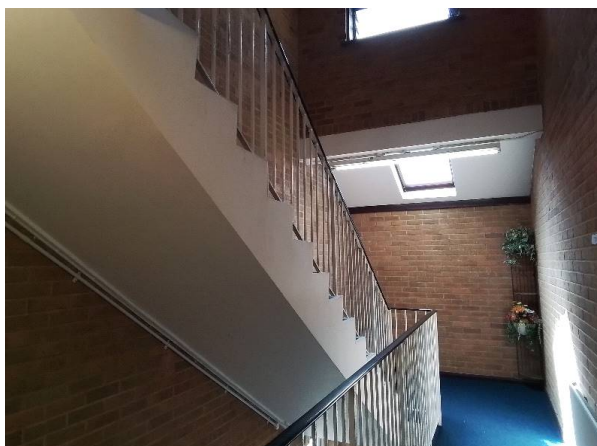
Building:	1 - 31 Maes Trisant	Floor Level:	Ground	Item Ref:	J329567-17
Room Name:	(022) Stairs				
Sample Ref:					
Component:	No asbestos containing materials found				
Extent:

Material Assessment		
Product Type	Extent of damage	Surface Treatment Score
Asbestos Type	Material Assessment Score (MA)	
No suspect materials

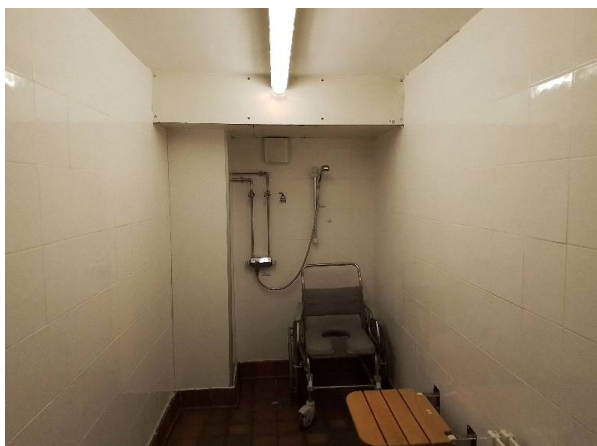
Building:	1 - 31 Maes Trisant	Floor Level:	Ground	Item Ref:	J329567-18
Room Name:	(023) Communal Shower				
Sample Ref:					
Component:	No asbestos containing materials found				
Extent:

Material Assessment		
Product Type	Extent of damage	Surface Treatment Score
Asbestos Type	Material Assessment Score (MA)	
No suspect materials

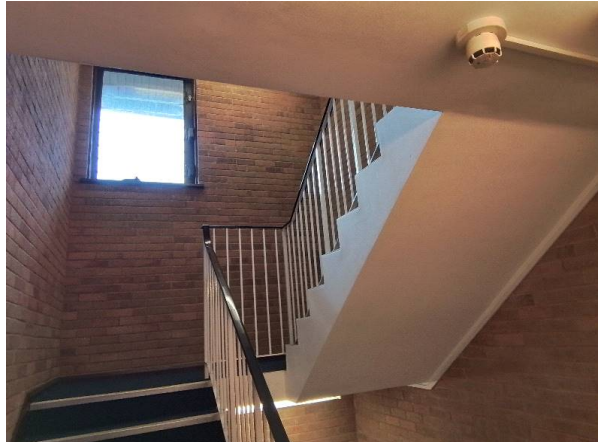
Building:	1 - 31 Maes Trisant	Floor Level:	Ground	Item Ref:	J329567-19
Room Name:	(024) Stairs				
Sample Ref:					
Component:	No asbestos containing materials found				
Extent:

Material Assessment		
Product Type	Extent of damage	Surface Treatment Score
Asbestos Type	Material Assessment Score (MA)	
No suspect materials

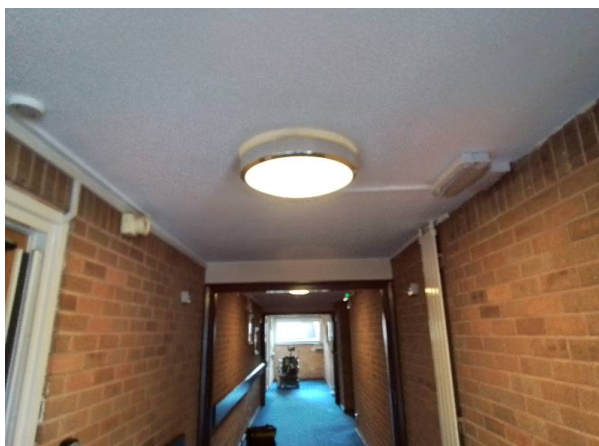
Building:	1 - 31 Maes Trisant	Floor Level:	Ground	Item Ref:	J329567-20
Room Name:	(025) Lobby				
Sample Ref:	JZ001103				
Component:	Textured coating to plasterboard ceiling				
Extent:	20m ²

Material Assessment		
Product Type	Extent of damage	Surface Treatment Score
Asbestos Type	Material Assessment Score (MA)	
No Asbestos Detected

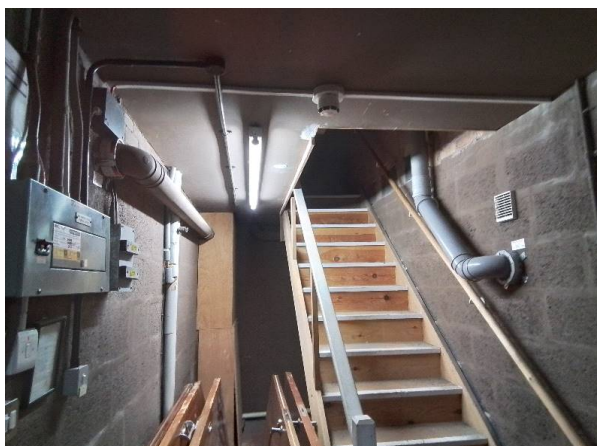
Building:	1 - 31 Maes Trisant	Floor Level:	First	Item Ref:	J329567-21
Room Name:	(026) Loft Access				
Sample Ref:					
Component:	No asbestos containing materials found				
Extent:

Material Assessment		
Product Type	Extent of damage	Surface Treatment Score
Asbestos Type	Material Assessment Score (MA)	
No suspect materials

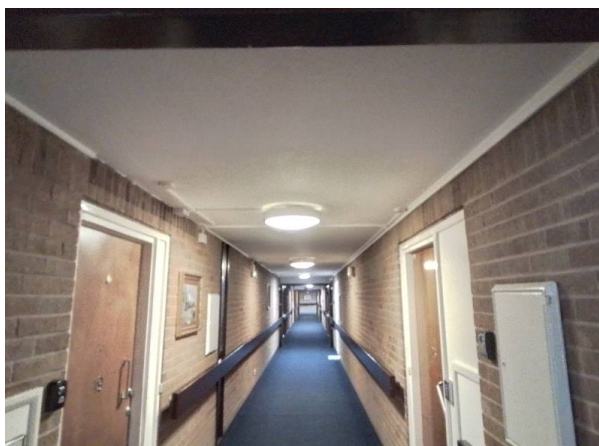
Building:	1 - 31 Maes Trisant	Floor Level:	First	Item Ref:	J329567-22
Room Name:	(027) Corridor				
Sample Ref:	JZ001104				
Component:	Textured coating to plasterboard ceiling				
Extent:	70m ²

Material Assessment		
Product Type	Extent of damage	Surface Treatment Score
Asbestos Type	Material Assessment Score (MA)	
No Asbestos Detected

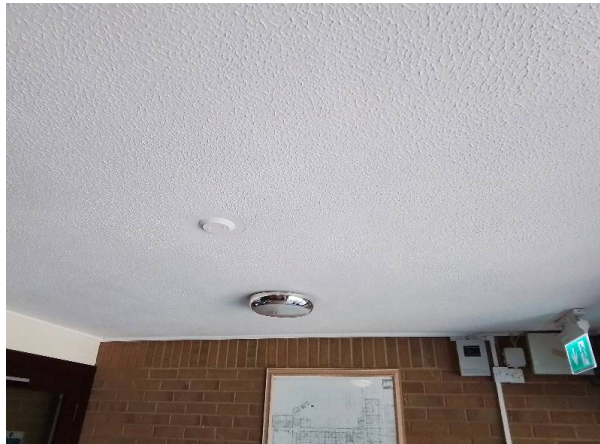
Building:	1 - 31 Maes Trisant	Floor Level:	First	Item Ref:	J329567-23
Room Name:	(028) Entrance				
Sample Ref:	As JZ001104				
Component:	Textured coating to concrete ceiling				
Extent:	12m ²

Material Assessment		
Product Type	Extent of damage	Surface Treatment Score
Asbestos Type	Material Assessment Score (MA)	
No asbestos detected in visually consistent material

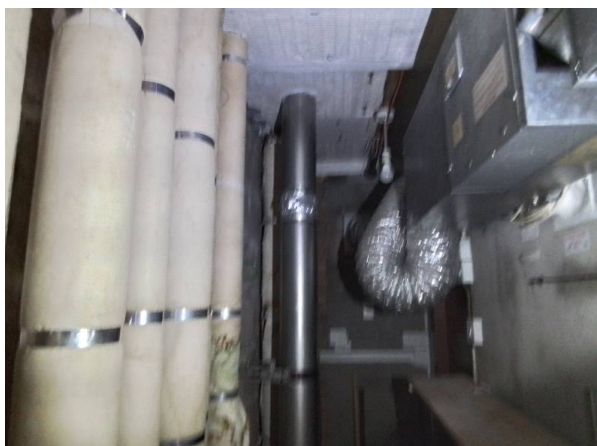
Building:	1 - 31 Maes Trisant	Floor Level:	First	Item Ref:	J329567-55
Room Name:	(029) Riser				
Sample Ref:					
Component:	No asbestos containing materials found				
Extent:

Material Assessment		
Product Type	Extent of damage	Surface Treatment Score
Asbestos Type	Material Assessment Score (MA)	
No suspect materials

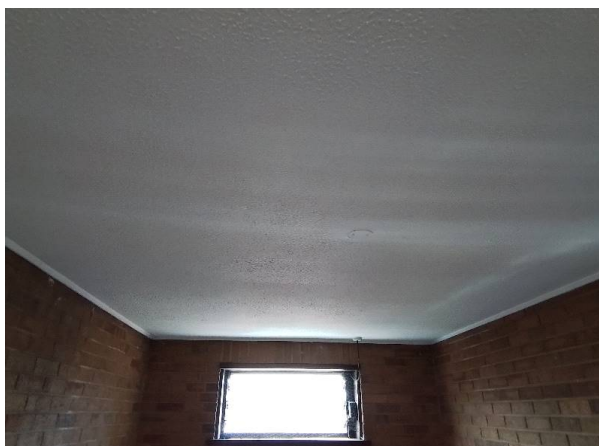
Building:	1 - 31 Maes Trisant	Floor Level:	First	Item Ref:	J329567-24
Room Name:	(030) Stairs				
Sample Ref:	As JZ001104				
Component:	Textured coating to plasterboard ceiling				
Extent:	12m ²

Material Assessment		
Product Type	Extent of damage	Surface Treatment Score
Asbestos Type	Material Assessment Score (MA)	
No asbestos detected in visually consistent material

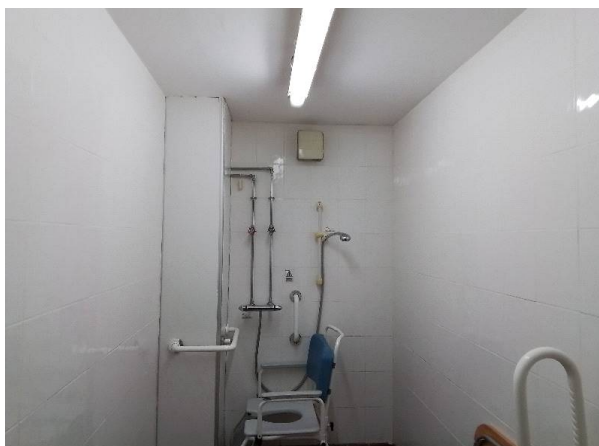
Building:	1 - 31 Maes Trisant	Floor Level:	First	Item Ref:	J329567-27
Room Name:	(031) Communal Shower				
Sample Ref:					
Component:	No asbestos containing materials found				
Extent:

Material Assessment		
Product Type	Extent of damage	Surface Treatment Score
Asbestos Type	Material Assessment Score (MA)	
No suspect materials

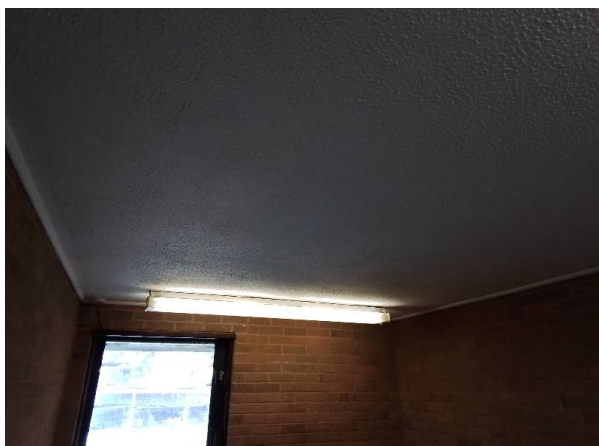
Building:	1 - 31 Maes Trisant	Floor Level:	First	Item Ref:	J329567-28
Room Name:	(032) Stairs				
Sample Ref:	As JZ001104				
Component:	No asbestos containing materials found				
Extent:	12m ²

Material Assessment		
Product Type	Extent of damage	Surface Treatment Score
Asbestos Type	Material Assessment Score (MA)	
No asbestos detected in visually consistent material

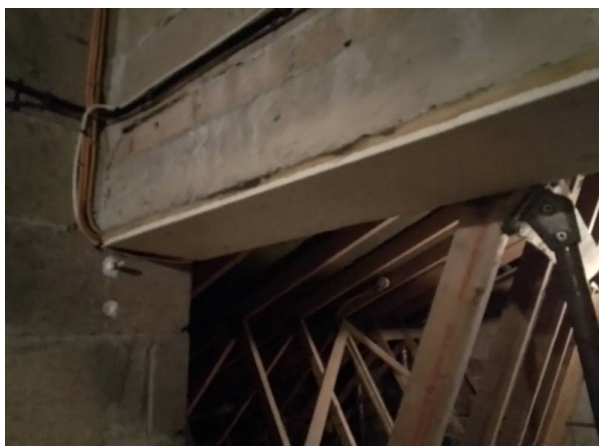
Building:	1 - 31 Maes Trisant	Floor Level:	Roof Void	Item Ref:	J329567-30
Room Name:	(034) Loft				
Sample Ref:	JZ001106				
Component:	Insulation board panel to arch				
Extent:	1m ²

Material Assessment		
Product Type	Extent of damage	Surface Treatment Score
Asbestos Type	Material Assessment Score (MA)	
No Asbestos Detected

Conclusions and Actions	
Recommendation:	No further action required
Further Information:	None
General Notes: Modern sarking felt. Breeze block walls. Wooden floorboards. Insulation board panel to top of arch. MMMF insulation. MMMF insulated pipework below wooden floorboards and running along loft. Presumed asbestos containing gaskets to pipe flanges. Gaiters to metal ducting running in loft. Plasterboard panels adjacent to wooden fire door between loft sections. Coated MMMF panel to wall where wiring on a cable tray passes through. Wooden fire doors to loft spaces above flats. Plastic pipes passing through wooden panels on wall.

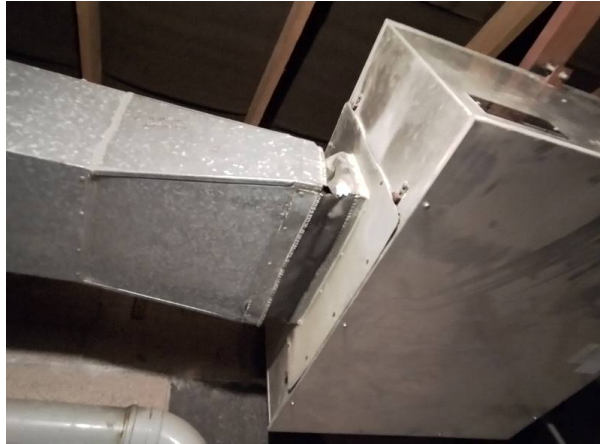
Building:	1 - 31 Maes Trisant	Floor Level:	Roof Void	Item Ref:	J329567-31
Room Name:	(034) Loft				
Sample Ref:	JZ001107				
Component:	Gaiter to metal ducting				
Extent:	0.2m ²

Material Assessment		
Product Type	Extent of damage	Surface Treatment Score
Asbestos Type	Material Assessment Score (MA)	
No Asbestos Detected

Conclusions and Actions	
Recommendation:	No further action required
Further Information:	None
General Notes: Modern sarking felt. Breeze block walls. Wooden floorboards. Insulation board panel to top of arch. MMMF insulation. MMMF insulated pipework below wooden floorboards and running along loft. Presumed asbestos containing gaskets to pipe flanges. Gaiters to metal ducting running in loft. Plasterboard panels adjacent to wooden fire door between loft sections. Coated MMMF panel to wall where wiring on a cable tray passes through. Wooden fire doors to loft spaces above flats. Plastic pipes passing through wooden panels on wall.

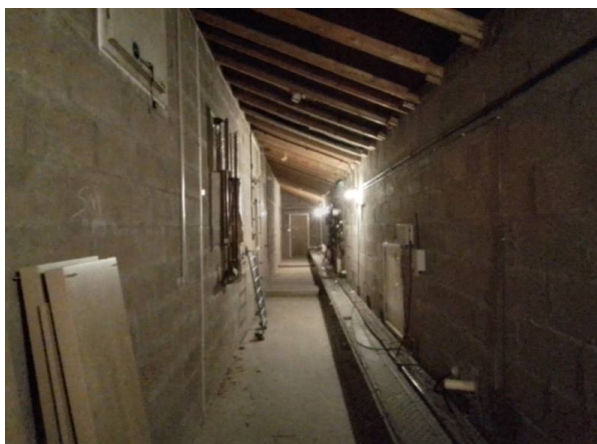
Building:	1 - 31 Maes Trisant	Floor Level:	Roof Void	Item Ref:	J329567-34
Room Name:	(035) Loft				
Sample Ref:					
Component:	No asbestos containing materials found				
Extent:

Material Assessment		
Product Type	Extent of damage	Surface Treatment Score
Asbestos Type	Material Assessment Score (MA)	
No suspect materials

Conclusions and Actions	
Recommendation:	No further action required
Further Information:	None
General Notes: Modern sarking felt. Breeze block walls. Concrete floor. MMMF insulated metal pipework running along loft. Plasterboard panels to wooden fire door between loft sections. Wooden emergency exit doors. Wooden fire doors to loft over flats. Wooden panel to rear of textured equipment on wall. Wooden panelling over plastic pipework.

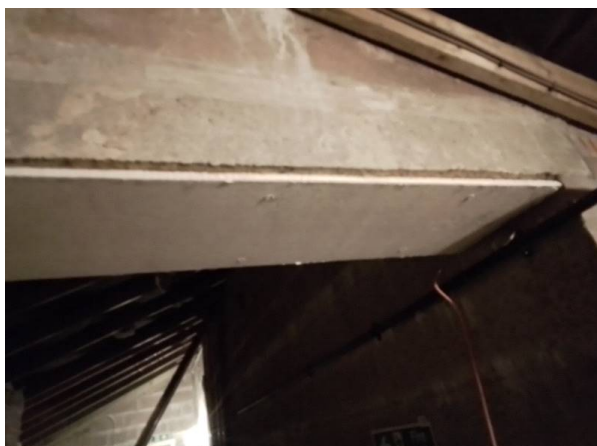
Building:	1 - 31 Maes Trisant	Floor Level:	Roof Void	Item Ref:	J329567-35
Room Name:	(036) Loft				
Sample Ref:	As JZ001106				
Component:	Insulation board panel to arch				
Extent:	1m ²

Material Assessment		
Product Type	Extent of damage	Surface Treatment Score
Asbestos Type	Material Assessment Score (MA)	
No asbestos detected in visually consistent material

Conclusions and Actions	
Recommendation:	No further action required
Further Information:	None
General Notes: Modern sarking felt. Breeze block walls. Wooden floorboards. MMMF insulation. MMMF insulated metal pipework below wooden floorboards and running along loft. Insulation board panels to floor and arch. Modern fire doors to lofts above flats.

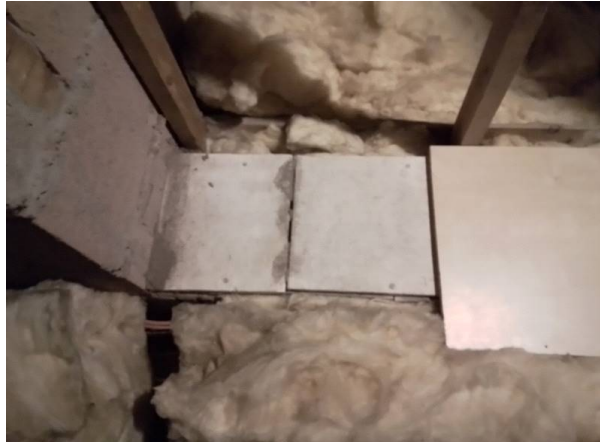
Building:	1 - 31 Maes Trisant	Floor Level:	Roof Void	Item Ref:	J329567-38
Room Name:	(036) Loft				
Sample Ref:	As JZ001106				
Component:	Insulation board panels to floor				
Extent:	1m ²

Material Assessment		
Product Type	Extent of damage	Surface Treatment Score
Asbestos Type	Material Assessment Score (MA)	
No asbestos detected in visually consistent material

Conclusions and Actions	
Recommendation:	No further action required
Further Information:	None
General Notes: Modern sarking felt. Breeze block walls. Wooden floorboards. MMMF insulation. MMMF insulated metal pipework below wooden floorboards and running along loft. Insulation board panels to floor and arch. Modern fire doors to lofts above flats.

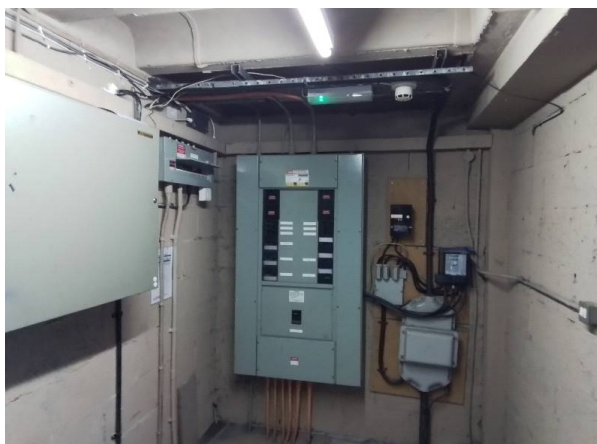
Building:	1 - 31 Maes Trisant	Floor Level:	External	Item Ref:	J329567-39
Room Name:	(037) Electrical Cupboard				
Sample Ref:					
Component:	No asbestos containing materials found				
Extent:

Material Assessment		
Product Type	Extent of damage	Surface Treatment Score
Asbestos Type	Material Assessment Score (MA)	
No suspect materials

Conclusions and Actions	
Recommendation:	No further action required
Further Information:	None
General Notes: Concrete ceiling. Breeze block walls. Concrete floor. Modern cabling running into clay pipes in floor. Modern electrics on wall. Plastic soil pipe. Wooden door.

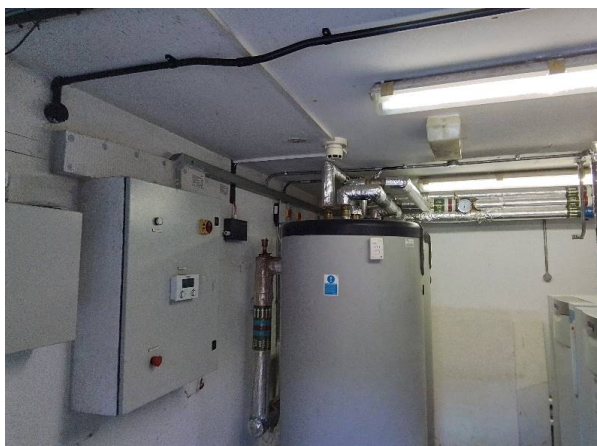
Building:	1 - 31 Maes Trisant	Floor Level:	External	Item Ref:	J329567-41
Room Name:	(038) Boiler Room				
Sample Ref:					
Component:	Additional photo				
Extent:

Material Assessment		
Product Type	Extent of damage	Surface Treatment Score
Asbestos Type	Material Assessment Score (MA)	
No suspect materials

Conclusions and Actions	
Recommendation:	No further action required
Further Information:	None
General Notes: Plasterboard ceiling. Plasterboard left hand side of. Breeze block walls to rest of room. MMMF insulated metal pipework. Modern gaskets to boiler pipework flanges. Modern Vaillant boilers with metal flues. Modern fibreboard panels to walls where boiler flues and pipework pass through. Gaskets to gas pipe flanges. Loose non asbestos fibreboard panels to rear of boiler room wooden door.

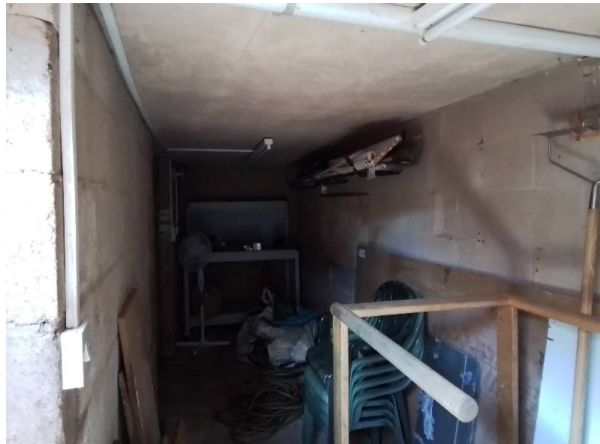
Building:	1 - 31 Maes Trisant	Floor Level:	External	Item Ref:	J329567-42
Room Name:	(039) External Store				
Sample Ref:					
Component:	No asbestos containing materials found				
Extent:

Material Assessment		
Product Type	Extent of damage	Surface Treatment Score
Asbestos Type	Material Assessment Score (MA)	
No suspect materials

Conclusions and Actions	
Recommendation:	No further action required
Further Information:	None
General Notes: Concrete ceiling. Breeze block walls. Concrete floor. Wooden doors.

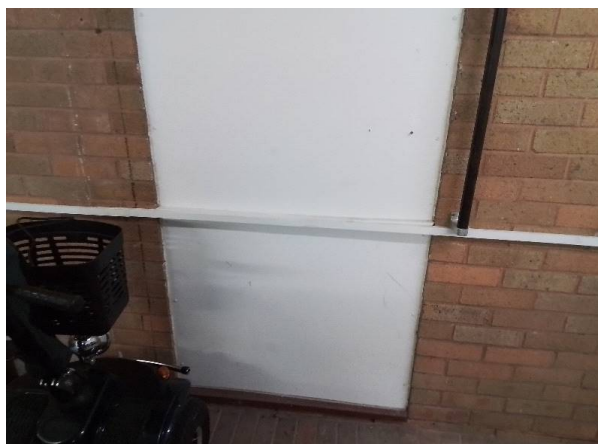
Building:	1 - 31 Maes Trisant	Floor Level:	External	Item Ref:	J329567-44
Room Name:	(041) Scooter Store				
Sample Ref:	JZ001110				
Component:	Insulation board panel to rear wall				
Extent:	2m ²

Material Assessment		
Product Type	Extent of damage	Surface Treatment Score
Asbestos Type	Material Assessment Score (MA)	
No Asbestos Detected

Conclusions and Actions	
Recommendation:	No further action required
Further Information:	None
General Notes: Wooden ceiling panels. Plaster to brick and brick walls. Concrete floor. Insulation board wall panel to rear wall. Wooden door.

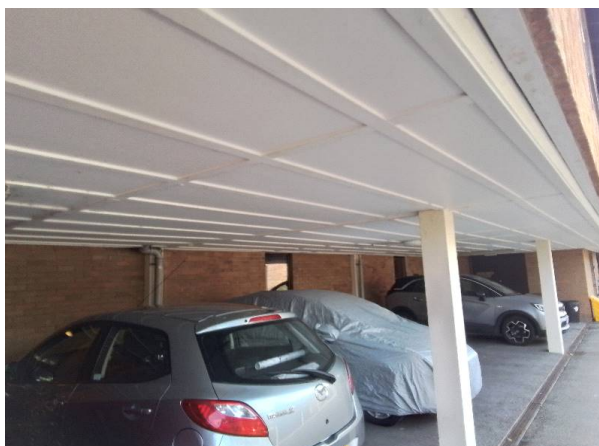
Building:	1 - 31 Maes Trisant	Floor Level:	External	Item Ref:	J329567-46
Room Name:	(042) Car Port				
Sample Ref:					
Component:	No asbestos containing materials found				
Extent:

Material Assessment		
Product Type	Extent of damage	Surface Treatment Score
Asbestos Type	Material Assessment Score (MA)	
No suspect materials

Conclusions and Actions	
Recommendation:	No further action required
Further Information:	None
General Notes: Wooden ceiling panels. Brick walls. Tarmac floor. Plastic drainpipes.

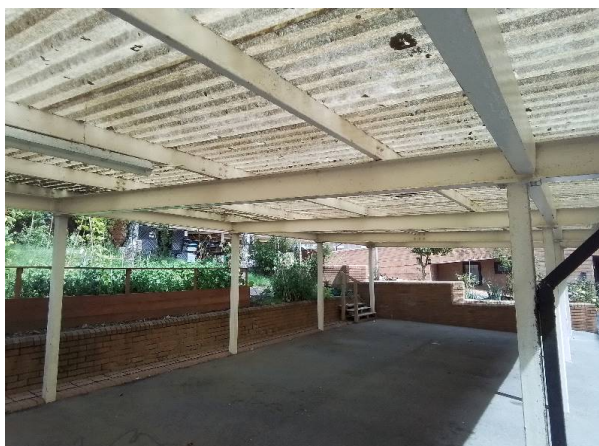
Building:	1 - 31 Maes Trisant	Floor Level:	External	Item Ref:	J329567-47
Room Name:	(043) Car Port				
Sample Ref:					
Component:	No asbestos containing materials found				
Extent:

Material Assessment		
Product Type	Extent of damage	Surface Treatment Score
Asbestos Type	Material Assessment Score (MA)	
No suspect materials

Conclusions and Actions	
Recommendation:	No further action required
Further Information:	None
General Notes: Corrugated plastic roof sheets on metal supports. Brick walls. Tarmac floor. Plastic drainpipes and guttering.

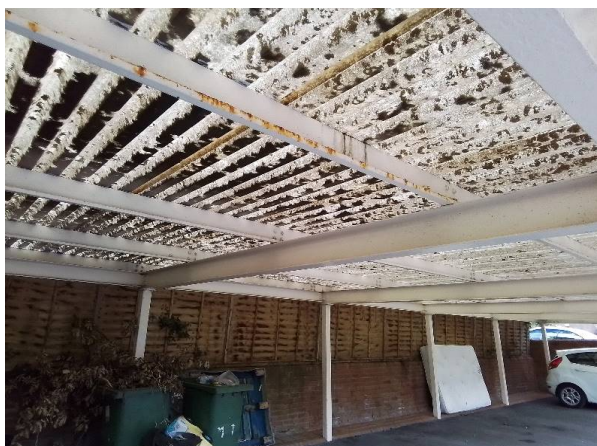
Building:	1 - 31 Maes Trisant	Floor Level:	External	Item Ref:	J329567-48
Room Name:	(044) Car Port				
Sample Ref:					
Component:	No asbestos containing materials found				
Extent:

Material Assessment		
Product Type	Extent of damage	Surface Treatment Score
Asbestos Type	Material Assessment Score (MA)	
No suspect materials

Conclusions and Actions	
Recommendation:	No further action required
Further Information:	None
General Notes: Corrugated plastic roof sheets on metal supports. Upper wooden wall panels and lower brick wall. Tarmac floor. Plastic drainpipes and guttering.

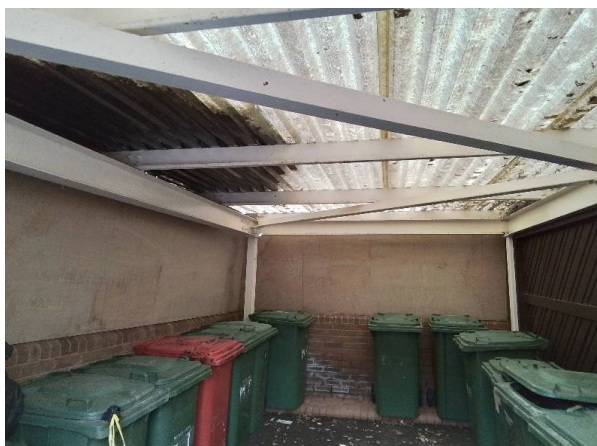
Building:	1 - 31 Maes Trisant	Floor Level:	External	Item Ref:	J329567-49
Room Name:	(045) Bin Store				
Sample Ref:					
Component:	No asbestos containing materials found				
Extent:

Material Assessment		
Product Type	Extent of damage	Surface Treatment Score
Asbestos Type	Material Assessment Score (MA)	
No suspect materials

Conclusions and Actions	
Recommendation:	No further action required
Further Information:	None
General Notes: Corrugated plastic roof sheets on metal supports. Upper wooden wall panels and lower brick wall. Tarmac floor. Plastic drainpipes and guttering.

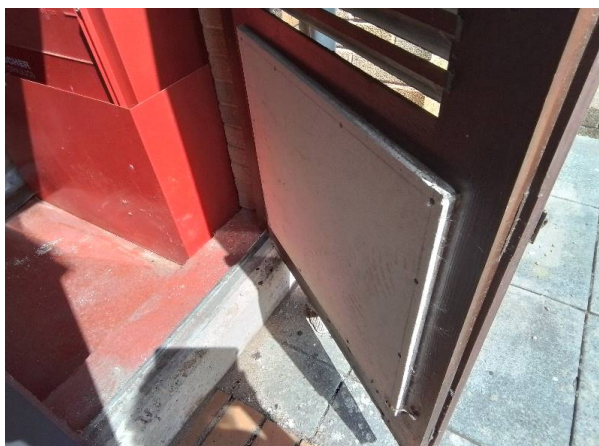
Building:	1 - 31 Maes Trisant	Floor Level:	External	Item Ref:	J329567-50
Room Name:	(046) Lift Motor Room				
Sample Ref:	JZ001111				
Component:	Insulation board panels to doors				
Extent:	2m ²

Material Assessment		
Product Type	Extent of damage	Surface Treatment Score
Asbestos Type	Material Assessment Score (MA)	
No Asbestos Detected

Conclusions and Actions	
Recommendation:	No further action required
Further Information:	None
General Notes: Modern sarking felt. Brick walls. Concrete floor. Modern hydraulic lift. Insulation board panels to wooden doors.

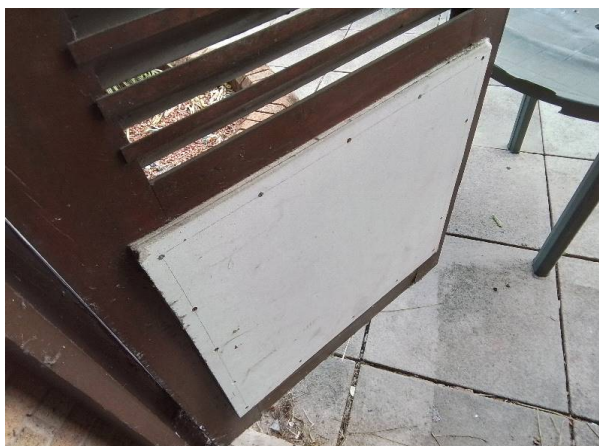
Building:	1 - 31 Maes Trisant	Floor Level:	External	Item Ref:	J329567-51
Room Name:	(047) Lift Motor Room				
Sample Ref:	As JZ001111				
Component:	Insulation board panels to doors				
Extent:	2m ²

Material Assessment		
Product Type	Extent of damage	Surface Treatment Score
Asbestos Type	Material Assessment Score (MA)	
No asbestos detected in visually consistent material

Conclusions and Actions	
Recommendation:	No further action required
Further Information:	None
General Notes: Modern sarking felt. Brick walls. Concrete floor. Modern hydraulic lift. Insulation board panels to wooden doors.

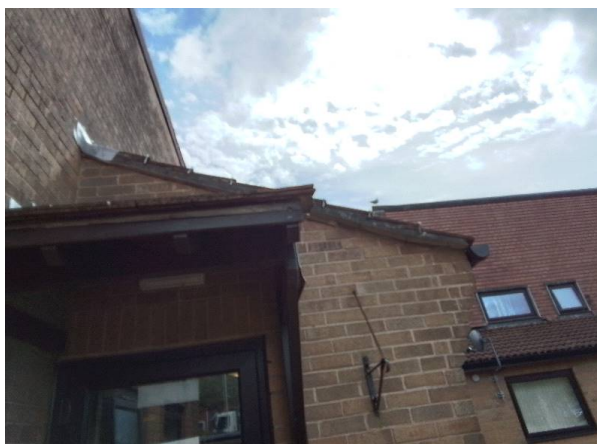
Building:	1 - 31 Maes Trisant	Floor Level:	External	Item Ref:	J329567-56
Room Name:	(048) External				
Sample Ref:	JZ001112				
Component:	Cement board undercloak to roof				
Extent:	40lm

Material Assessment		
Product Type	Extent of damage	Surface Treatment Score
Asbestos Type	Material Assessment Score (MA)	
No Asbestos Detected

Conclusions and Actions	
Recommendation:	No further action required
Further Information:	None
General Notes: Modern roof tiles. Modern insulation board soffits and wooden fascias. Plastic drainpipes and guttering. Cement board undercloak to roof. Presumed asbestos cement board ridge tiles to roof. uPVC windows and sills. Metal front door sets to building. uPVC doors to front and rear of building. Wooden doors to electrical cupboard, boiler room, gas intake room, external store, lift motor rooms and scooter store. Foam lagging to metal pipework. Wooden ceiling panels at entrance to building. Modern damp proof course.
