## Management with Targeted Refurbishment Survey to Shower Room

19 Trem y Mynydd  
Taff Street  
Treherbert  
Treorchy  
CF42 5LJ  
UPRN: 6686

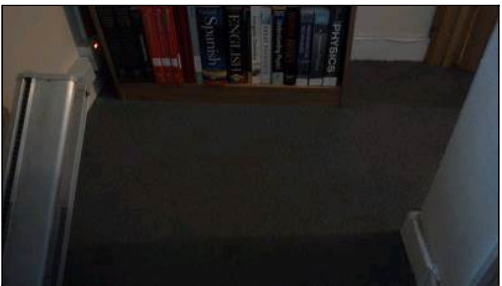
| | Survey Date: | Lead Surveyor | Survey Type | Floor | Analysis |
|---|---|---|---|---|---|
| | 24 Jan 2018 | Dave Milton | Management Survey | 1st | Chrysotile (1) |

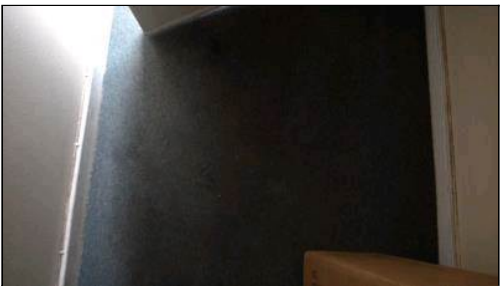
| | Survey Date: | Lead Surveyor | Survey Type | Floor | Analysis |
|---|---|---|---|---|---|
| | 24 Jan 2018 | Dave Milton | Management Survey | Ground | Chrysotile (1) |
