## Management Survey

28 Trem y Mynydd  
Taff Street  
Treherbert  
Treorchy  
CF42 5JL  
UPRN: 6695

**Kovia**

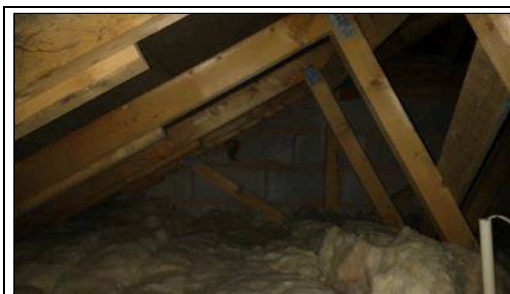
| Survey Date: | Lead Surveyor | Survey Type | Floor | Analysis |
| 24 Jan 2018 | Dave Milton | Management Survey | Roof | N/A |

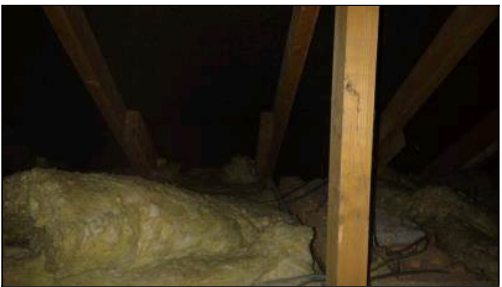
| | Survey Date: | Lead Surveyor | Survey Type | Floor | Analysis |
| | 24 Jan 2018 | Dave Milton | Management Survey | Roof | N/A |

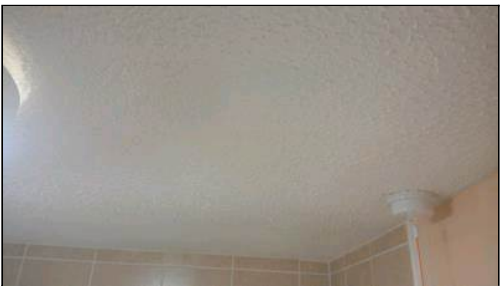
| | Survey Date: | Lead Surveyor | Survey Type | Floor | Analysis |
| | 24 Jan 2018 | Dave Milton | Management Survey | 1st | No Asbestos Detected (0) |

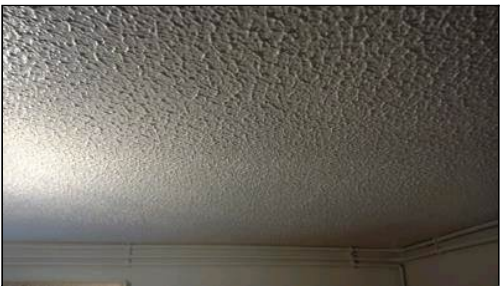
| | Survey Date: | Lead Surveyor | Survey Type | Floor | Analysis |
| | 24 Jan 2018 | Dave Milton | Management Survey | 1st | No Asbestos Detected (0) |

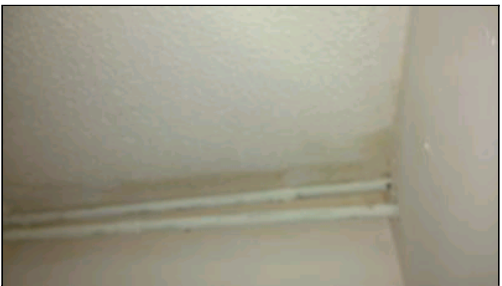
| | Survey Date: | Lead Surveyor | Survey Type | Floor | Analysis |
| | 24 Jan 2018 | Dave Milton | Management Survey | 1st | No Asbestos Detected (0) |

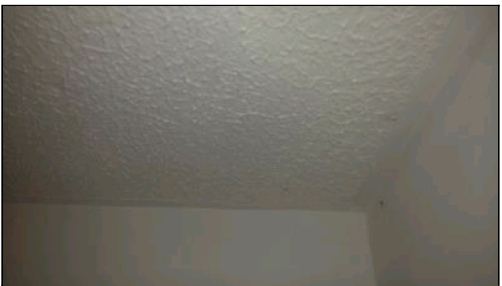
| | Survey Date: | Lead Surveyor | Survey Type | Floor | Analysis |
| | 24 Jan 2018 | Dave Milton | Management Survey | 1st | No Asbestos Detected (0) |

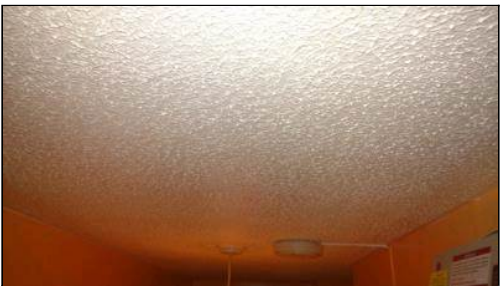
| | Survey Date: | Lead Surveyor | Survey Type | Floor | Analysis |
| | 24 Jan 2018 | Dave Milton | Management Survey | 1st | No Asbestos Detected (0) |

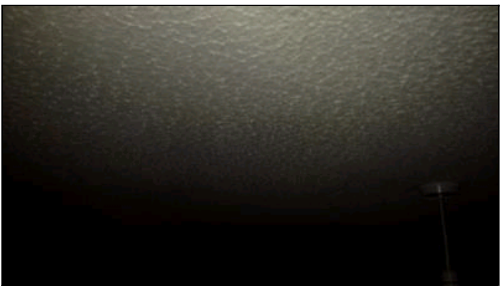
| | Survey Date: | Lead Surveyor | Survey Type | Floor | Analysis |
| | 24 Jan 2018 | Dave Milton | Management Survey | 1st | No Asbestos Detected (0) |

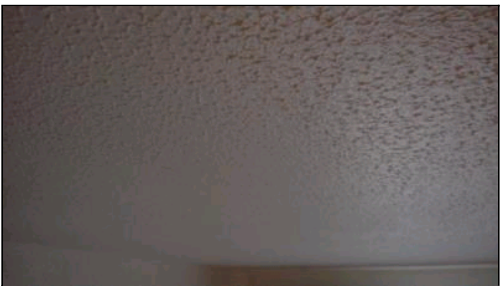
| | Survey Date: | Lead Surveyor | Survey Type | Floor | Analysis |
| | 24 Jan 2018 | Dave Milton | Management Survey | 1st | No Asbestos Detected (0) |

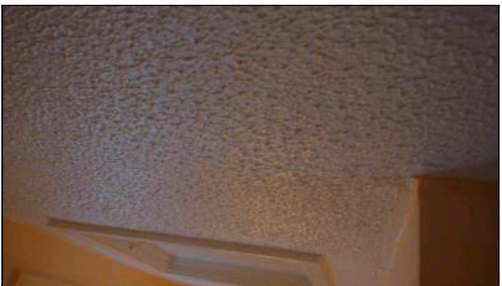
| | Survey Date: | Lead Surveyor | Survey Type | Floor | Analysis |
| | 24 Jan 2018 | Dave Milton | Management Survey | 1st | No Asbestos Detected (0) |

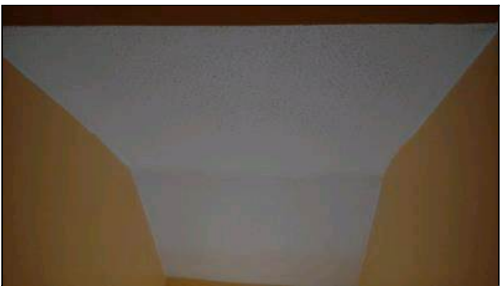
| | Survey Date: | Lead Surveyor | Survey Type | Floor | Analysis |
| | 24 Jan 2018 | Dave Milton | Management Survey | Ground | No Asbestos Detected (0) |
