## Asbestos Management Survey

26 Cyncoed  
Ynysyawl  
Pontypridd  
Mid Glamorgan  
CF37 3PL  
UPRN: 007931

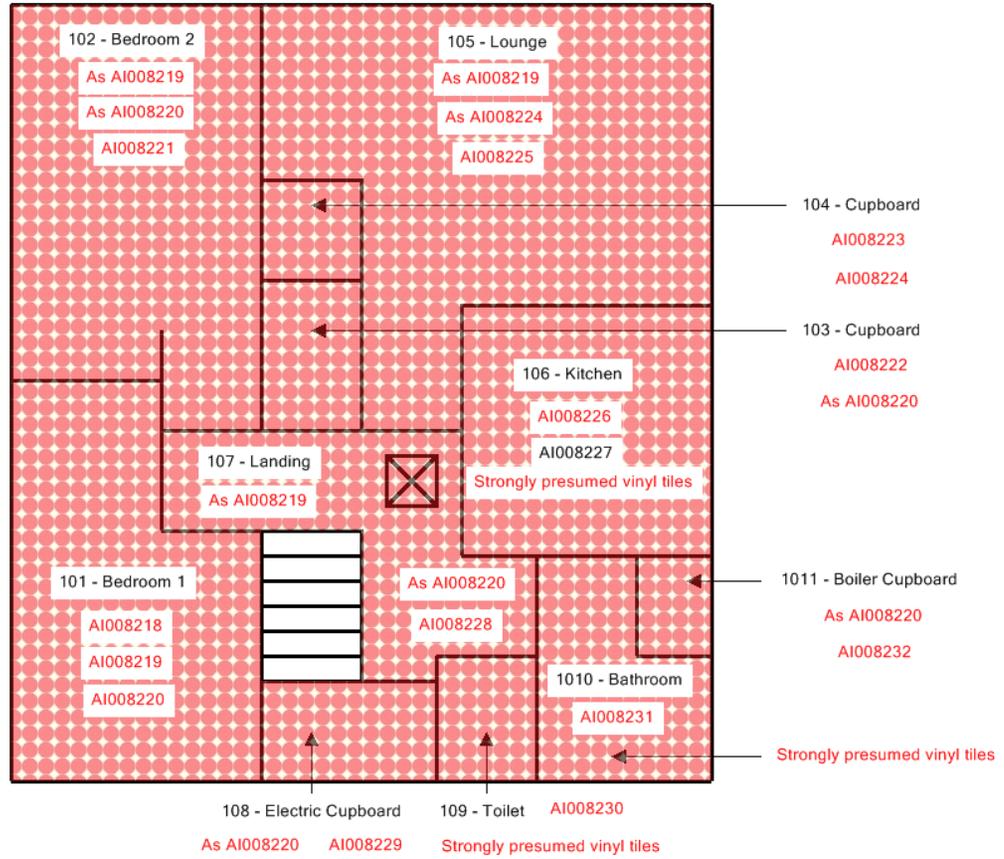
Client: Wales & West Housing  
Site: 26 Cyncoed Building: Block 25-28, Flat 26  
Floor: 1st Floor  
UPRN No: 007931

Building	Floor	Room	Description	Material	Risk assessment Score	Recommendations
Block 25-28, Flat 26						
Block 25-28, Flat 26	1st	Bedroom 1 101	Textured coating to plasterboard ceiling	Textured Coating	LOW (4 + 7)	Encapsulate or repair
Block 25-28, Flat 26	1st	Bedroom 1 101	Dark brown vinyl tiles to concrete floor	Vinyl floor tiles	LOW (2 + 7)	Manage and re-inspect
Block 25-28, Flat 26	1st	Bedroom 1 101	Beige vinyl tiles and bitumen adhesive to concrete floor	Vinyl floor tiles	LOW (2 + 7)	Manage and re-inspect
Block 25-28, Flat 26	1st	Bedroom 2 102	Textured coating to plasterboard ceiling	Textured Coating	LOW (2 + 7)	Manage and re-inspect
Block 25-28, Flat 26	1st	Bedroom 2 102	Dark brown vinyl tiles to concrete floor	Vinyl floor tiles	LOW (3 + 7)	Manage and re-inspect
Block 25-28, Flat 26	1st	Bedroom 2 102	Beige vinyl tiles and bitumen adhesive to concrete floor	Vinyl floor tiles	LOW (2 + 7)	Manage and re-inspect

Building	Floor	Room	Description	Material	Risk assessment Score	Recommendations
Block 25-28, Flat 26	1st	Lounge 105	Textured coating to plasterboard ceiling	Textured Coating	LOW (4 + 6)	Encapsulate or repair
Block 25-28, Flat 26	1st	Lounge 105	Dark brown vinyl tiles to concrete floor	Vinyl floor tiles	LOW (3 + 6)	Manage and re-inspect
Block 25-28, Flat 26	1st	Lounge 105	Green vinyl tiles and bitumen adhesive to concrete floor	Vinyl floor tiles	LOW (2 + 7)	Manage and re-inspect
Block 25-28, Flat 26	1st	Kitchen 106	Textured coating to plasterboard ceiling	Textured Coating	LOW (2 + 6)	Manage and re-inspect
Block 25-28, Flat 26	1st	Kitchen 106	Strongly presumed vinyl tiles to concrete floor	Textured Coating	LOW (2 + 4)	Inspection required
Block 25-28, Flat 26	1st	Landing 107	Textured coating to plasterboard ceiling	Textured Coating	LOW (3 + 6)	Manage and re-inspect
Block 25-28, Flat 26	1st	Landing 107	Dark brown vinyl tiles to concrete floor	Vinyl floor tiles	LOW (3 + 6)	Manage and re-inspect

Building	Floor	Room	Description	Material	Risk assessment Score	Recommendations
Block 25-28, Flat 26	1st	Toilet 109	Textured coating to plasterboard ceiling	Textured Coating	LOW (2 + 6)	Manage and re-inspect
Block 25-28, Flat 26	1st	Toilet 109	Strongly presumed vinyl tiles to concrete floor	Textured Coating	LOW (2 + 4)	Inspection required
Block 25-28, Flat 26	1st	Bathroom 110	Textured coating to plasterboard ceiling	Textured Coating	LOW (2 + 6)	Manage and re-inspect
Block 25-28, Flat 26	1st	Bathroom 110	Strongly presumed vinyl tiles to concrete floor	Textured Coating	LOW (2 + 4)	Inspection required
Block 25-28, Flat 26	1st	Boiler Cupboard 111	Textured coating to plasterboard ceiling	Textured Coating	LOW (2 + 6)	Manage and re-inspect
Block 25-28, Flat 26	1st	Boiler Cupboard 111	Beige vinyl tiles and bitumen adhesive to concrete floor	Vinyl floor tiles	LOW (2 + 6)	Manage and re-inspect
Block 25-28, Flat 26	Ground	Hall G01	Textured coating to concrete and plasterboard ceiling	Textured Coating	LOW (2 + 6)	Manage and re-inspect
