**WALES & WEST HOUSING  
ASSOCIATION  
3 ALEXANDRA GATE  
FFORDD PENGAM  
TREMORFA  
CARDIFF  
CF24 2UD**

**PROJECT NO: J172296**

**DATE: APRIL 2014**

**ASBESTOS MANAGEMENT SURVEY  
OF  
ST PETERS COURT, PENTRE ROAD, PENTRE, CF41 7DQ**

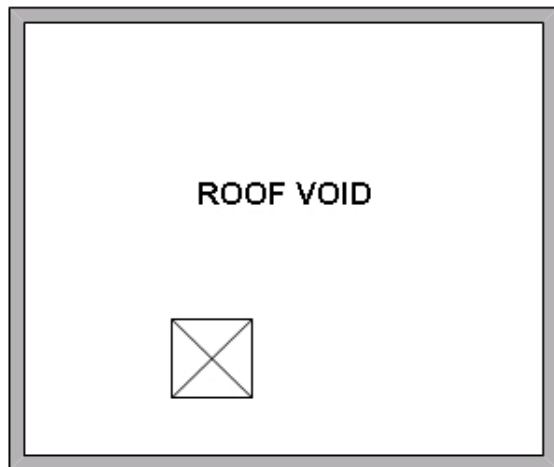
**These plans are provided to assist in the location and designation of rooms etc**

**“This Plan Must Be Read In Conjunction With The Register”**
