**ASBESTOS MANAGEMENT SURVEY  
OF  
5 ST. PETERS COURT, PENTRE ROAD, PENTRE, RHONDDA, CF41 7DQ**

**CLIENT: WALES & WEST HOUSING ASSOCIATION  
3 ALEXANDRA GATE, FFORDD PENGAM, TREMORFA, CARDIFF, CF24 2UD**

**UPRN NO: 6402  
PROJECT NO: J237967  
DATE: MARCH 2015**

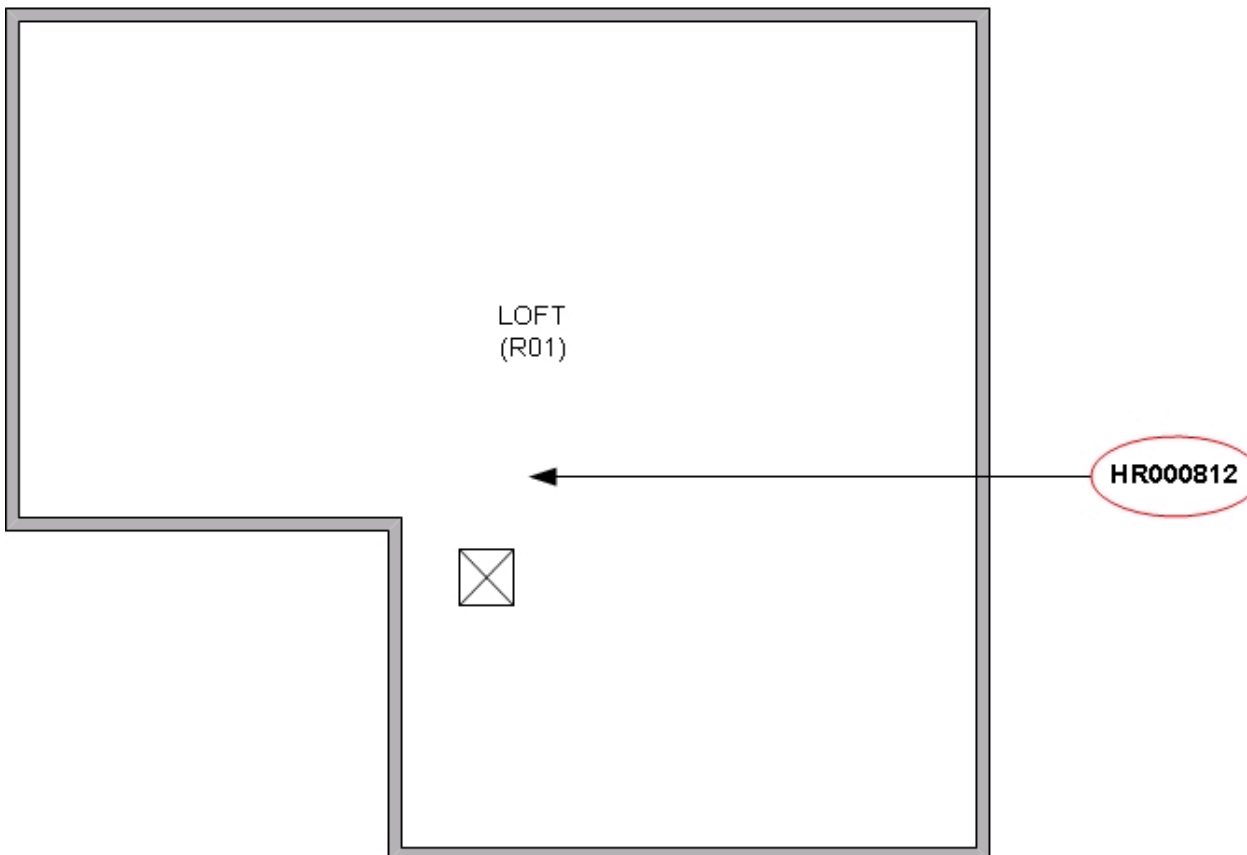
Floor: Roof Void

**"This Plan Must Be Read In Conjunction With The Register" Plan Generated by Farooq Chaudhary**
