**ASBESTOS MANAGEMENT SURVEY  
OF  
2 CYNCOED, YNYSYBWL, PONTYPRIDD, CF37 3PL**

**CLIENT: WALES & WEST HOUSING ASSOCIATION  
3 ALEXANDRA GATE, FFORDD PENGAM, TREMORFA, CARDIFF, CF24 2UD**

**UPRN NO: 7907  
PROJECT NO: J226239  
DATE: FEBRUARY 2015**

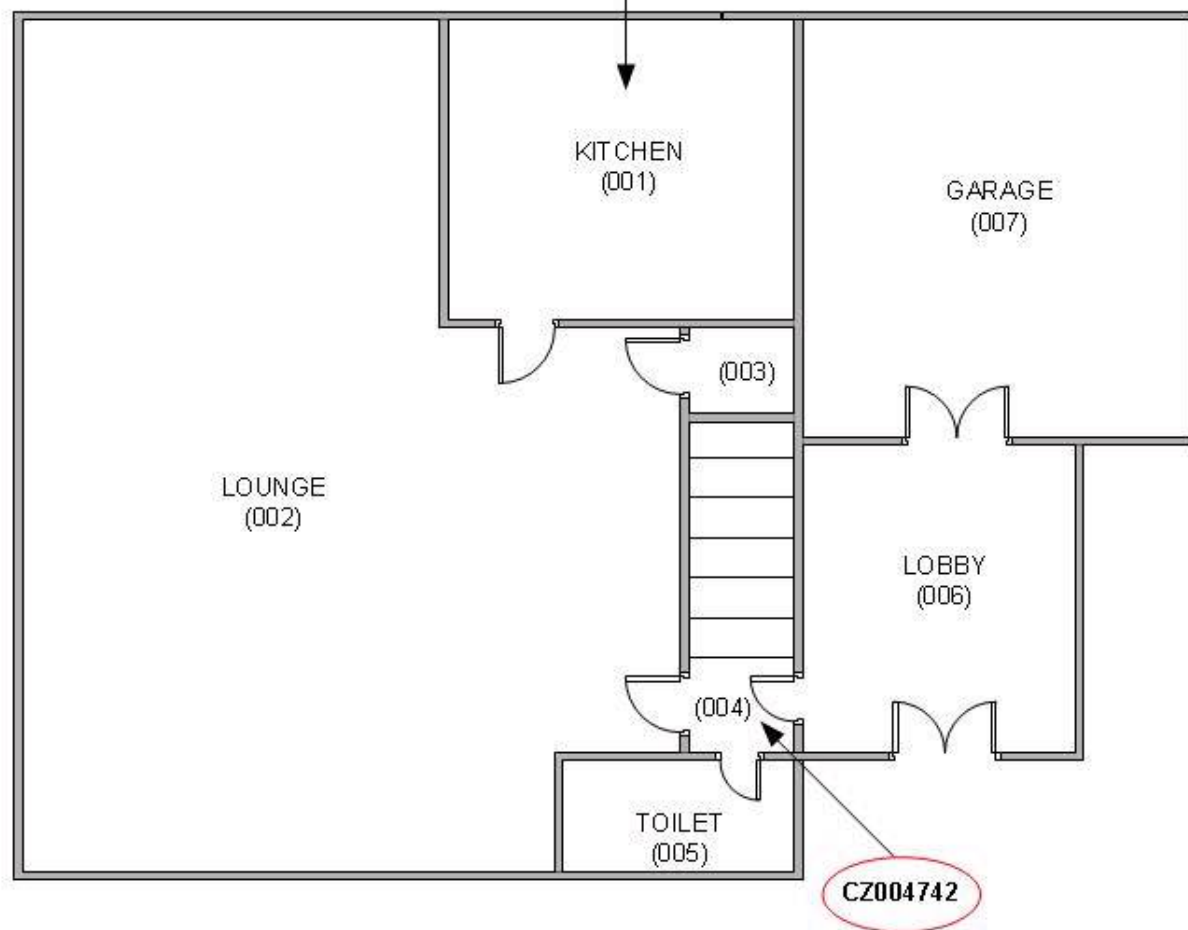
**These plans are provided to assist in the location and designation of rooms etc**

**The accuracy of the plans / sketches cannot be guaranteed.**

S = Sample Location

location and designation of rooms for ease of reference. It must be noted that these plans are not to be regarded as accurate but for assistance purposes only. These plans are located within the appendices of this report.

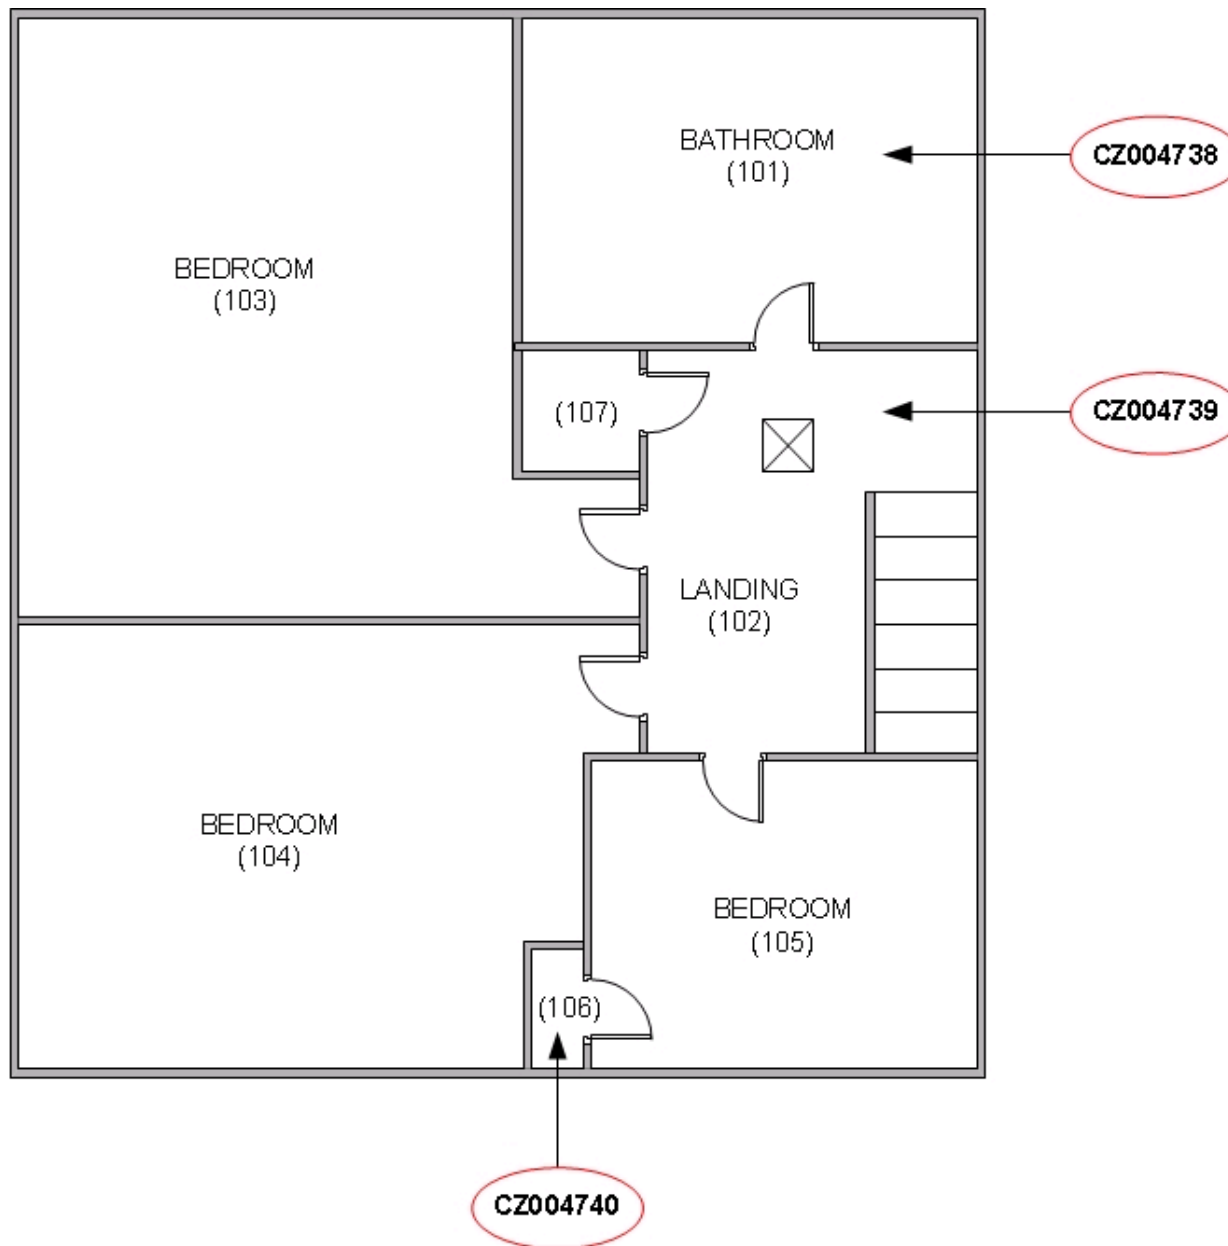
Floor: 1st Floor

N.T.S (Not To Scale)

**"This Plan Must Be Read In Conjunction With The Register"**
