Asbestos Register
based upon a
Sampling Type '2' Survey

of
'Rhondda Housing Association'
Ty Rhondda,
97 Dunraven Street,
Tonypanydy.
CF40 1AR

Surveyor: John Noonan
Registrar: Karen Parsons-Young
Report No. CES 207035
Authorised By: Nick Parsons-Young (Managing Director)

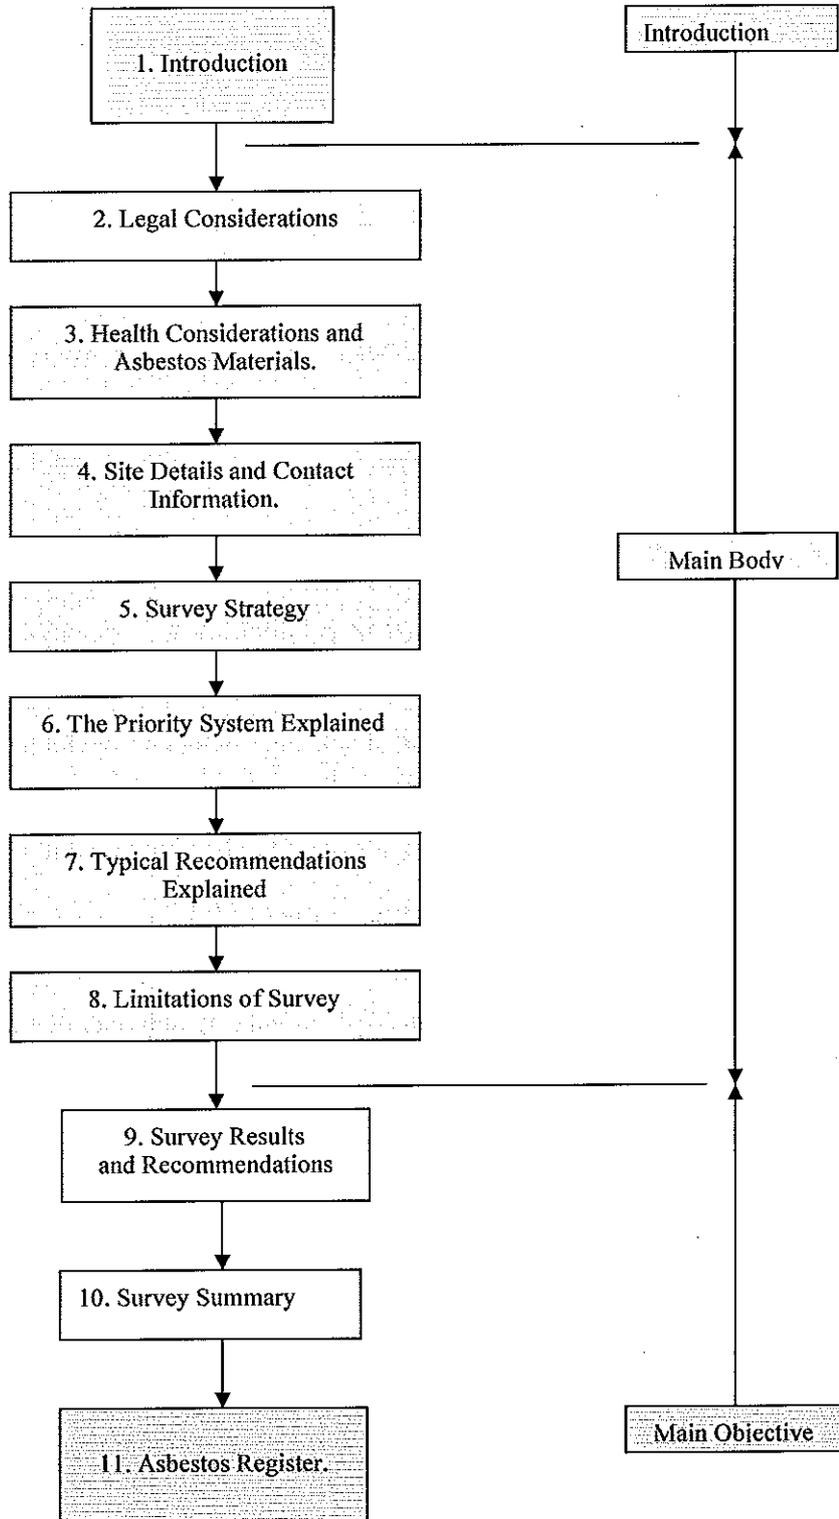
**Structure
Of
Report.**

As an aid to understanding, a flow chart has been drawn below to illustrate the contents and order of this report.

This report has been written in as logical an order as possible. The main body of the report seeks to present the basis upon which the survey results will be assessed. The closing sections display firstly the survey results with corresponding recommendations and then finally the Asbestos Register which forms the conclusion of this document.

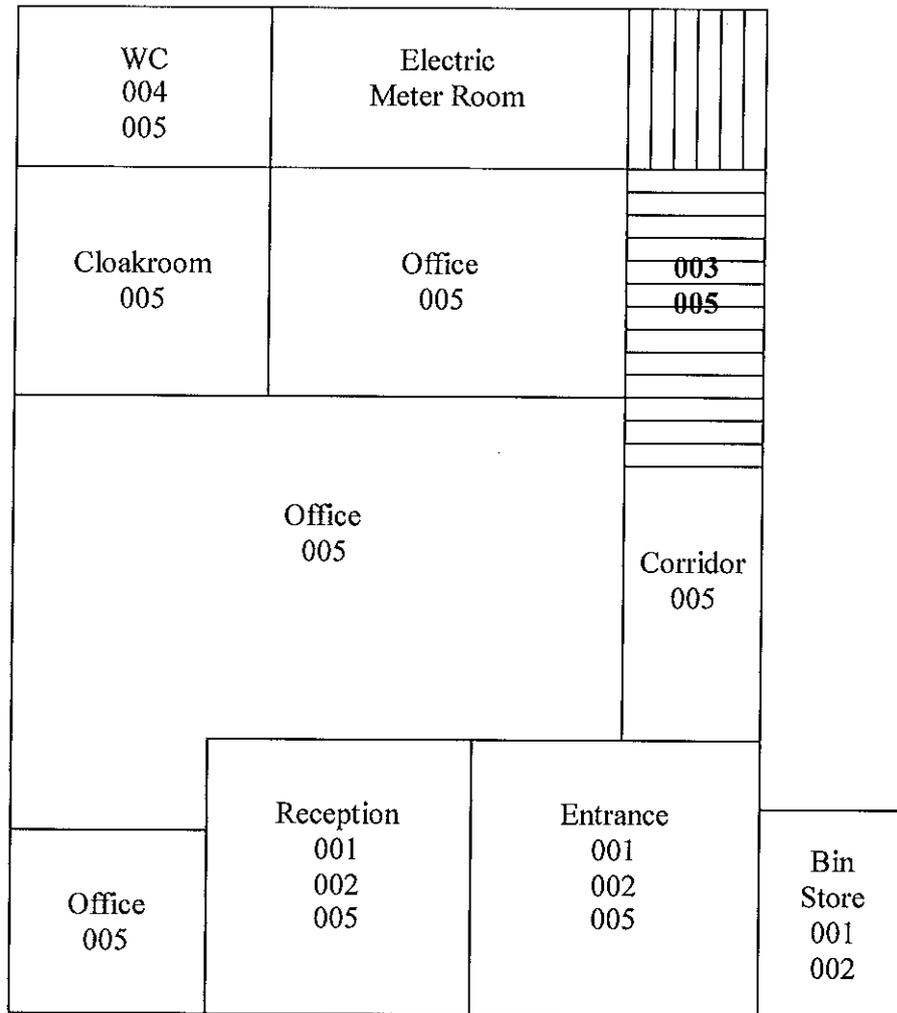
GROUND FLOOR RECEPTION AREA

97 DUNRAVEN STREET

Check Contents page (next page) and look up 'Survey Results and Recommendations' The location plan can be found at the rear of this section. However, some surveys do not require a location plan so please check the photos on the 'Survey Results and Recommendations' sheets.

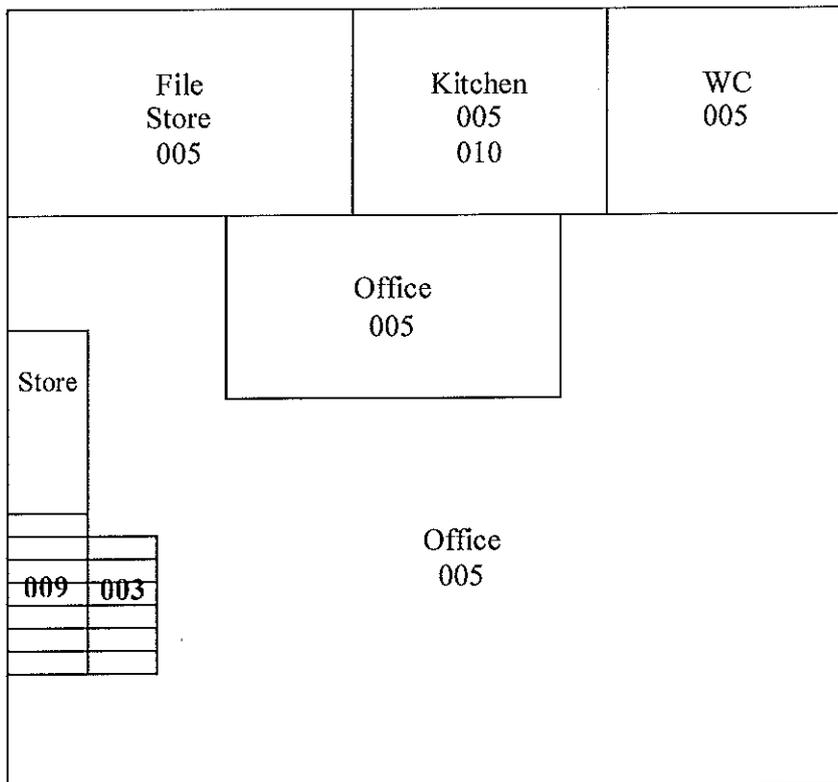
GROUND FLOOR ACCOUNTS DEPARTMENT

97 DUNRAVEN STREET

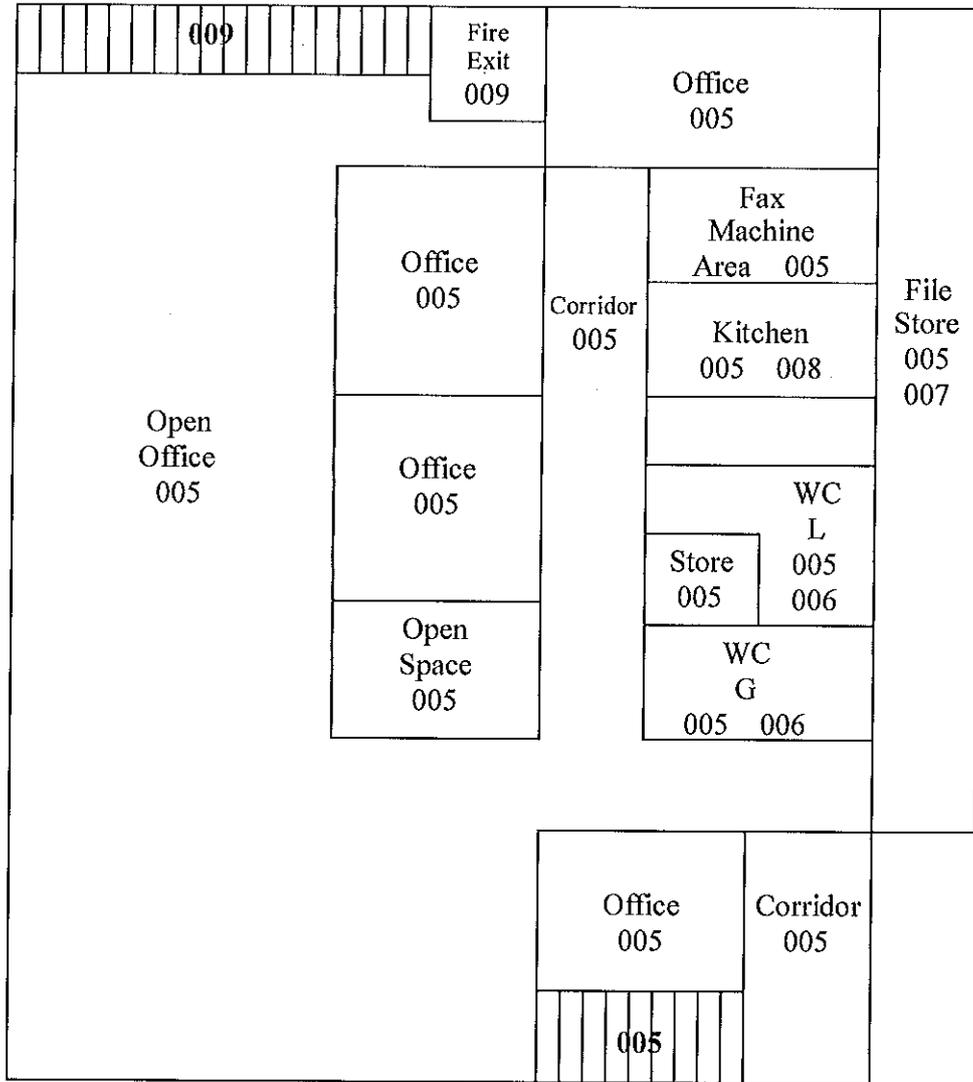
FIRST FLOOR

97 DUNRAVEN STREET
